State of California — The Resources Agency  
 DEPARTMENT OF PARKS AND RECREATION  
**PRIMARY RECORD**

Page 1 of 3 \*Resource name(s) or number (assigned by recorder) 1003 – 1013 Shetler Avenue

\*P11. Report Citation: (Cite survey report and other sources, or enter "none") Heritage Napa: Soscol Gateway/East Napa Historic Resource Survey

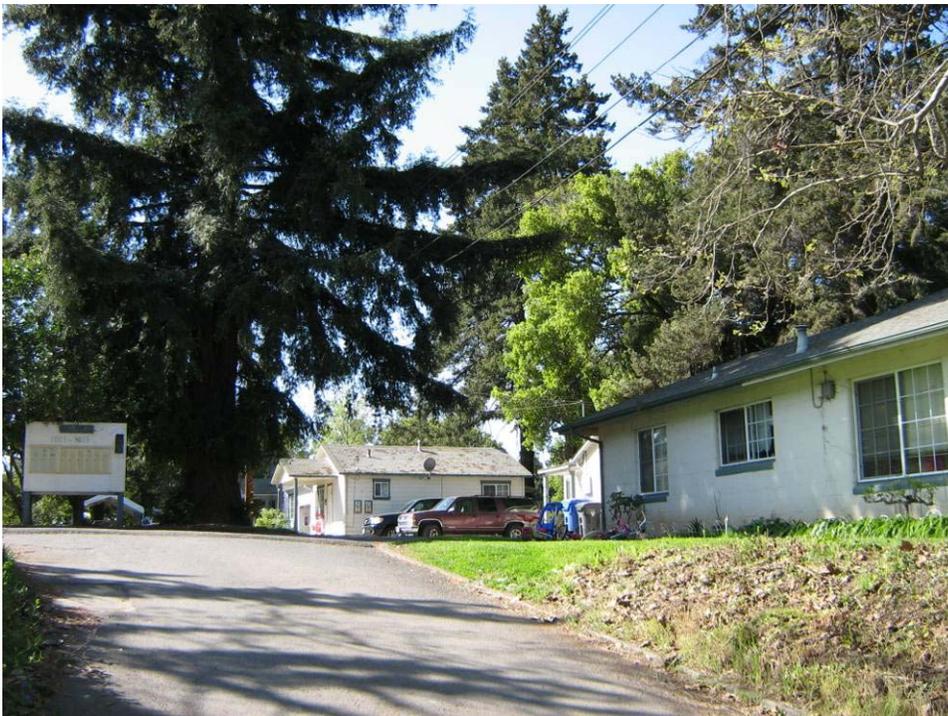
\*P5b. Photo: (view and date)  
West side of bungalow court,  
looking south  
3/24/2009

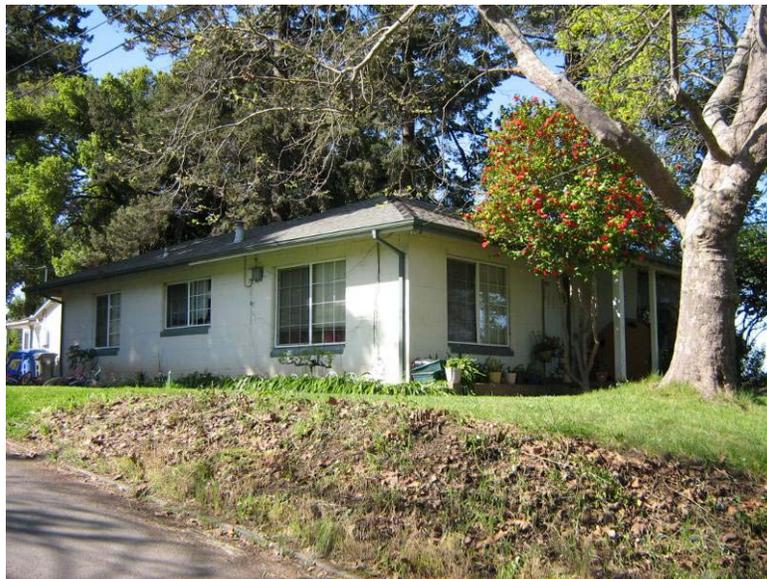
Northwestern house, primary and east facades, looking southwest.

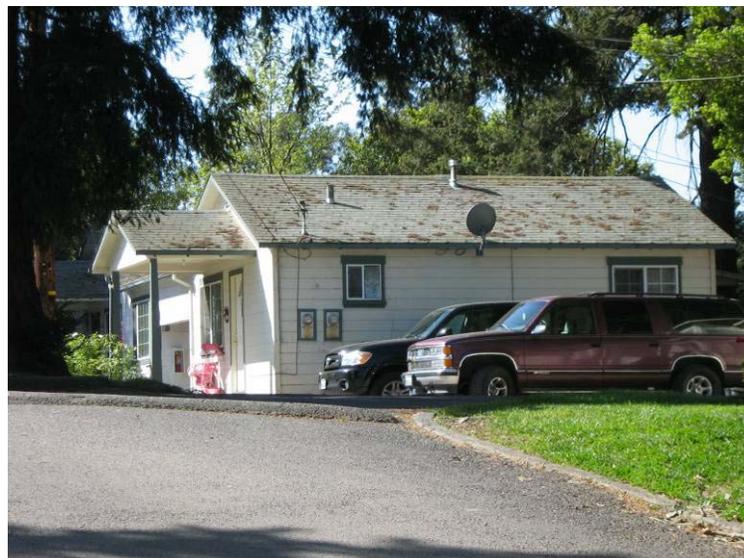
Southwestern duplex, primary and north facades, looking southwest.

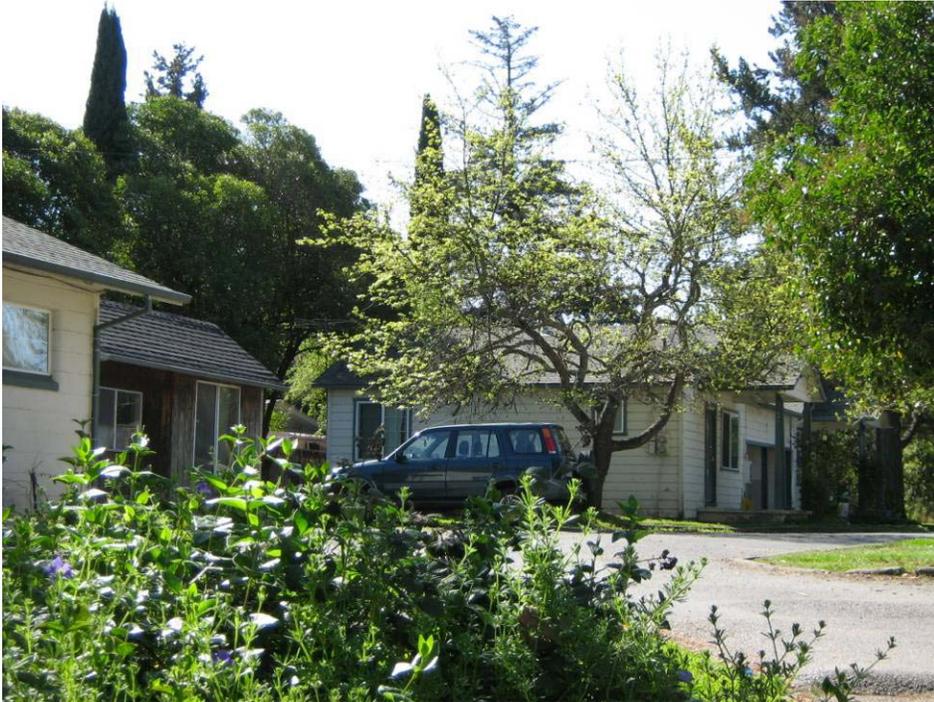
Southeastern duplex, primary and north facades, looking southeast.  
(Garage addition and portion of northeastern house visible at left.)

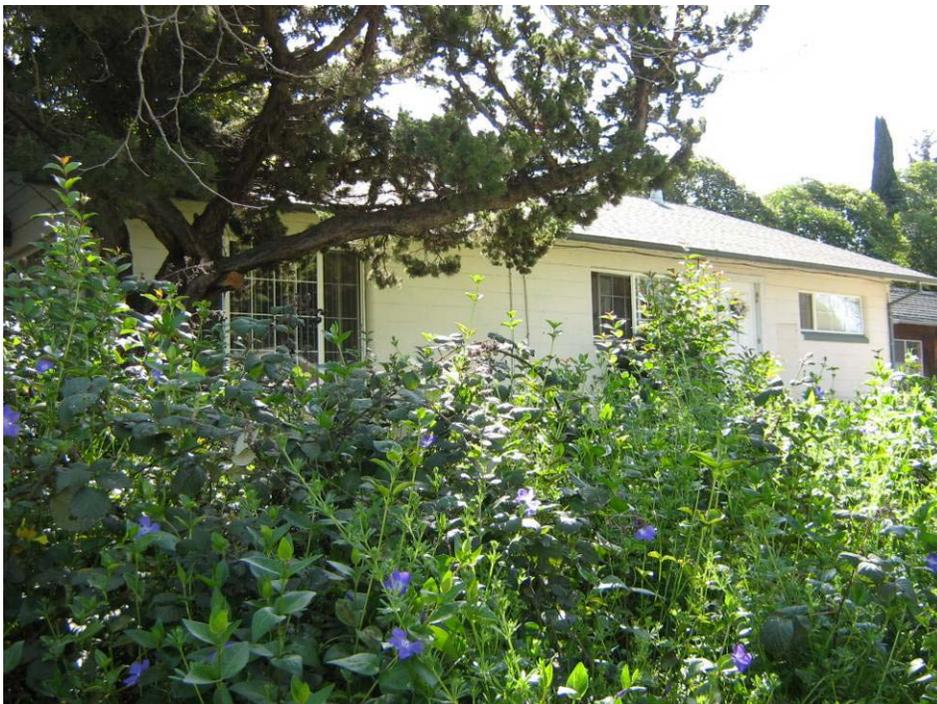
Northeastern house, primary facade, looking southeast.
