Napa Oaks Project
 City of Napa, Napa County, California

Prepared by:
HortScience, Inc.
325 Ray Street
Pleasanton, CA 94566

July 2011

REVISED TREE REPORT
Napa Oaks
Napa, CA

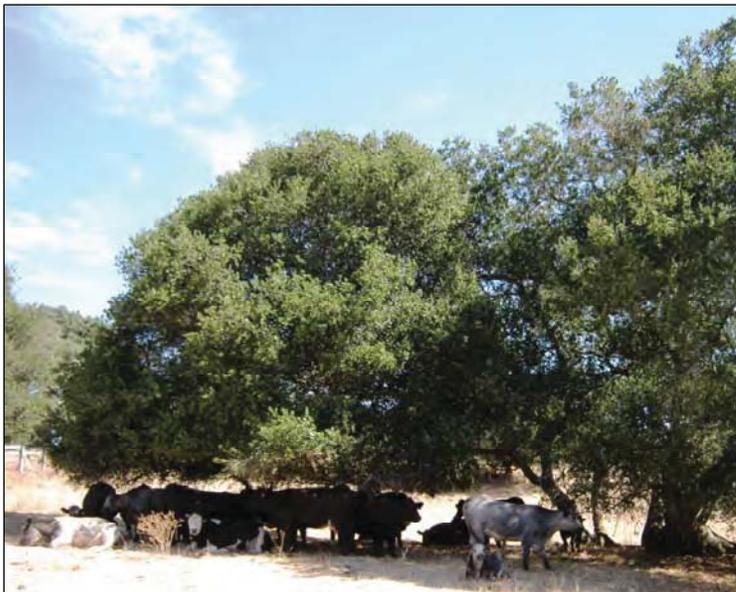
The site was a native oak woodland with groupings of trees separated by open grasslands, where cattle grazed (photo 1). Cattle grazing can have a direct impact on vegetation, through feeding (especially on young plants), rubbing on tree trunks and compacting soil beneath trees, where they gather for shade. Evidence of these impacts was present at the Napa Oaks site.

Photo 1: Cattle grazing beneath the shade of a group of coast live oaks (#909-914). Grazing, soil compaction and direct injury can lead to a variety of tree impacts. Typically, grazing leads to a lack of young trees, as they are browsed on. However, this was not the case at the Napa Oaks site, where there were many young coast live oaks.

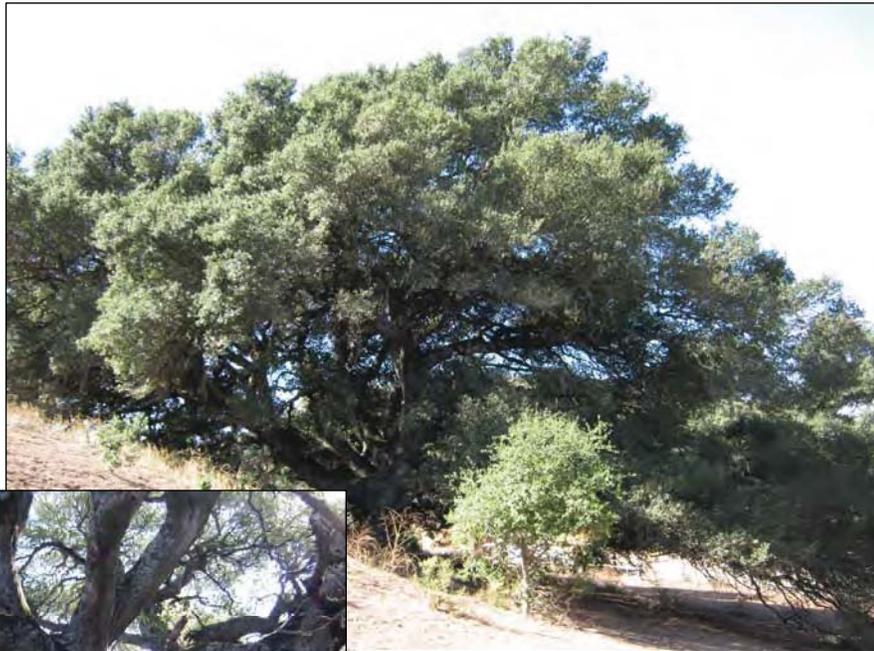
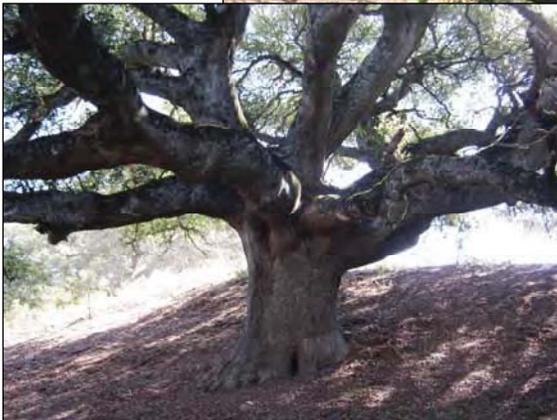
Photo 2: Coast live oak #1080 was in excellent condition, with a spreading crown and branches to the ground. Inset shows branching structure comprised of several heavy lateral limbs.

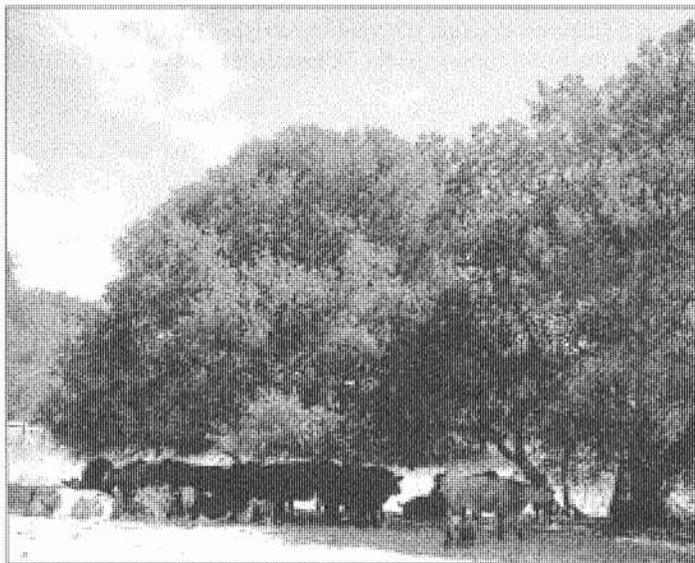
The site was a native oak woodland with groupings of trees separated by open grasslands, where cattle grazed (photo 1). Cattle grazing can have a direct impact on vegetation, through feeding (especially on young plants), rubbing on tree trunks and compacting soil beneath trees, where they gather for shade. Evidence of these impacts was present at the Napa Oaks site.

Photo 1: Cattle grazing beneath the shade of a group of coast live oaks (#909-914). Grazing, soil compaction and direct injury can lead to a variety of tree impacts. Typically, grazing leads to a lack of young trees, as they are browsed on. However, this was not the case at the Napa Oaks site, where there were many young coast live oaks.

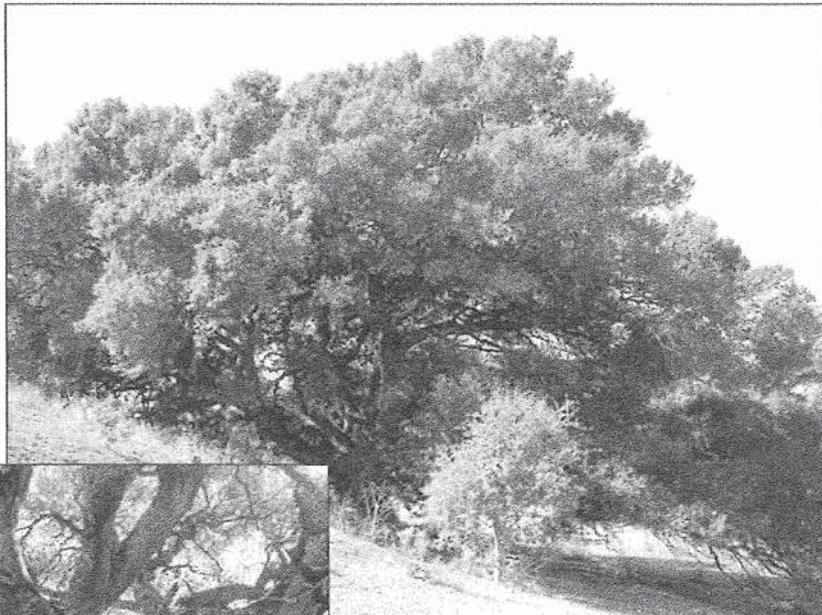
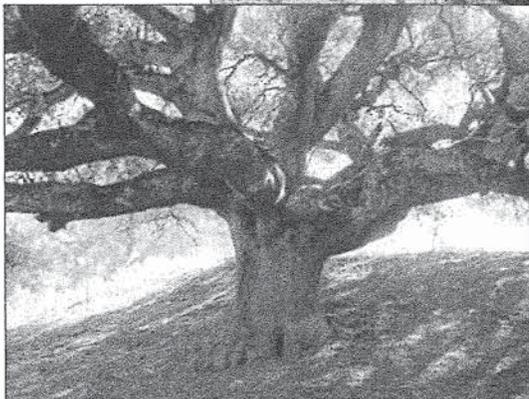
Photo 2: Coast live oak #1080 was in excellent condition, with a spreading crown and branches to the ground. Inset shows branching structure comprised of several heavy lateral limbs.
