State of California -- The Resources Agency
DEPARTMENT OF PARKS AND RECREATION
PRIMARY RECORD

Page 1 of 1 *Resource Name or #: (Assigned by Recorder) 1404 BANKS AVE

*P11. Report Citation: Alta Heights Historic

Context Statement and Survey Report

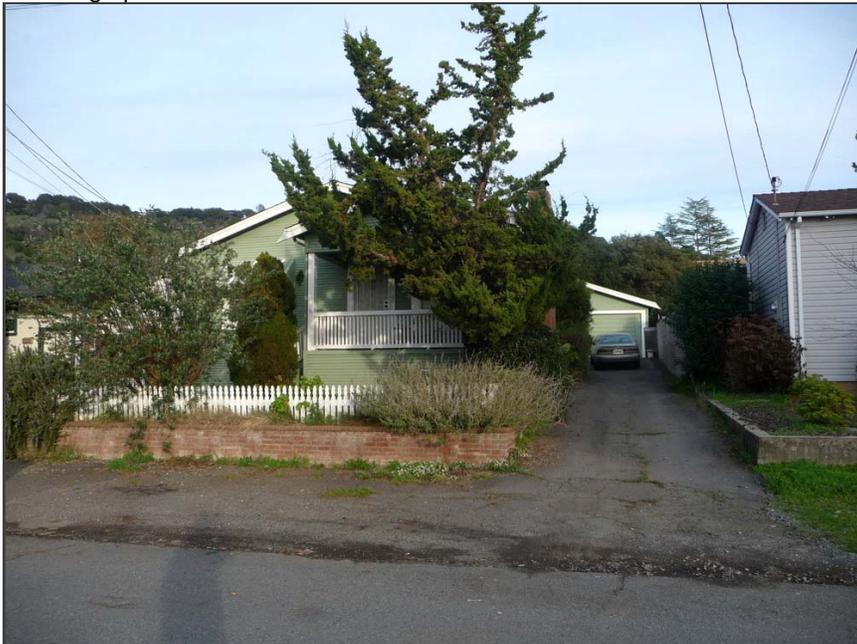
P5a. Photograph

- Style(s): No style
- Stories: 1
- Cladding: wood clapboards
- Porch: entrance porch, partial width, wood steps, wood supports, wood rail
- Door(s): single, security door, door material unknown
- Windows: Type 1 - not visible
- Roof: front gable, material not visible, exposed rafter tails, vergeboards
- Chimney: none visible
- Related Features: detached 2-car garage
- Alterations: awnings incompatible, security door added
- Notes: Windows obscured by vegetation and not visible for evaluation

P5b. Description of Photo:
West elevation
ARG, January 2011

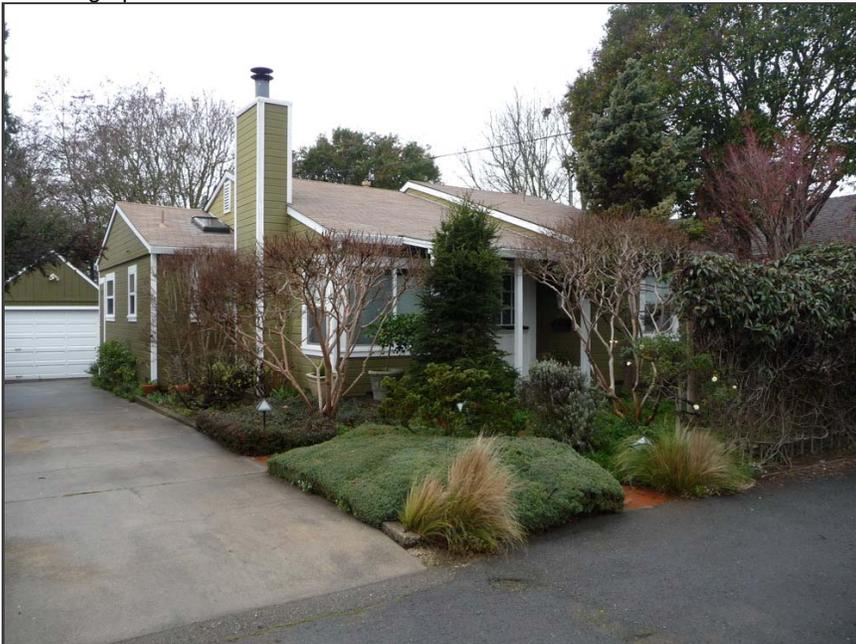
P5a. Photograph

- Style(s): Minimal Traditional
- Stories: 1
- Cladding: wood clapboards
- Porch: entrance porch, recessed, wood posts
- Door(s): single, divided lights, partially glazed, paneled; Secondary - single, door material unknown
- Windows: Type 1 - grouped, fixed, wood; Type 2 - single, double hung, vinyl
- Roof: side gable, composition sheets
- Chimney: wood, exterior
- Related Features: detached 2-car garage
- Alterations: Possibly that door was replaced, cladding altered over chimney
- Notes:

East elevation

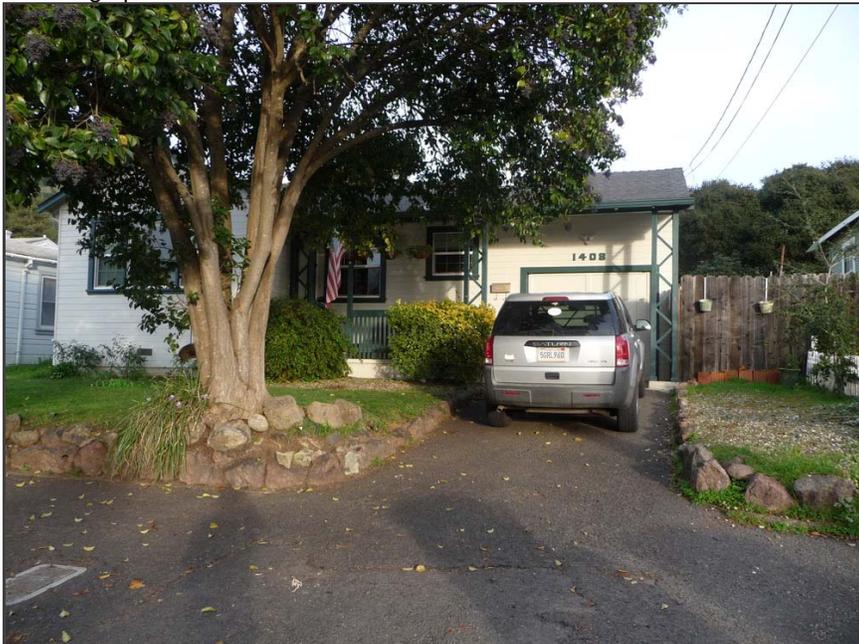
P5a. Photograph

- Style(s): Minimal Traditional
- Stories: 1
- Cladding: wood clapboards
- Porch: partial width, recessed, concrete steps, wood supports, wood rail
- Door(s): not visible
- Windows: Type 1 - grouped, double hung, vinyl; Type 2 - single, double hung, vinyl
- Roof: cross gable, composition shingle, open eaves
- Chimney: none visible
- Related Features: attached 1-car garage
- Alterations: windows replaced
- Notes:

West elevation

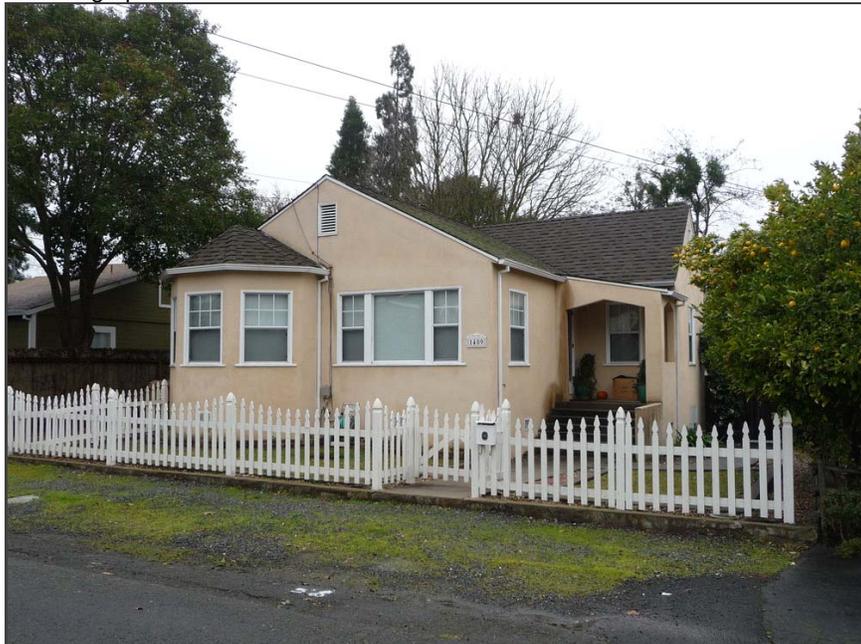
P5a. Photograph

- Style(s): Minimal Traditional / English Revival
- Stories: 1
- Cladding: smooth stucco
- Porch: entrance porch, recessed, concrete steps, stucco arches, stucco solid rail
- Door(s): single, door material unknown, metal screen
- Windows: Type 1 - single, double hung, vinyl; Type 2 - tripartite, double hung, vinyl, fixed, wood
- Roof: combination, cross gable, pyramidal hipped, composition shingle
- Chimney: none visible
- Related Features:
- Alterations: windows replaced
- Notes:

East elevation
ARG, January 2011

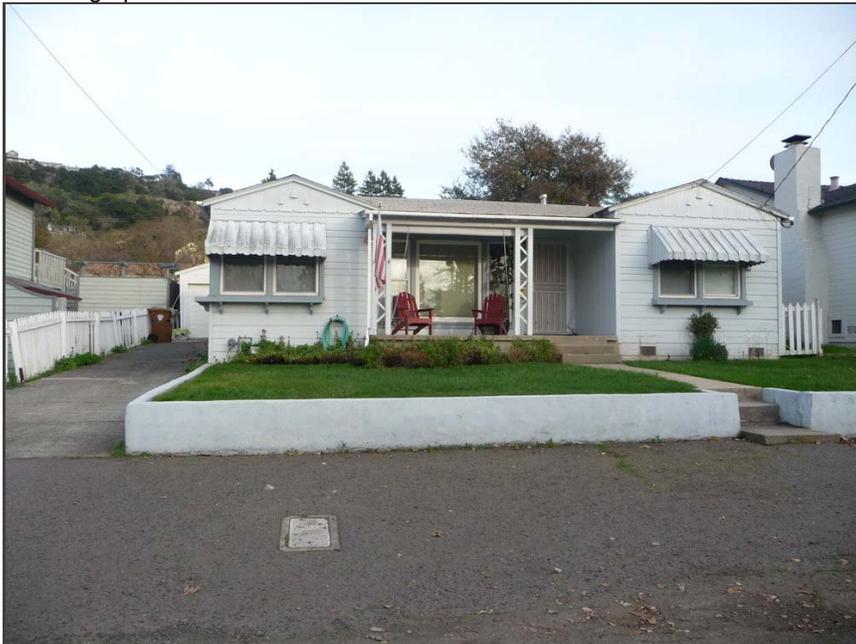
P5a. Photograph

- Style(s): Minimal Traditional
- Stories: 1
- Cladding: wood drop channel
- Porch: partial width, recessed, concrete steps, wood supports
- Door(s): single, security door, door material unknown
- Windows: Type 1 - grouped, double hung, aluminum; Type 2 - tripartite, fixed, vinyl, double hung, wood
- Roof: cross gable, composition sheets, open eaves
- Chimney: none visible
- Related Features: detached 2-car garage
- Alterations: awnings incompatible, security door added, windows replaced
- Notes:

West elevation

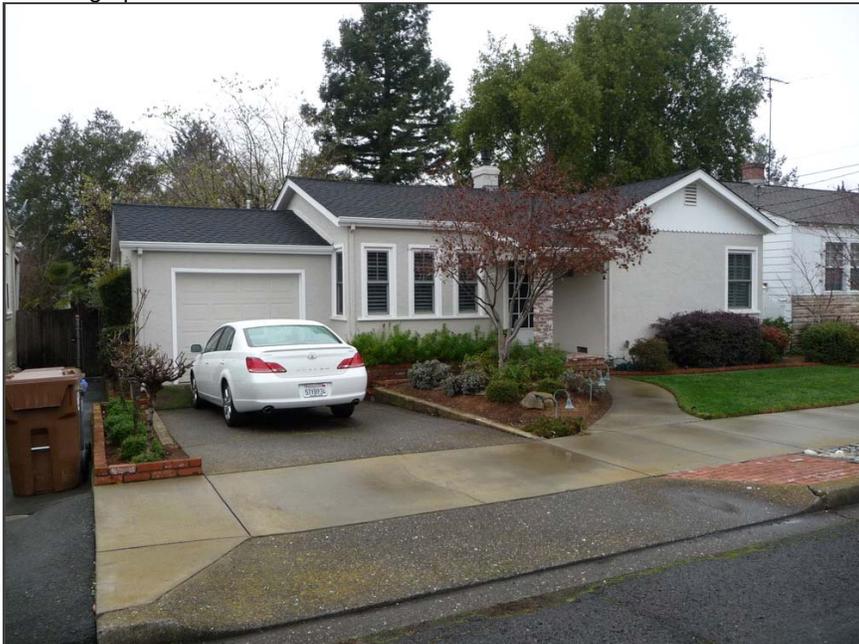
P5a. Photograph

- Style(s): Minimal Traditional
- Stories: 1
- Cladding: textured stucco
- Porch: entrance porch, recessed, brick steps, brick supports
- Door(s): single, door material unknown, divided lights, fully glazed
- Windows: Type 1 - grouped, double hung, vinyl; Type 2 - single, double hung, vinyl
- Roof: cross hipped, composition shingle
- Chimney: stucco, exterior
- Related Features: attached 1-car garage
- Alterations: windows replaced, porch supports altered
- Notes:

East elevation

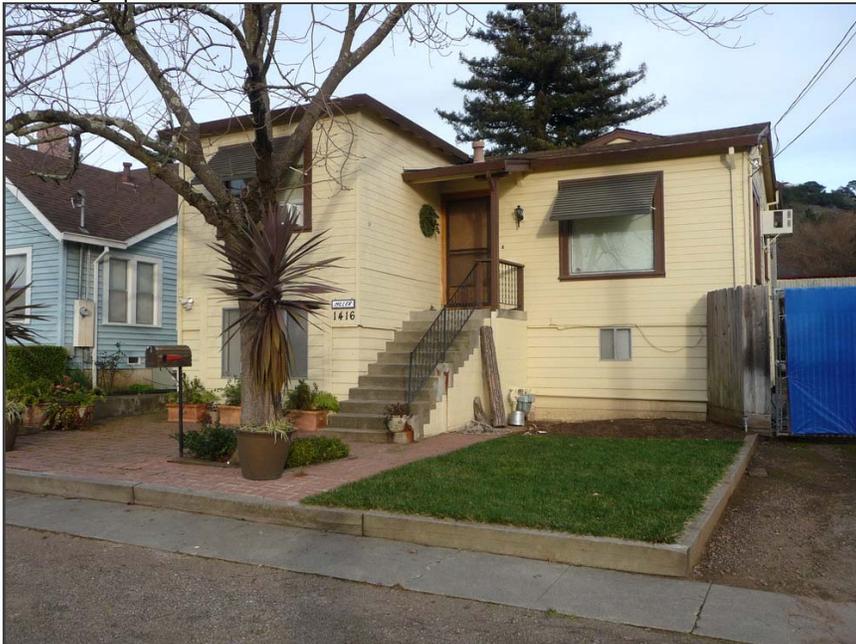
P5a. Photograph

- Style(s): Minimal Traditional
- Stories: 2
- Cladding: wood clapboards
- Porch: entrance porch, concrete steps, wood posts, pierced iron rail
- Door(s): single, wood, metal screen
- Windows: Type 1 - single, fixed, aluminum; Type 2 - single, sliding, aluminum
- Roof: combination, flat, side gable, composition shingle, intersecting gable at ridgeline, open eaves
- Chimney: none visible
- Related Features:
- Alterations: awnings incompatible, some windows replaced, attached one car garage converted to inhabitable space
- Notes:

West elevation

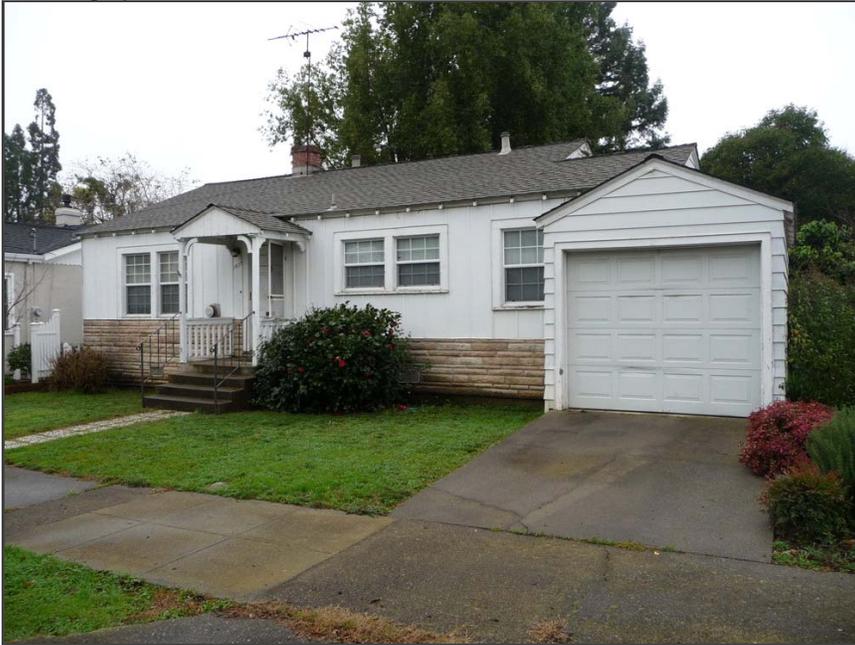
P5a. Photograph

- Style(s): Minimal Traditional
- Stories: 1
- Cladding: board and batten, permastone
- Porch: entrance porch, concrete steps, wood posts, wood rail
- Door(s): single, wood, paneled, metal screen
- Windows: Type 1 - single, double hung; Type 2 - paired, double hung, vinyl
- Roof: side gable, composition shingle, exposed rafter tails
- Chimney: brick, exterior
- Related Features: attached 1-car garage
- Alterations: cladding altered, windows replaced
- Notes: Garage has metal siding

East elevation

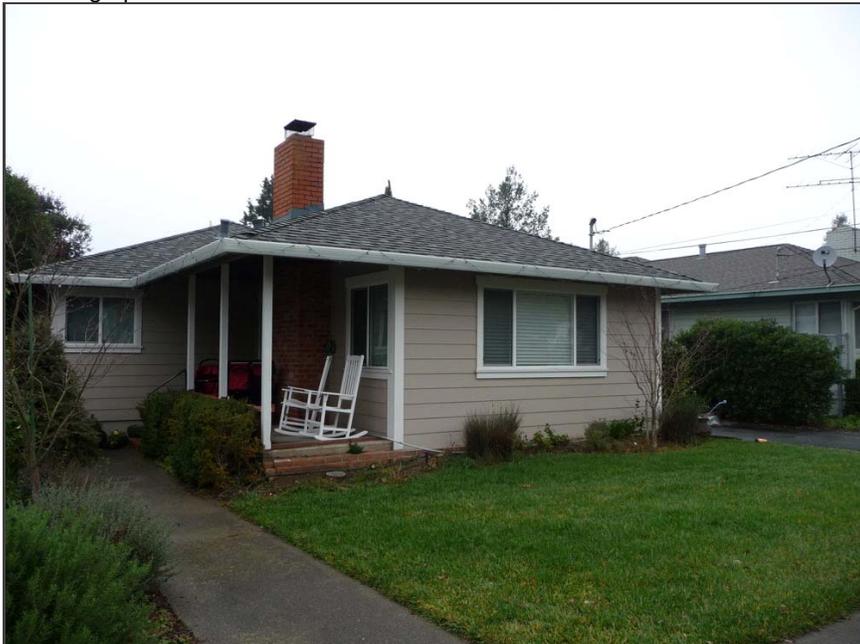
P5a. Photograph

- Style(s): Ranch, Minimal / Minimal Traditional
- Stories: 1
- Cladding: vinyl
- Porch: partial width, recessed, brick steps, wood posts
- Door(s): not visible, door material unknown
- Windows: Type 1 - grouped, sliding, vinyl; Type 2 - single, sliding, vinyl
- Roof: cross hipped, composition shingle, open eaves, wide eaves
- Chimney: brick, exterior
- Related Features: detached 1-car garage
- Alterations: cladding altered, windows replaced
- Notes:

East elevation
ARG, January 2011

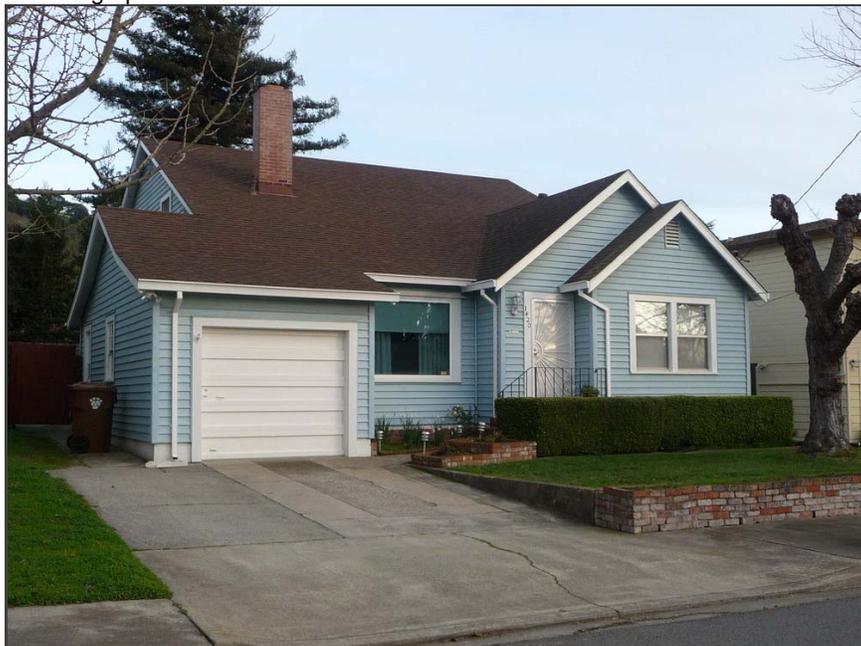
P5a. Photograph

- Style(s): Minimal Traditional
- Stories: 1
- Cladding: wood lap
- Porch: entrance porch, brick steps, pierced iron rail
- Door(s): single, security door, door material unknown
- Windows: Type 1 - paired, double hung, vinyl; Type 2 - single, fixed, vinyl; Type 3 - single, double hung, wood
- Roof: cross gable, composition shingle, open eaves
- Chimney: brick, exterior
- Related Features: attached 1-car garage
- Alterations: security door added, some windows replaced
- Notes:

West elevation
ARG, January 2011

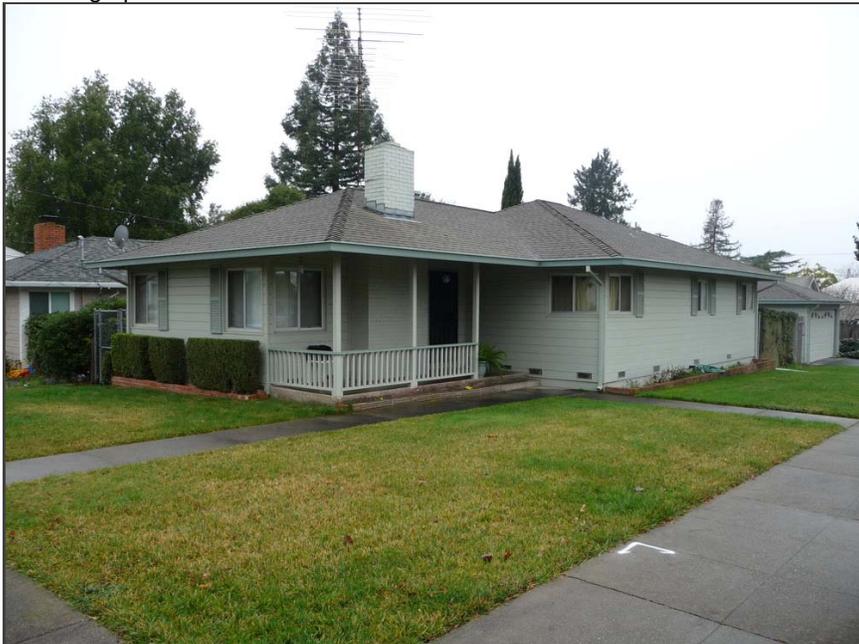
P5a. Photograph

- Style(s): Ranch, Contemporary / Minimal Traditional
- Stories: 1
- Cladding: wood clapboards
- Porch: entrance porch, partial width, recessed, concrete steps, wood posts, wood rail
- Door(s): single, security door, door material unknown
- Windows: Type 1 - single, sliding, aluminum, shutters
- Roof: cross hipped, composition shingle, open eaves, wide eaves
- Chimney: brick, exterior
- Related Features: detached 2-car garage
- Alterations: some windows replaced
- Notes:

North and east elevations

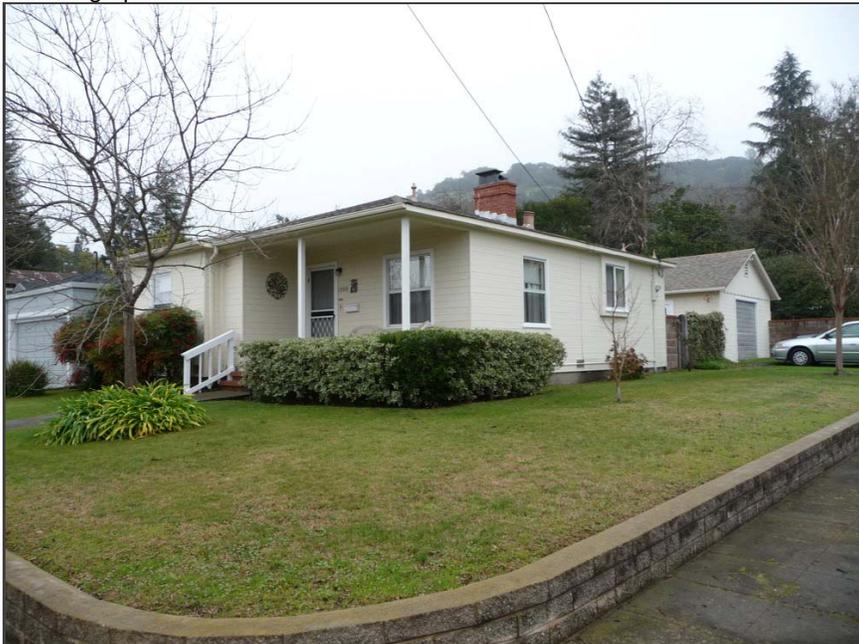
P5a. Photograph

- Style(s): Minimal Traditional
- Stories: 1
- Cladding: wood clapboards
- Porch: partial width, brick steps, wood posts, wood rail
- Door(s): single, wood, paneled
- Windows: Type 1 - single, double hung, aluminum; Type 2 - single, sliding, aluminum
- Roof: hipped, composition shingle, boxed eaves
- Chimney: brick, exterior
- Related Features: detached 1-car garage
- Alterations: some windows replaced
- Notes:

West and south elevations

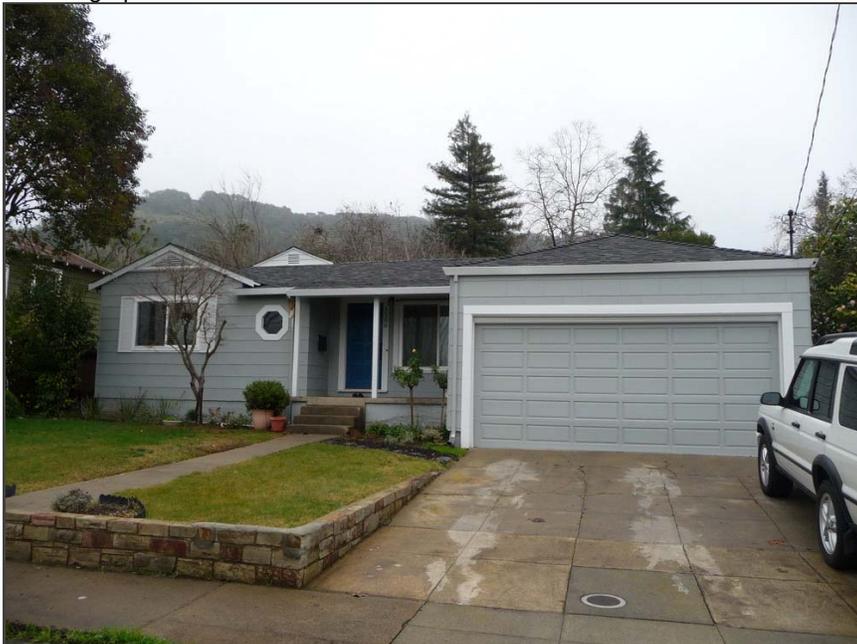
P5a. Photograph

- Style(s): Minimal Traditional
- Stories: 1
- Cladding: wood shingles
- Porch: partial width, recessed, concrete steps, wood posts
- Door(s): single, wood, paneled
- Windows: Type 1 - single, sliding, aluminum, shutters; Type 2 - single, sliding, aluminum; Type 3 - single, fixed, wood
- Roof: combination, front gable, hipped, composition shingle, intersecting gable at ridgeline, open eaves
- Chimney: none visible
- Related Features: attached 2-car garage
- Alterations: windows replaced
- Notes: Third window is octagon-shaped

West elevation

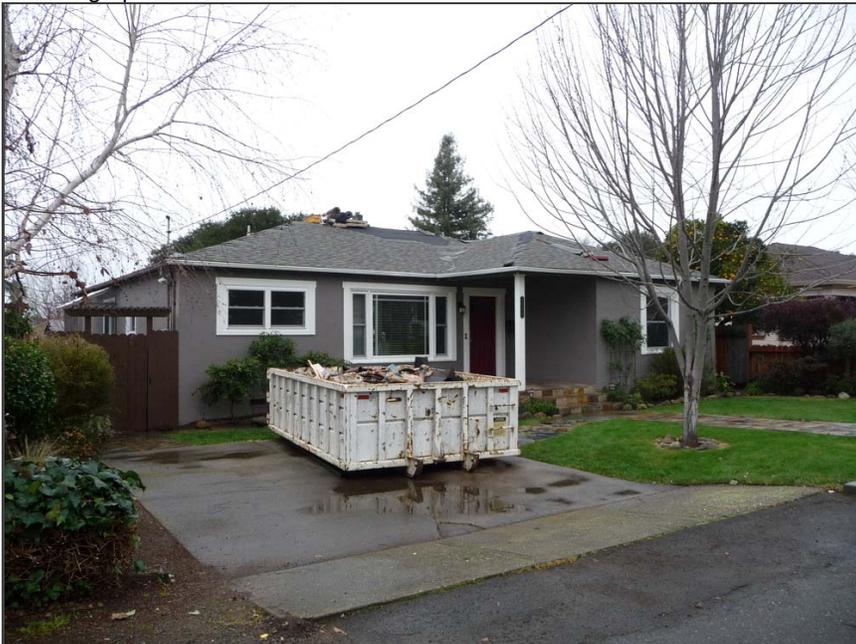
P5a. Photograph

- Style(s): Minimal Traditional
- Stories: 1
- Cladding: smooth stucco
- Porch: partial width, stone steps, wood posts
- Door(s): single, wood, partially glazed
- Windows: Type 1 - paired, double hung, wood; Type 2 - grouped, fixed, wood, double hung, wood; Type 3 - single, double hung, wood
- Roof: cross hipped, composition shingle, open eaves
- Chimney: none visible
- Related Features:
- Alterations: some windows replaced
- Notes:

East elevation
ARG, January 2011

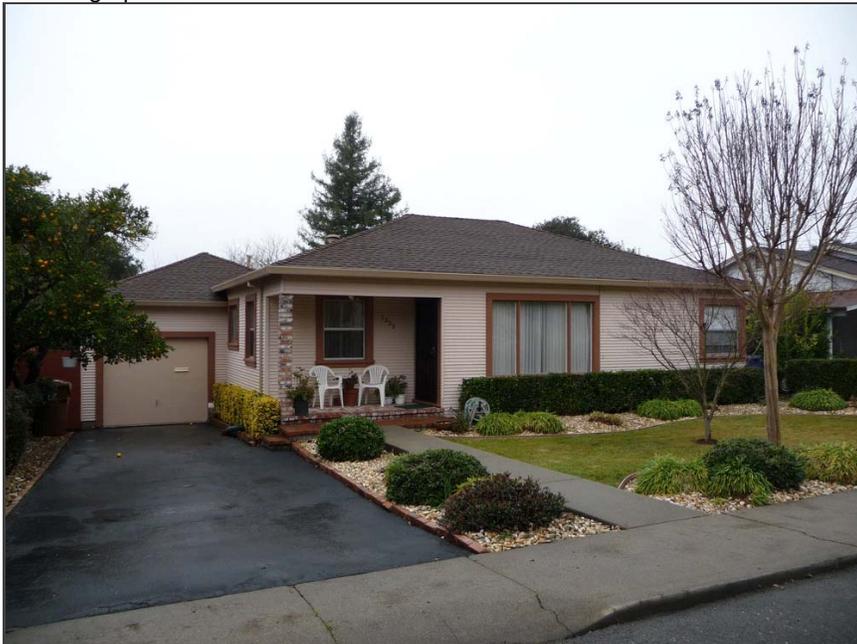
P5a. Photograph

- Style(s): Minimal Traditional
- Stories: 1
- Cladding: wood clapboards
- Porch: partial width, brick steps, brick supports
- Door(s):
- Windows: Type 1 - single, double hung, aluminum; Type 2 - grouped, fixed, aluminum
- Roof: hipped, composition shingle, boxed eaves
- Chimney: none visible
- Related Features: attached 1-car garage
- Alterations: windows replaced
- Notes:

P5b. Description of Photo:
East elevation
ARG, January 2011

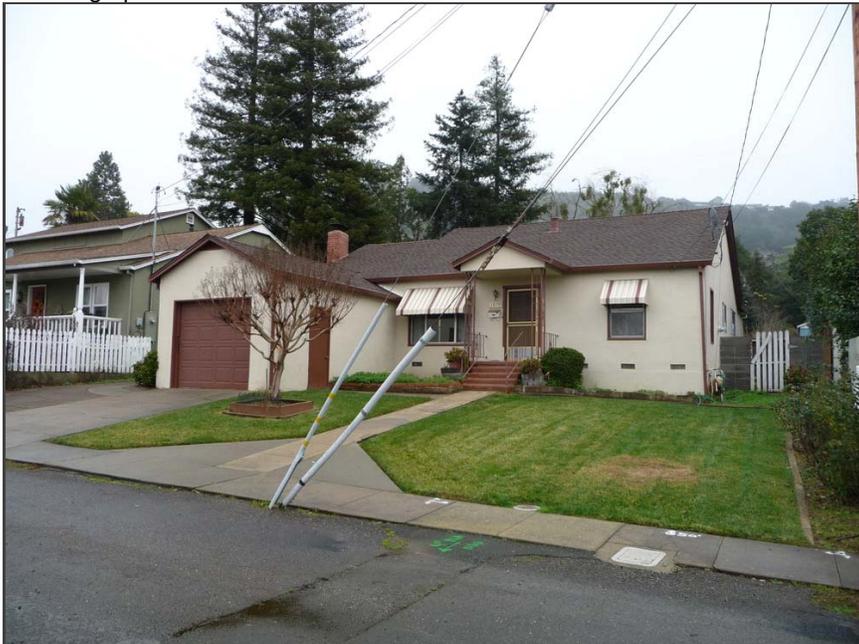
P5a. Photograph

- Style(s): Minimal Traditional
- Stories: 1
- Cladding: smooth stucco
- Porch: entrance porch, concrete steps, iron supports, pierced iron rail
- Door(s): single, wood, paneled, metal screen; Secondary - single, wood
- Windows: Type 1 - single, sliding, aluminum; Type 2 - single, double hung, aluminum
- Roof: cross gable, composition shingle, open eaves
- Chimney: brick, exterior
- Related Features: attached 1-car garage
- Alterations: awnings incompatible, some windows replaced
- Notes:

West elevation

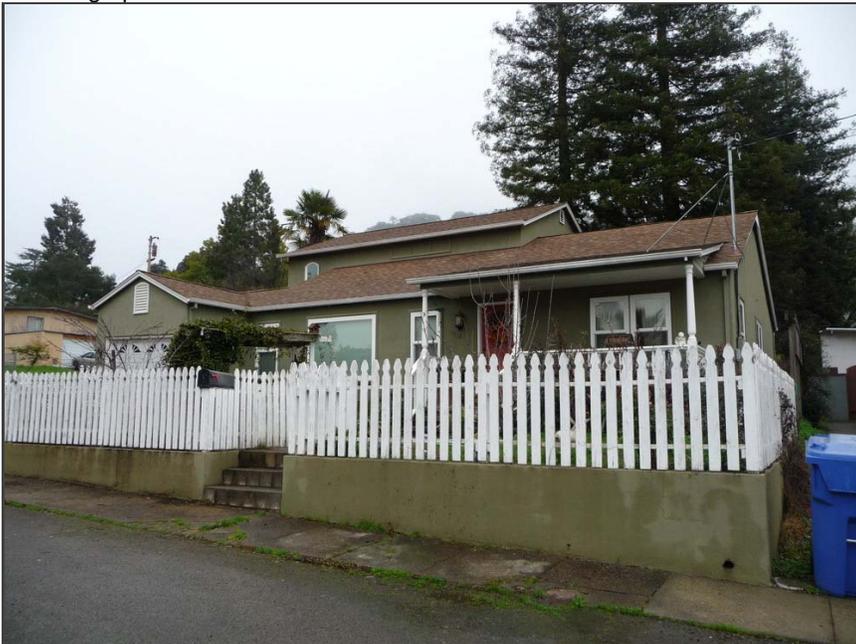
P5a. Photograph

- Style(s): Minimal Traditional
- Stories: 2
- Cladding: smooth stucco
- Porch: partial width, concrete steps, wood spindles, wood rail
- Door(s): single, wood, partially glazed, paneled
- Windows: Type 1 - grouped, double hung, wood; Type 2 - single, double hung, wood; Type 3 - single, fixed, wood
- Roof: cross gable, composition shingle, boxed eaves
- Chimney: none visible
- Related Features: attached 1-car garage
- Alterations: addition to rear elevation, some window openings filled in, some windows replaced, perimeter fence added
- Notes:

P5b. Description of Photo:
West elevation
ARG, January 2011

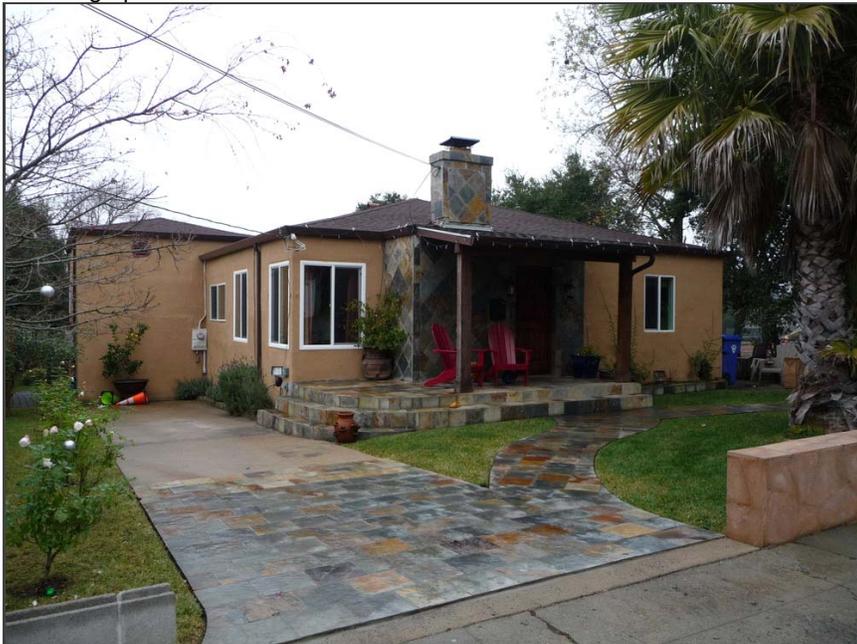
P5a. Photograph

- Style(s): Minimal Traditional
- Stories: 1
- Cladding: smooth stucco
- Porch: partial width, stone steps, wood posts
- Door(s): single, wood
- Windows: Type 1 - single, sliding, vinyl
- Roof: hipped, composition shingle, boxed eaves
- Chimney: stone, exterior
- Related Features:
- Alterations: addition to rear elevation, cladding altered, some windows replaced, porch altered
- Notes:

East elevation

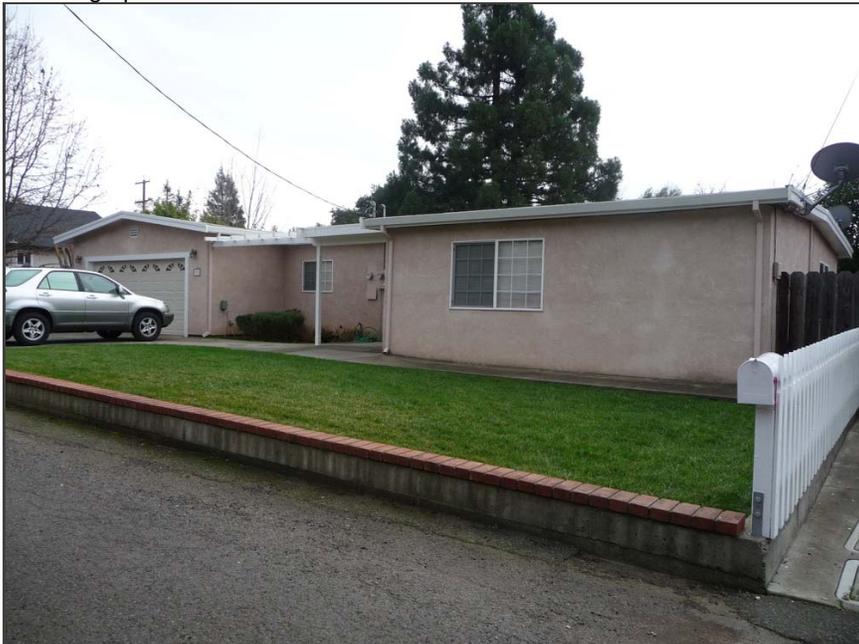
P5a. Photograph

- Style(s): Ranch, Minimal
- Stories: 1
- Cladding: textured stucco
- Porch: entrance porch, recessed, wood posts
- Door(s): not visible
- Windows: Type 1 - single, sliding, vinyl
- Roof: cross gable, material not visible, open eaves
- Chimney: none visible
- Related Features: attached 2-car garage
- Alterations: completely remodeled, windows replaced
- Notes: There are two buildings on the property: 9 Berna and 15 Berna. Both have been significantly altered.

North elevation
ARG, January 2011

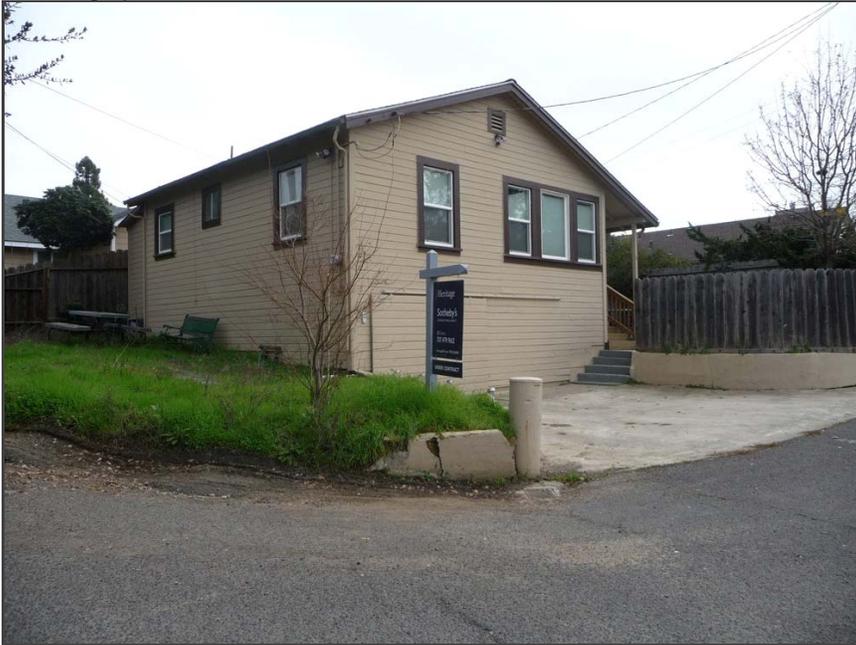
P5a. Photograph

- Style(s): Victorian, Vernacular Cottage, gable roof
- Stories: 1
- Cladding: wood clapboards
- Porch: full width, wood steps, wood posts, wood rail
- Door(s): not visible
- Windows: Type 1 - grouped, double hung, vinyl; Type 2 - single, double hung, vinyl
- Roof: side gable, composition shingle, open eaves
- Chimney: brick, exterior
- Related Features: attached 1-car garage
- Alterations: windows replaced
- Notes:

West and north elevations
ARG, January 2011

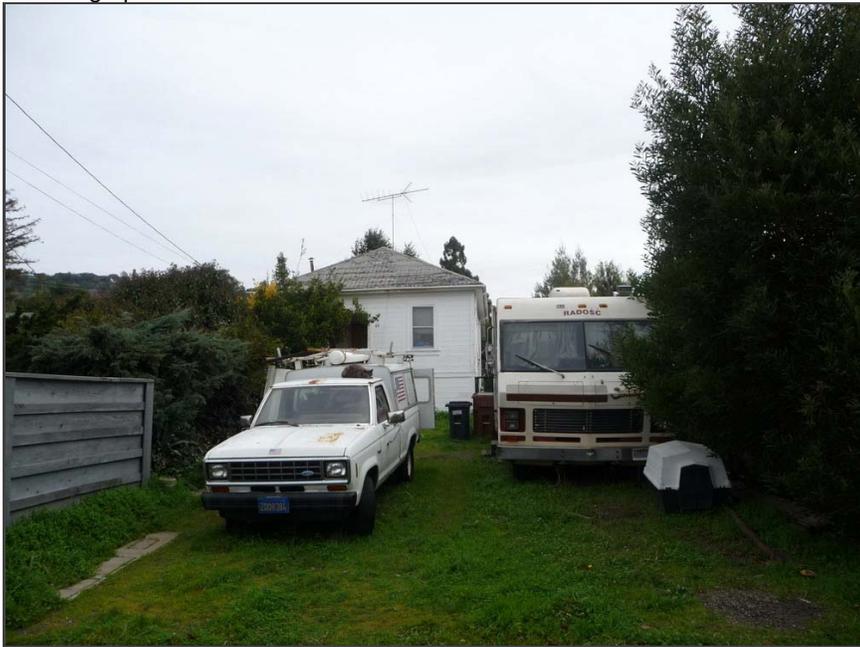
P5a. Photograph

- Style(s): Victorian, Vernacular Cottage, hip roof
- Stories: 2
- Cladding: wood clapboards
- Porch: entrance porch, partial width, recessed
- Door(s): not visible
- Windows: Type 1 - single, double hung, aluminum
- Roof: hipped, composition shingle, boxed eaves
- Chimney: none visible
- Related Features:
- Alterations: some windows replaced
- Notes: entrance and porch obscured by brush

West elevation

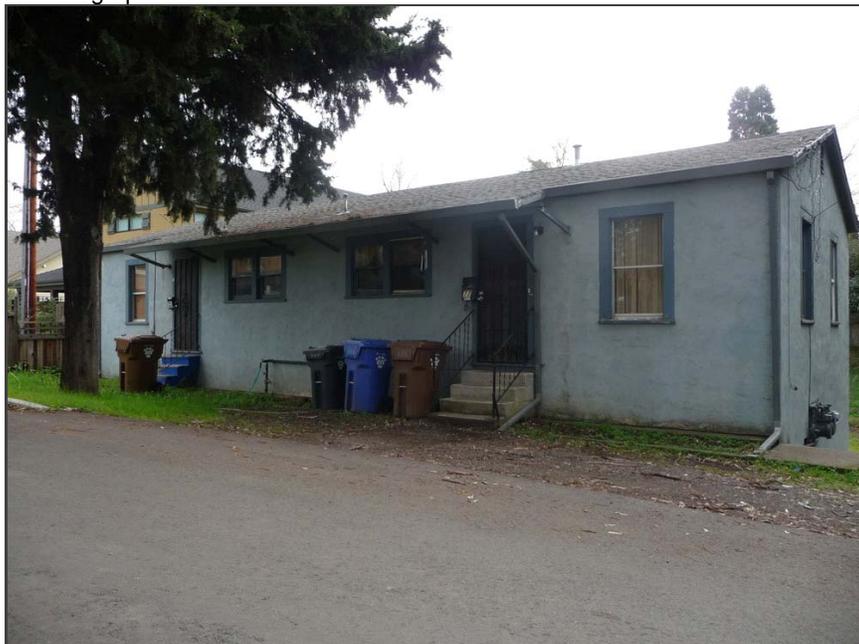
P5a. Photograph

- Style(s): No style
- Stories: 1
- Cladding: textured stucco
- Porch: entrance porch, concrete steps, wood brackets, pierced iron rail
- Door(s): single, security door, door material unknown; Secondary - single, security door, door material unknown
- Windows: Type 1 - single, double hung, aluminum; Type 2 - paired, double hung, wood
- Roof: side gable, composition shingle, open eaves
- Chimney: none visible
- Related Features:
- Alterations: security door added, some windows replaced
- Notes:

North elevation

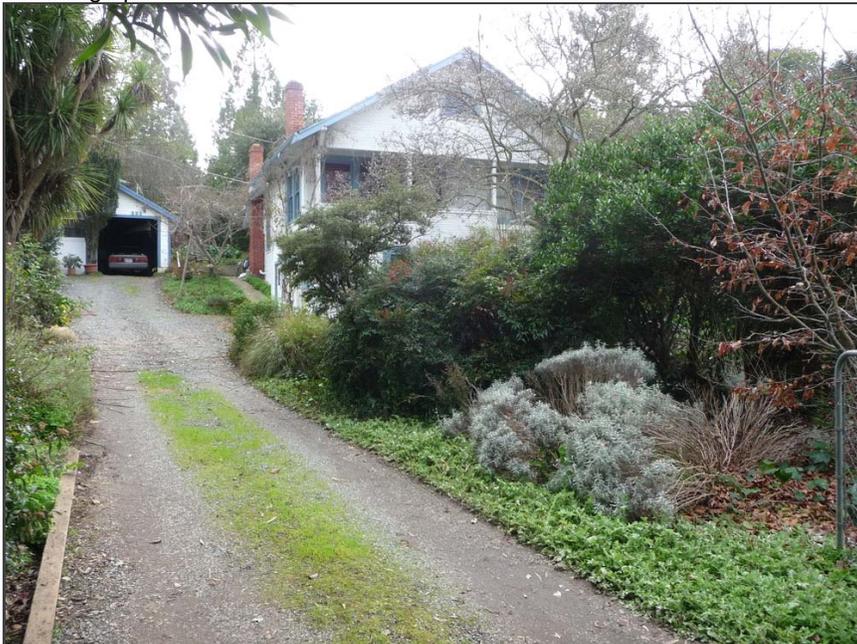
P5a. Photograph

- Style(s): Craftsman
- Stories: 1
- Cladding: wood clapboards
- Porch: full width, wood steps, wood posts, wood solid rail
- Door(s): not visible
- Windows: Type 1 - grouped, double hung, wood
- Roof: front gable, material not visible, brackets, open eaves
- Chimney: brick, exterior
- Related Features: detached 2-car garage
- Alterations: some windows replaced
- Notes: House obscured by trees and plants

North elevation

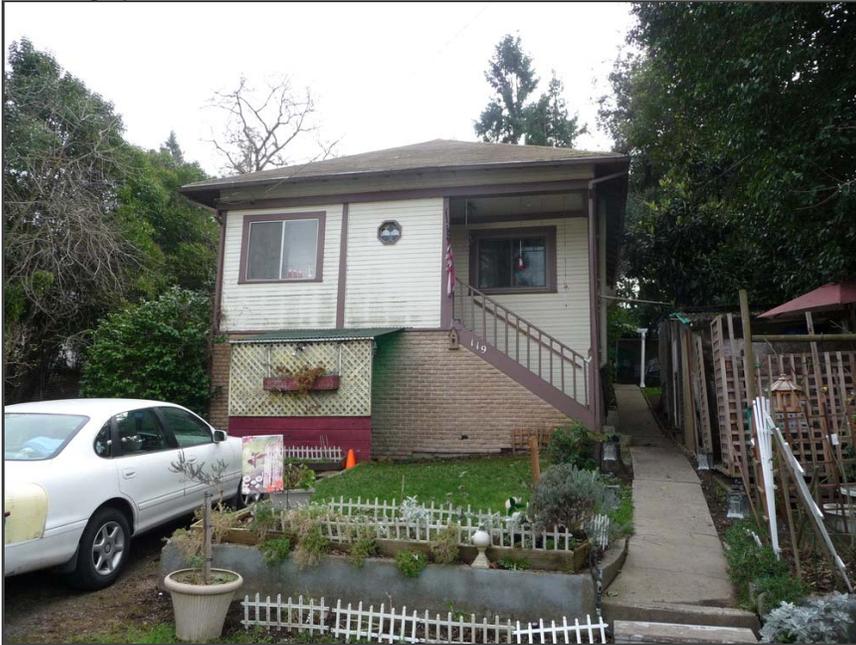
P5a. Photograph

- Style(s): Victorian, Vernacular Cottage, hip roof
- Stories: 2
- Cladding: brick, wood clapboards
- Porch: entrance porch, recessed, wood steps, wood posts, wood rail
- Door(s):
- Windows: Type 1 - single, sliding, aluminum; Type 2 - single, fixed, wood, leaded glass
- Roof: hipped, composition shingle, open eaves
- Chimney: none visible
- Related Features:
- Alterations: cladding altered, windows replaced
- Notes:

North elevation

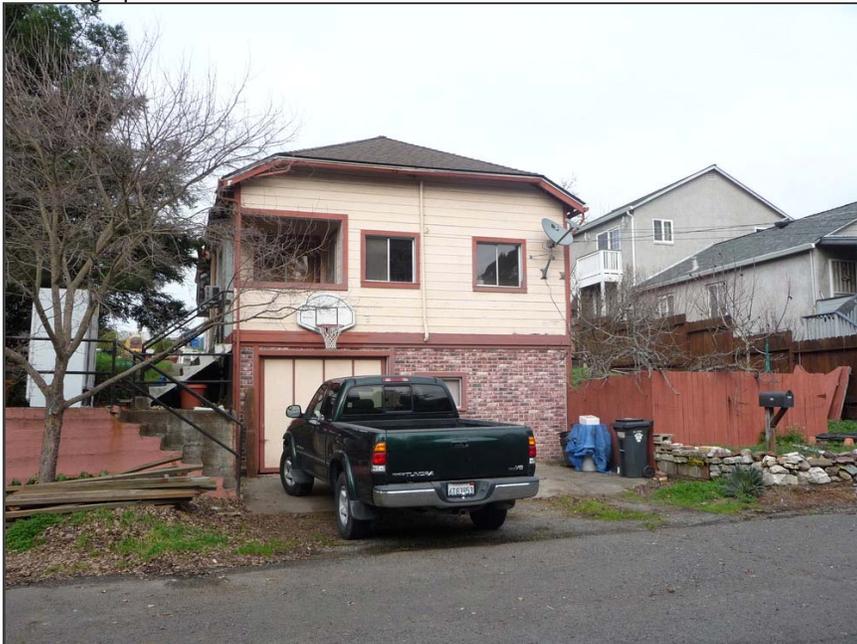
P5a. Photograph

- Style(s): Victorian, Vernacular Cottage, hip roof
- Stories: 2
- Cladding: brick, wood clapboards
- Porch: entrance porch, partial width, recessed, concrete steps, wood posts, wood solid rail
- Door(s): single, door material unknown, metal screen
- Windows: Type 1 - single, sliding, aluminum
- Roof: combination, hipped, jerkinhead, composition shingle, open eaves
- Chimney: none visible
- Related Features: attached 1-car garage
- Alterations: cladding altered, some window openings resized, windows replaced, porch enclosed
- Notes:

South elevation
ARG, January 2011

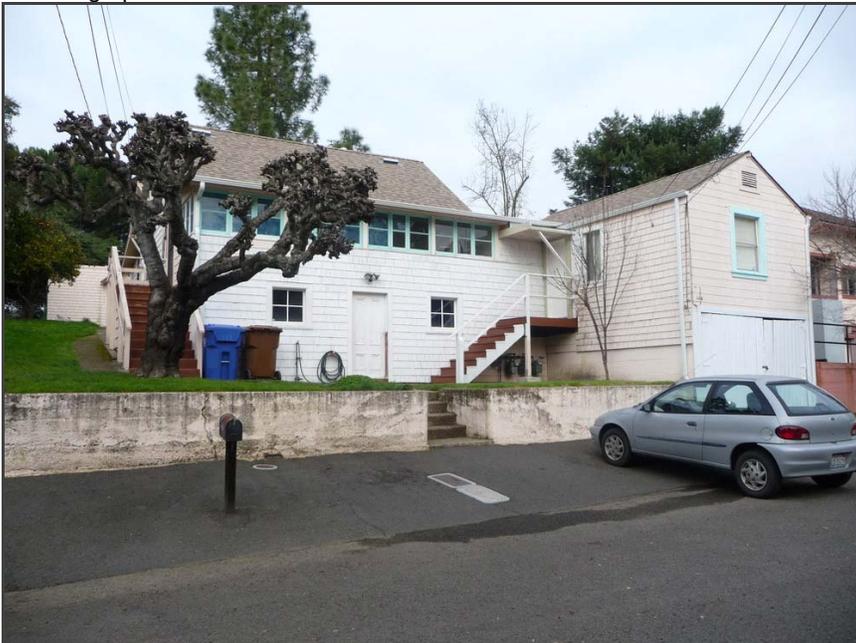
P5a. Photograph

- Style(s): Craftsman
- Stories: 2
- Cladding: wood clapboards, wood shingles
- Porch: entrance porch, wood steps, wood posts, wood rail
- Door(s): single, wood, paneled; Secondary - single, security door, door material unknown
- Windows: Type 1 - grouped, double hung, wood; Type 2 - single, casement, vinyl; Type 3 - single, sliding, aluminum
- Roof: side gable, composition shingle, brackets, exposed purlins, open eaves
- Chimney: none visible
- Related Features: attached 1-car garage
- Alterations: completely remodeled, addition to side elevation, door opening remodeled, some windows replaced, porch enclosed, entrance re-configured
- Notes: There are three entrances to the building. The two side entrances have entrance porches with wood steps and wood rails. The primary entrance has concrete steps, but no porch.

South elevation

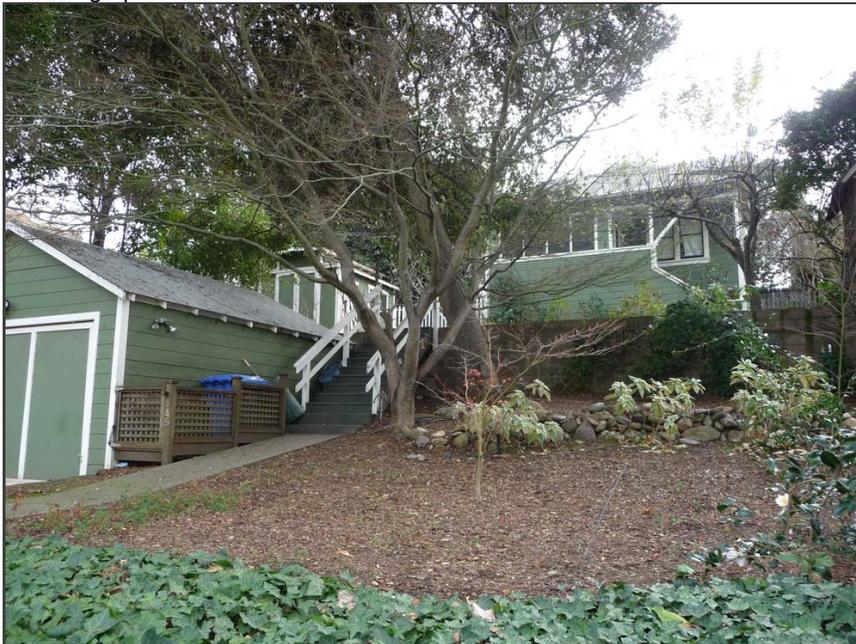
P5a. Photograph

- Style(s): Victorian, Vernacular Cottage, hip roof
- Stories: 1
- Cladding: wood clapboards
- Porch: full width, concrete steps, wood posts, wood solid rail
- Door(s): not visible
- Windows: Type 1 - grouped, double hung, vinyl
- Roof: hipped, material not visible, boxed eaves
- Chimney: none visible
- Related Features: detached 2-car garage, shed
- Alterations: some windows replaced
- Notes:

North elevation

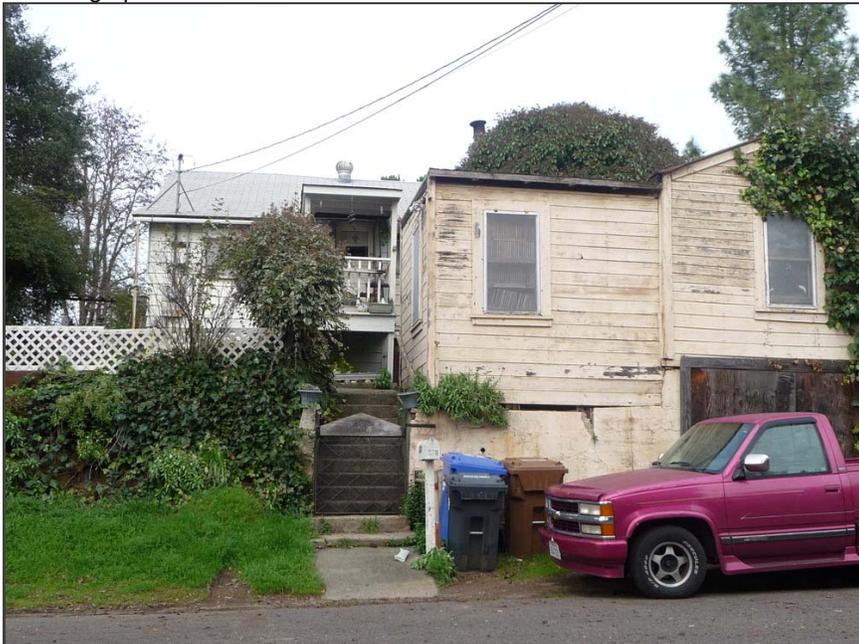
P5a. Photograph

- Style(s): Victorian, Vernacular Cottage, gable roof
- Stories: 1
- Cladding: wood clapboards, wood lap, see notes
- Porch: entrance porch, concrete steps, wood posts, wood rail
- Door(s): wood, partially glazed, historic hardware
- Windows: Type 1 - single, double hung, wood, multipane; Type 2 - single, sliding, material unknown
- Roof: combination, flat, side gable, composition sheets, material not visible, open eaves
- Chimney: none visible
- Related Features: attached 1-car garage
- Alterations: addition to primary façade, some windows replaced, some window openings resized
- Notes: Siding may be vinyl.

South elevation
ARG, January 2011

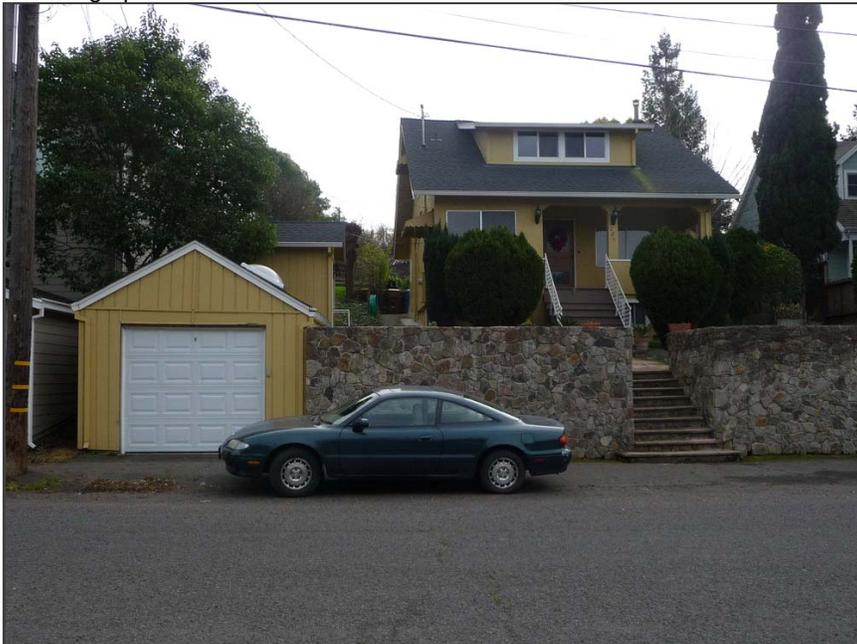
P5a. Photograph

- Style(s): Victorian, Vernacular Cottage, gable roof
- Stories: 2
- Cladding: smooth stucco
- Porch: partial width, recessed, wood steps, stucco supports, pierced iron, wood rail, solid rail
- Door(s): single, wood, divided lights, partially glazed, paneled
- Windows: Type 1 - grouped, sliding, aluminum
- Roof: combination, shed, side gable, composition shingle, dormer, open eaves
- Chimney: none visible
- Related Features: detached 1-car garage, shed
- Alterations: addition to roof, awnings incompatible, door replaced, windows replaced, porch altered
- Notes:

North elevation
ARG, January 2011

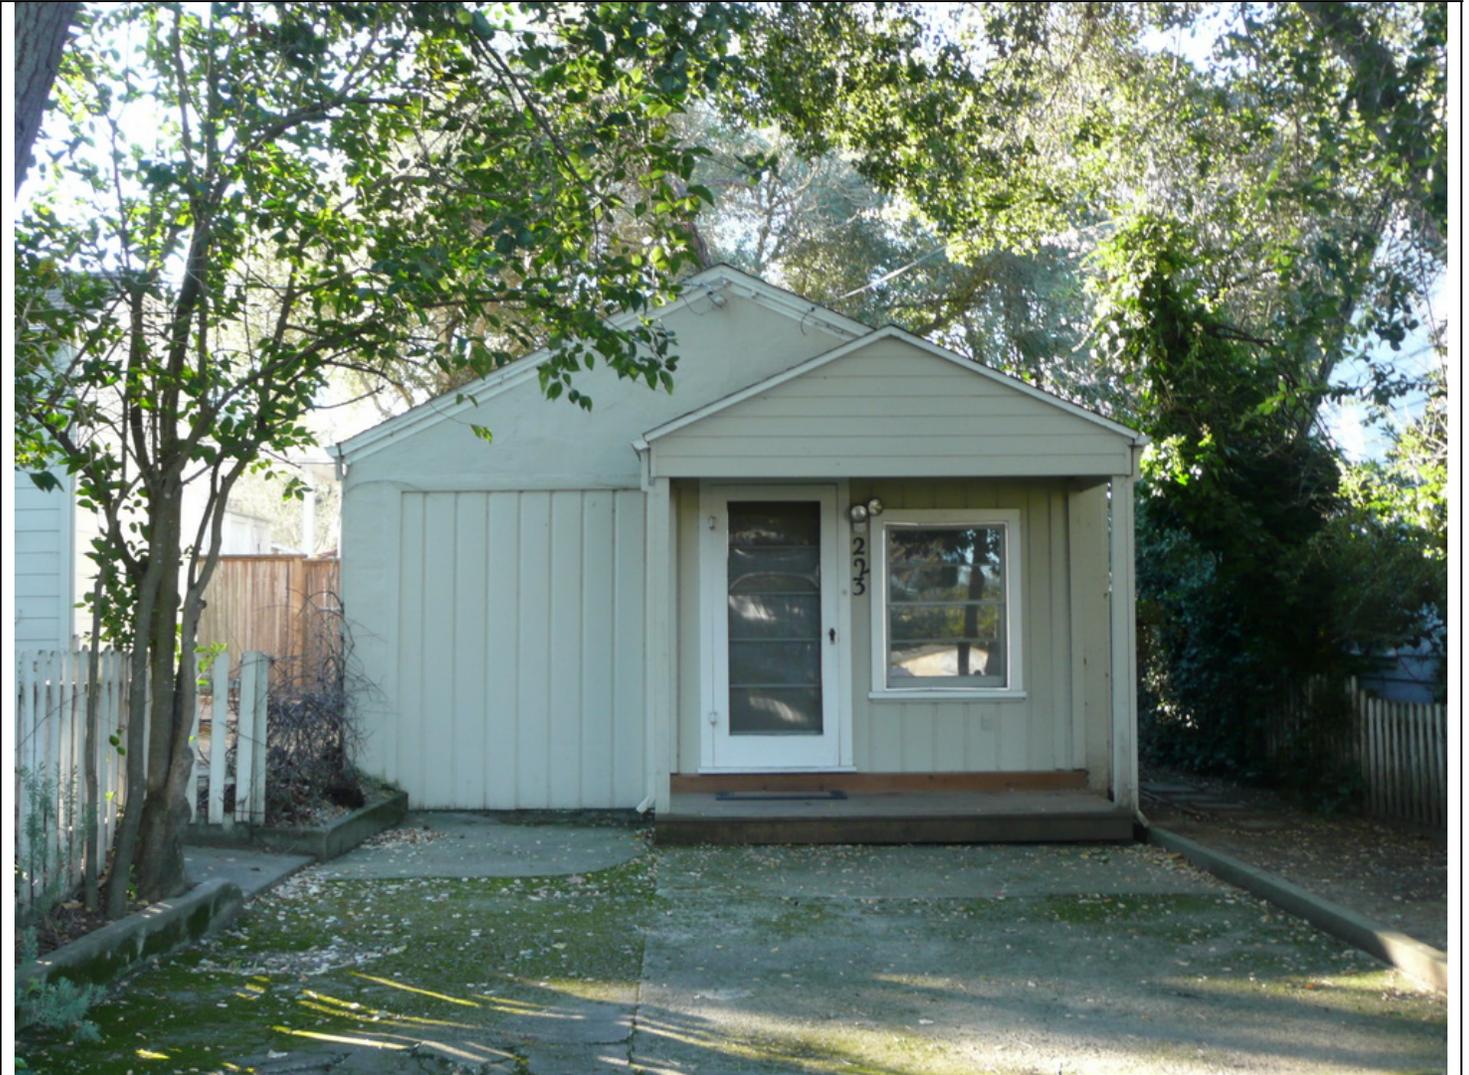
Image 2. North elevation of detached two-car garage on lot, which has been converted to residential use. (Architectural Resources Group, January 2011.)
