PRIMARY RECORD

Page 1 of 1 *Resource Name or #: (Assigned by Recorder) 1700 MEEK AVE

c. Address 1700 MEEK AVE City NAPA Zip 945591518

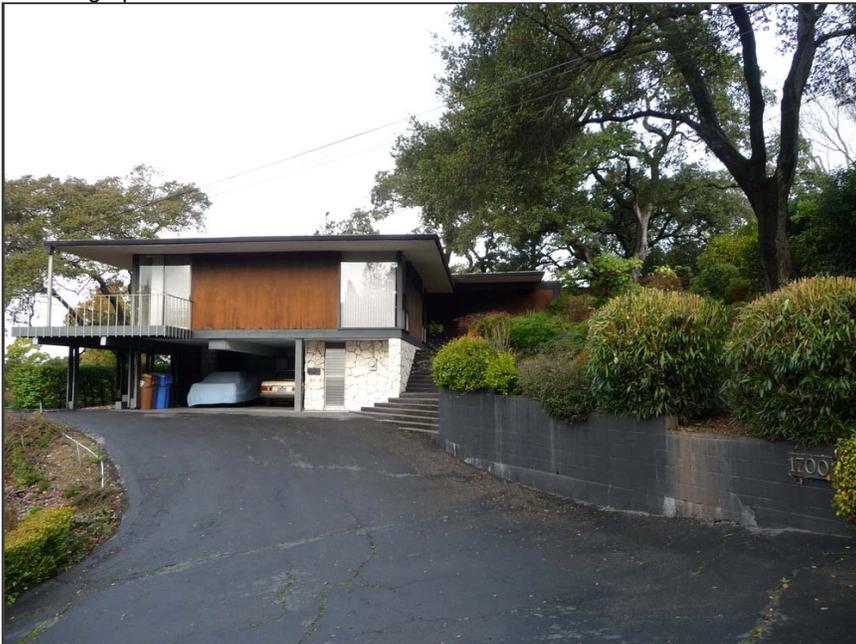
P5a. Photograph

- Style(s): Modernism, Late
- Stories: 1
- Cladding: fieldstone, smooth stucco, wood vertical boards
- Porch: partial width, recessed, concrete steps
- Door(s): not visible
- Windows: Type 1 - single, fixed, wood; Type 2 - single, sliding, metal; Type 3 - single, jalousie, aluminum
- Roof: flat, material not visible, wide eaves
- Chimney: none visible
- Related Features: carport
- Alterations: none visible
- Notes: Possibly individually eligible. Further research on architect. Angled meted beam porch support.

South elevation

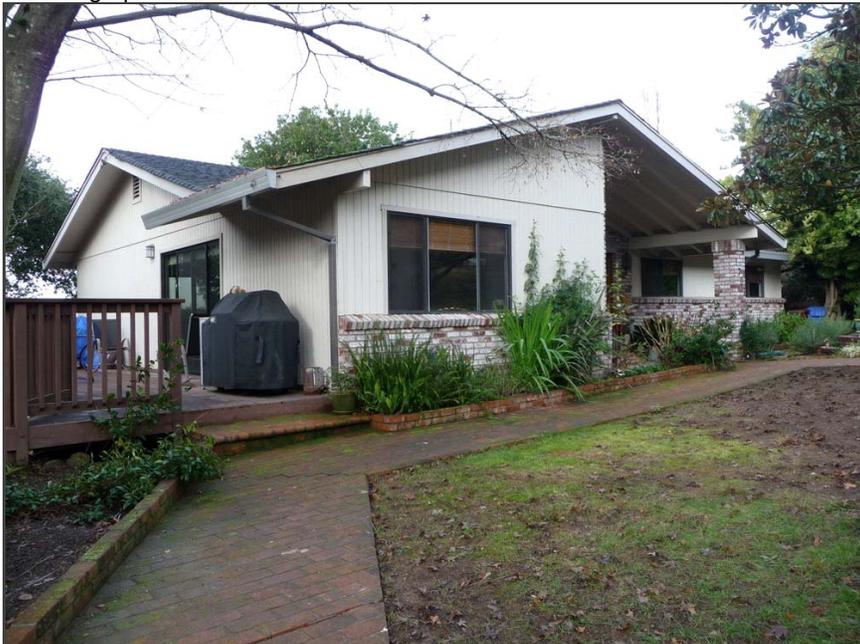
P5a. Photograph

East elevation
ARG, January 2011

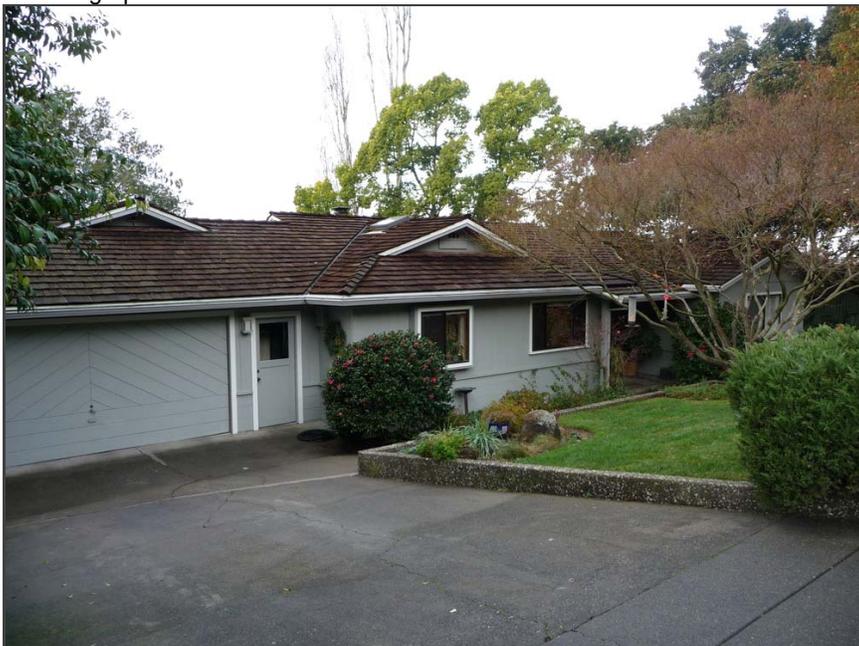
P5a. Photograph

East elevation

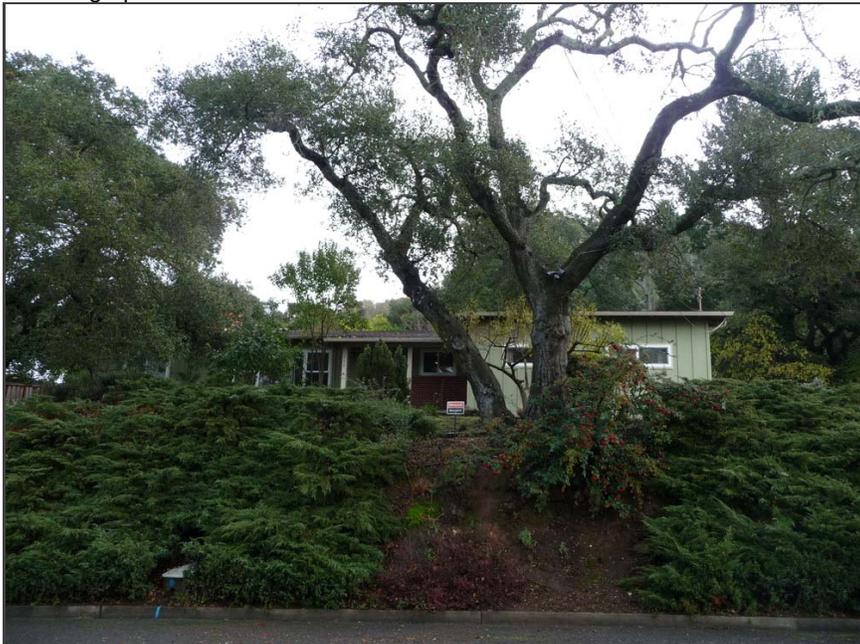
P5a. Photograph

- Style(s): Ranch
- Stories: 1
- Cladding: board and batten, brick
- Porch: partial width, wood posts
- Door(s): not visible
- Windows: Type 1 - single, sliding, vinyl; Type 2 - tripartite, double hung, vinyl, fixed, vinyl
- Roof: side gable, shake, open eaves
- Chimney: none visible
- Related Features:
- Alterations: some windows replaced
- Notes:

West elevation

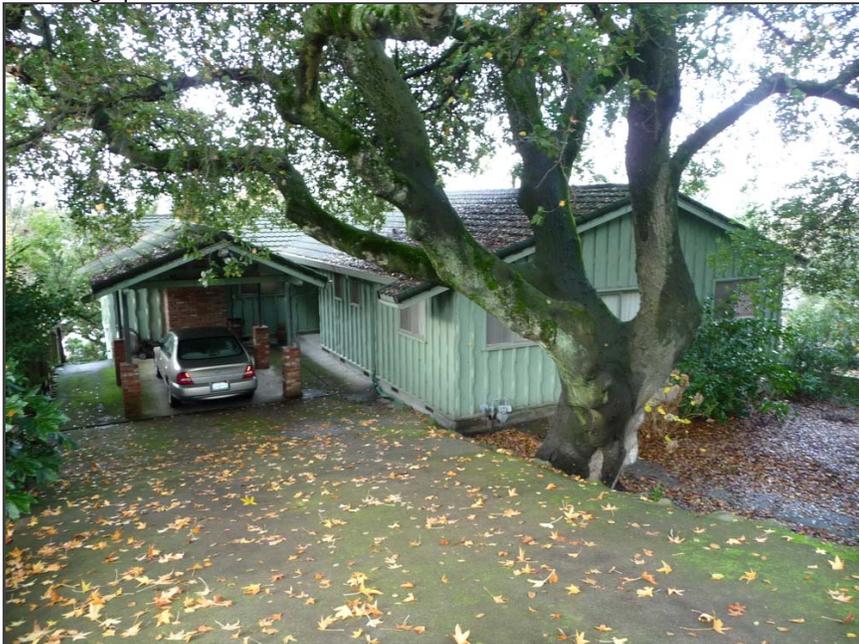
P5a. Photograph

- Style(s): Ranch, Custom
- Stories: 1
- Cladding: board and batten, wood rustic
- Porch: recessed
- Door(s): door material unknown
- Windows: Type 1 - single, sliding, aluminum
- Roof: cross gable, clay tile, clay tile coping, boxed eaves
- Chimney: brick, exterior
- Related Features: carport
- Alterations: carport added
- Notes: Carport possibly not an alteration.

East elevation

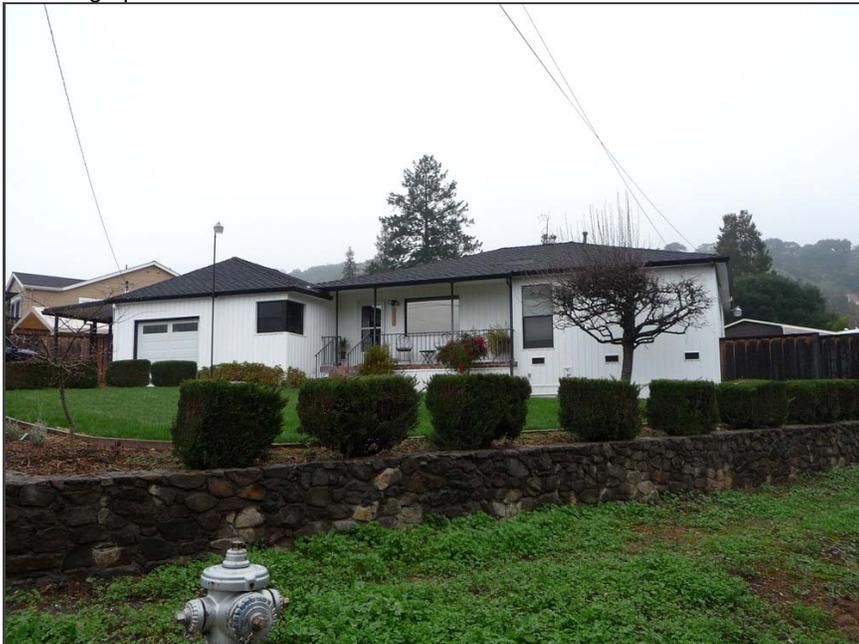
P5a. Photograph

- Style(s): Ranch, Minimal
- Stories: 1
- Cladding: vinyl
- Porch: partial width, recessed, brick steps, iron supports, pierced iron rail
- Door(s): single, door material unknown, fully glazed
- Windows: Type 1 - paired, double hung, vinyl; Type 2 - fixed, vinyl; Type 3 - single, double hung, vinyl
- Roof: cross hipped, composition shingle
- Chimney: none visible
- Related Features: attached 1-car garage, carport
- Alterations: cladding altered, windows replaced
- Notes: May have been a minimal traditional house with a side elevation addition (the garage)

West elevation
ARG, January 2011

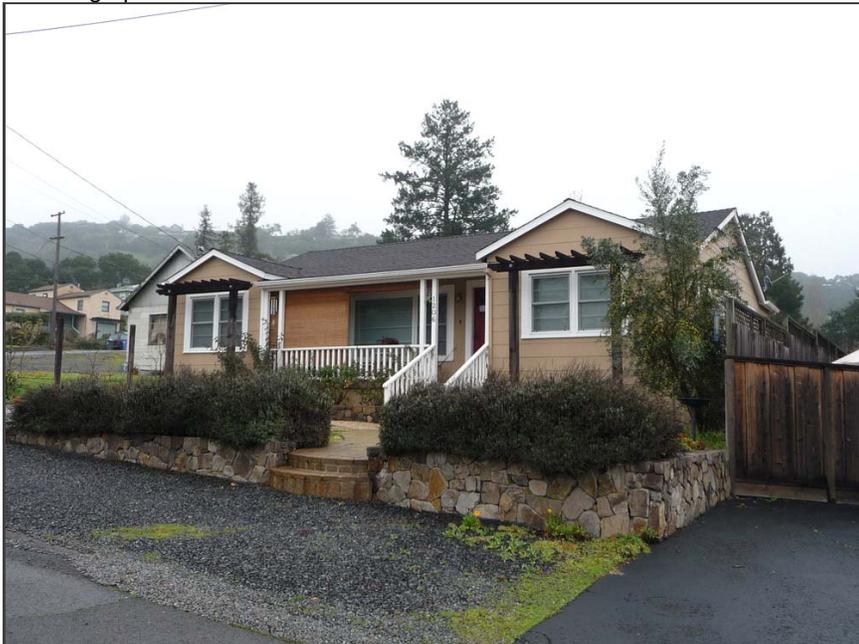
P5a. Photograph

West elevation

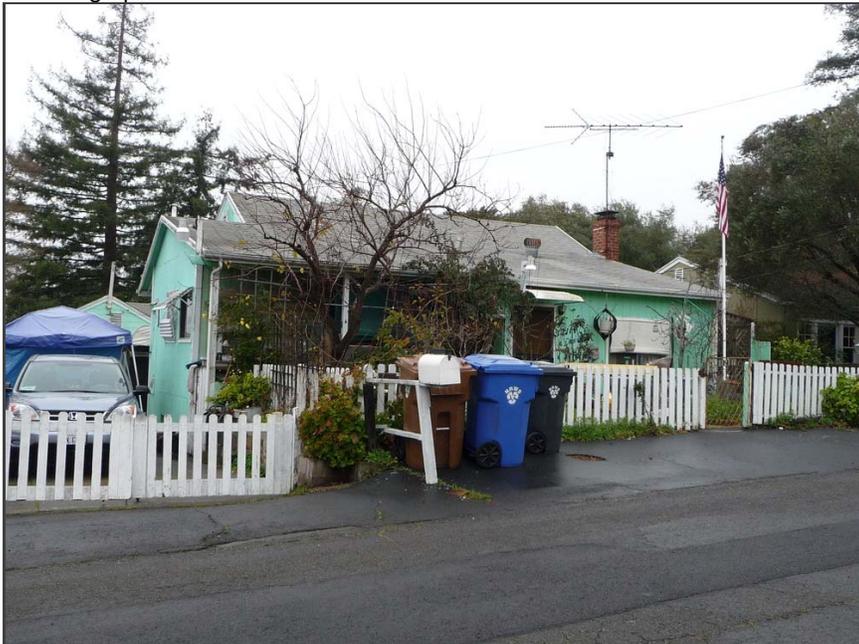
P5a. Photograph

- Style(s): Minimal Traditional
- Stories: 1
- Cladding: asbestos, wood vertical boards
- Porch: partial width, recessed, wood posts, wood rail
- Door(s): single, door material unknown, metal screen
- Windows: Type 1 - single, sliding, aluminum
- Roof: side gable, composition shingle, open eaves
- Chimney: brick, exterior
- Related Features: detached 2-car garage
- Alterations: cladding altered, awnings incompatible, windows replaced
- Notes:

East elevation
ARG, January 2011

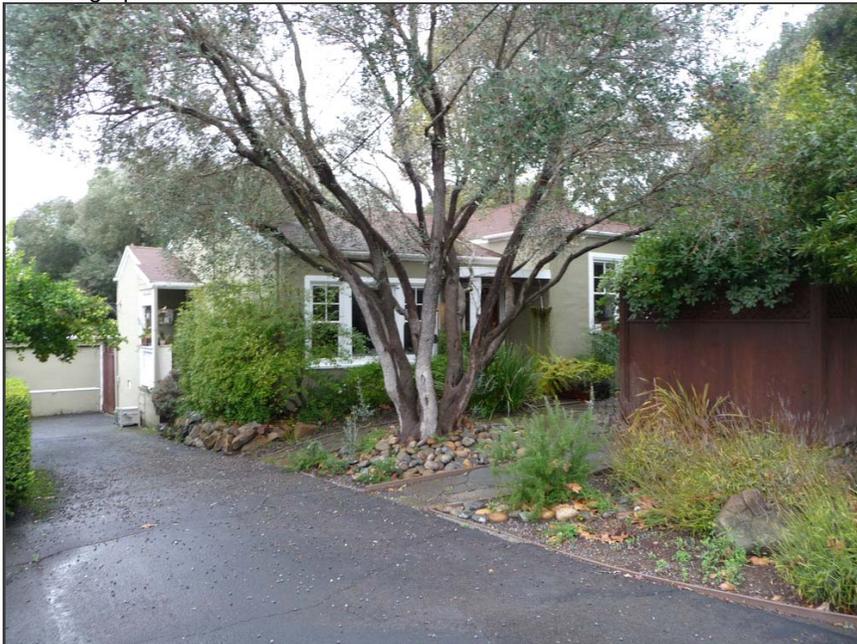
P5a. Photograph

- Style(s): Minimal Traditional
- Stories: 1
- Cladding: smooth stucco
- Porch: entrance porch, wood posts
- Door(s): not visible
- Windows: Type 1 - tripartite, fixed, vinyl, double hung, vinyl
- Roof: combination, hipped, side gable, composition sheets
- Chimney: none visible
- Related Features: detached 2-car garage
- Alterations: windows replaced
- Notes:

East elevation
ARG, January 2011

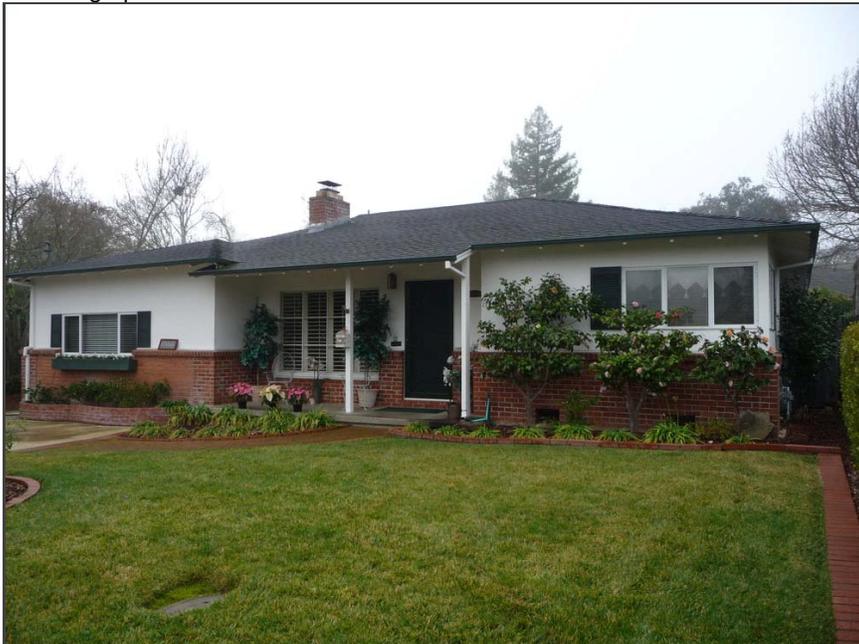
P5a. Photograph

- Style(s): Minimal Traditional
- Stories: 1
- Cladding: brick, smooth stucco
- Porch: partial width, recessed, brick steps, wood posts
- Door(s): single, door material unknown, metal screen
- Windows: Type 1 - paired, sliding, vinyl, shutters; Type 2 - single, fixed, wood, multipane
- Roof: hipped, composition shingle, open eaves
- Chimney: brick, exterior
- Related Features:
- Alterations: some windows replaced, Single attached garage converted to inhabitable space
- Notes:

East elevation

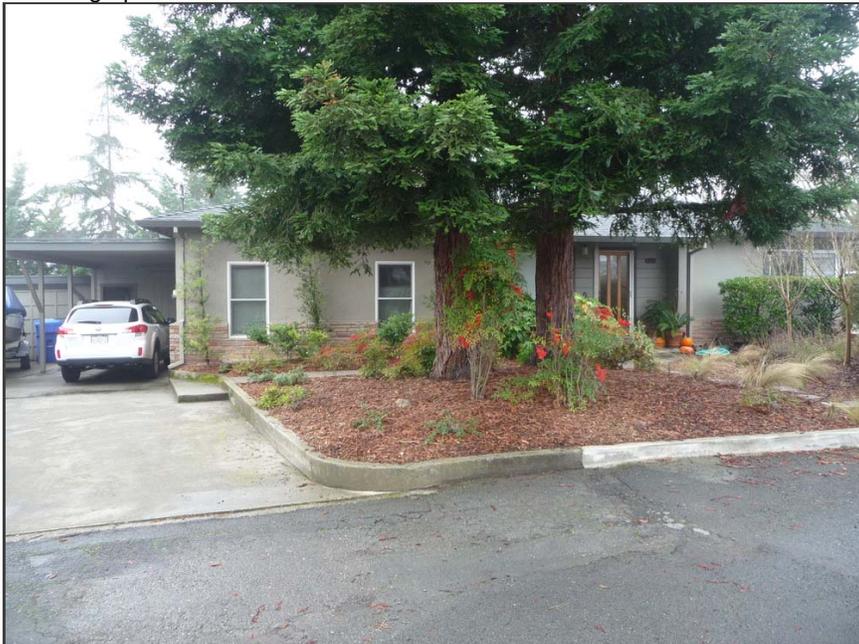
P5a. Photograph

- Style(s): Ranch, Minimal
- Stories: 1
- Cladding: fieldstone, smooth stucco
- Porch: entrance porch, recessed, concrete steps
- Door(s): single, wood, partially glazed
- Windows: Type 1 - single, vinyl, sliding
- Roof: cross hipped, composition shingle, open eaves
- Chimney: none visible
- Related Features: carport
- Alterations: door replaced, some windows replaced, some window openings resized, porch altered
- Notes:

North elevation

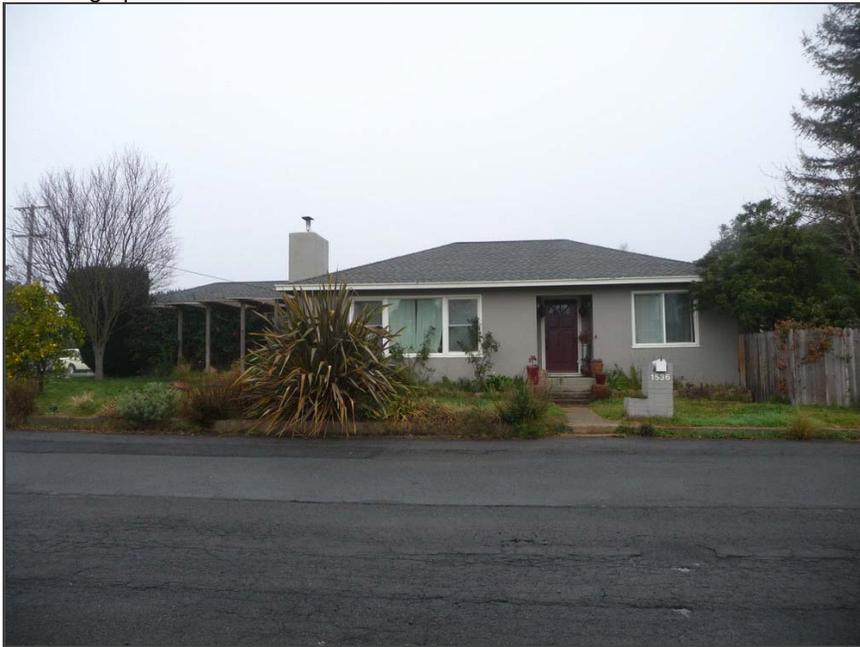
P5a. Photograph

- Style(s): Ranch, Minimal
- Stories: 1
- Cladding: smooth stucco
- Porch: entrance porch, recessed, concrete steps
- Door(s): single, wood, divided lights, paneled
- Windows: Type 1 - single, sliding, vinyl; Type 2 - tripartite, fixed, vinyl, double hung, vinyl
- Roof: cross hipped, composition shingle, open eaves
- Chimney: stucco, exterior
- Related Features: attached 1-car garage
- Alterations: cladding altered, door replaced, some windows replaced, porch enclosed
- Notes:

South elevation
ARG, January 2011

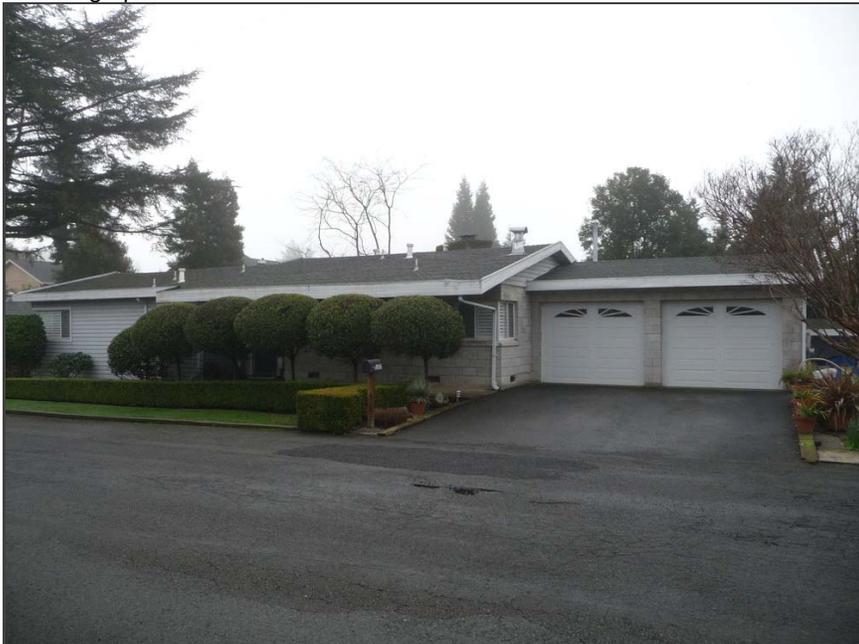
P5a. Photograph

- Style(s): Ranch, Minimal
- Stories: 1
- Cladding: concrete block, wood clapboards
- Porch: none visible
- Door(s): not visible
- Windows: Type 1 - grouped, sliding, vinyl
- Roof: side gable, composition shingle, vergeboards, open eaves
- Chimney: none visible
- Related Features: attached 2-car garage
- Alterations: addition to side elevation, windows replaced
- Notes:

North elevation

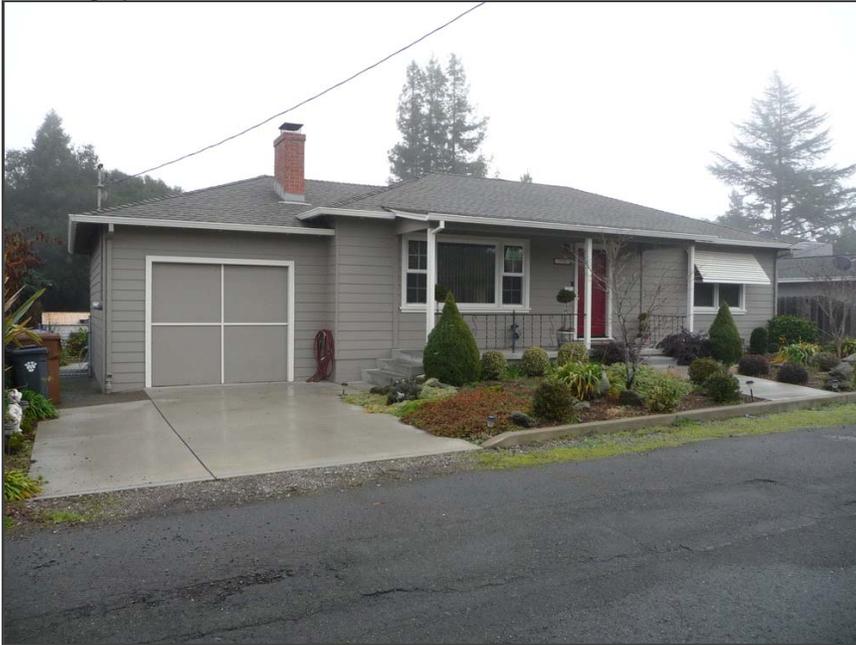
P5a. Photograph

- Style(s): Minimal Traditional
- Stories: 1
- Cladding: wood lap
- Porch: partial width, wood posts, pierced iron rail
- Door(s): single, wood, divided lights, paneled
- Windows: Type 1 - tripartite, fixed, vinyl, double hung, vinyl; Type 2 - paired, double hung, vinyl
- Roof: hipped, composition shingle, open eaves
- Chimney: brick, exterior
- Related Features: attached 1-car garage
- Alterations: awnings incompatible, windows replaced, porch rails altered
- Notes:

West elevation

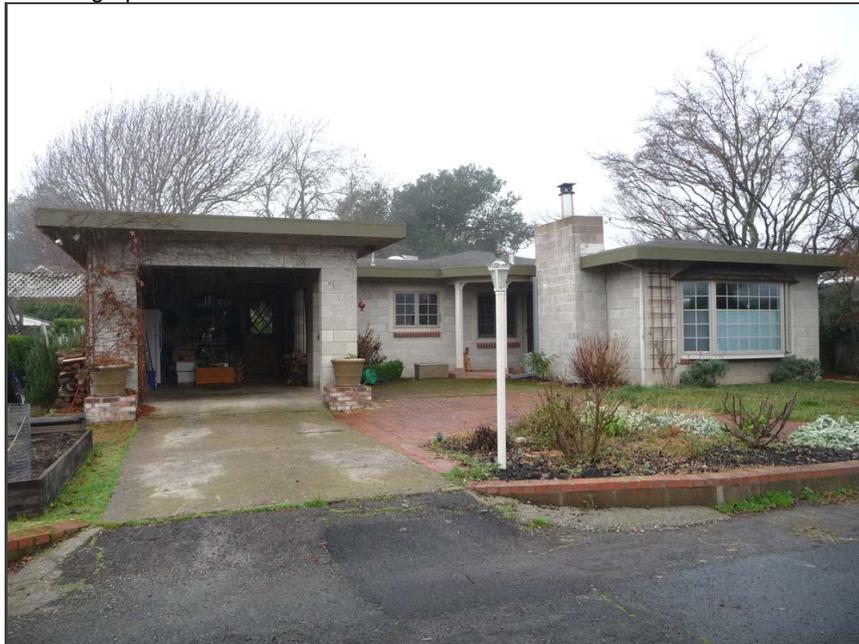
P5a. Photograph

- Style(s): Ranch, Contemporary
- Stories: 1
- Cladding: concrete block
- Porch: full width, brick steps, wood posts
- Door(s): single, door material unknown, metal screen
- Windows: Type 1 - canted bay, casement, wood, multipane, fixed, wood, multipane; Type 2 - paired, casement, wood, multipane
- Roof: cross hipped, flat, composition sheets, boxed eaves
- Chimney: brick, exterior
- Related Features: carport
- Alterations: some windows replaced
- Notes: Difficult to discern alterations: possible that carport was added, porch altered, cladding altered

East elevation
ARG, January 2011

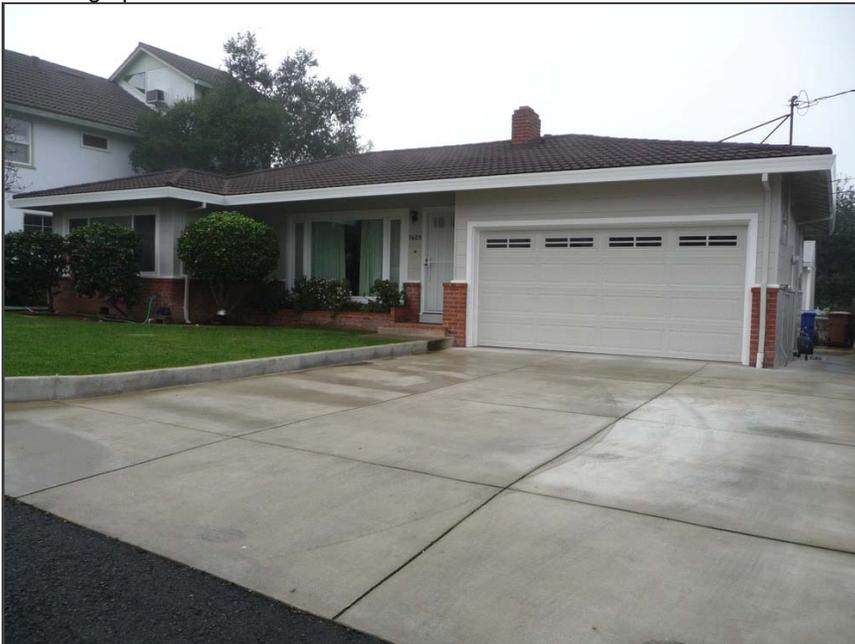
P5a. Photograph

- Style(s): Ranch, Minimal
- Stories: 1
- Cladding: brick, wood clapboards
- Porch: entrance porch, recessed, brick steps, brick solid rail
- Door(s): single, wood, divided lights, partially glazed, paneled, metal screen
- Windows: Type 1 - tripartite, casement, vinyl, fixed, vinyl; Type 2 - tripartite, sliding, vinyl
- Roof: cross hipped, clay tile, open eaves
- Chimney: brick, exterior
- Related Features: attached 2-car garage
- Alterations: security door added, some windows replaced, roof material replaced and incompatible
- Notes:

East elevation

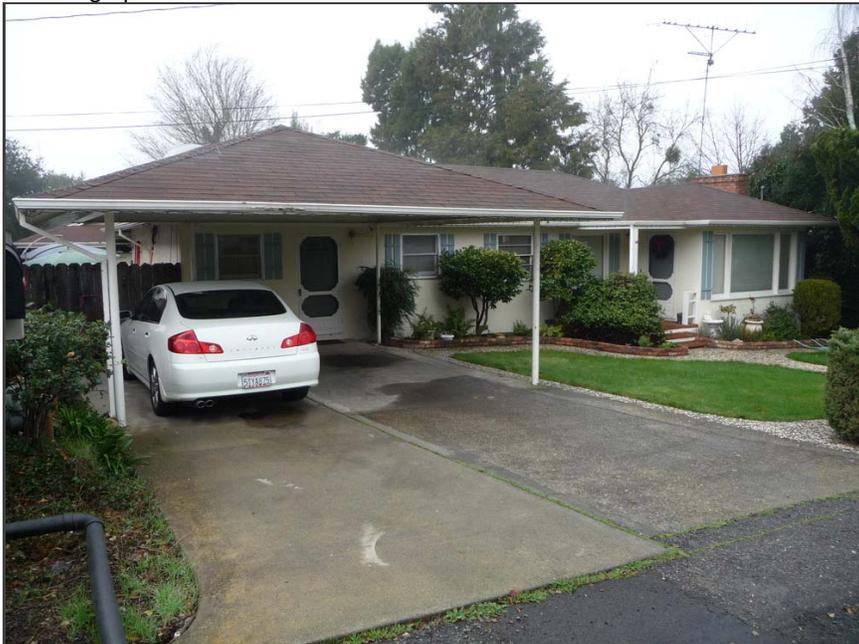
East elevation
ARG, January 2011

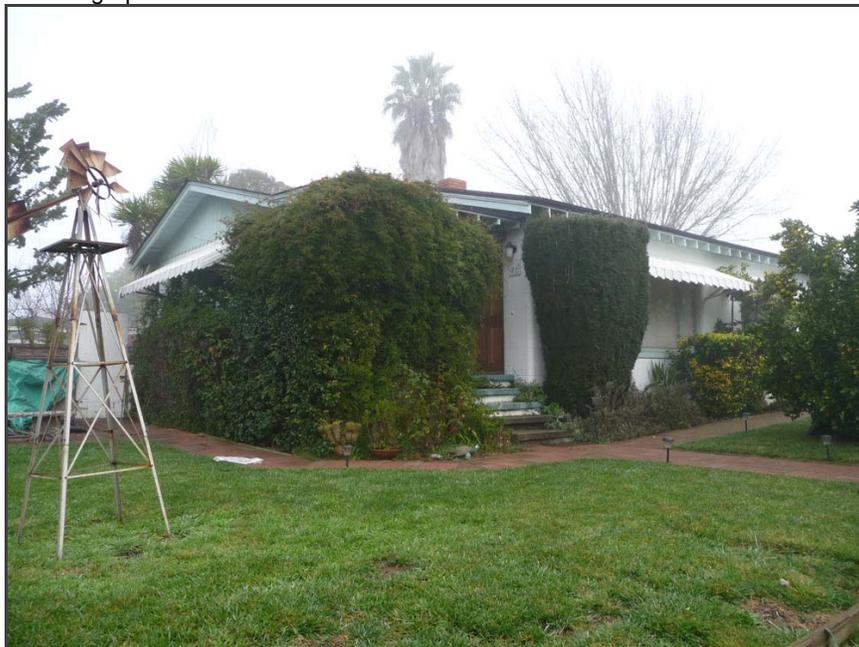
- Style(s): Ranch, Minimal
- Stories: 1
- Cladding: concrete block
- Porch: entrance porch, concrete steps
- Door(s): single, wood, paneled; Secondary - single, door material unknown
- Windows: Type 1 - tripartite, casement, aluminum, fixed, aluminum
- Roof: side gable, composition shingle, open eaves
- Chimney: brick, exterior
- Related Features: Second building
- Alterations: awnings incompatible, door replaced, some window openings resized, porch altered, Garage opening infilled. Solar panels added to roof. Handicap ramp added to side entrance porch.
- Notes: Two buildings an property. Front house is Ranch-Minimal. Rear building is (possibly) a shotgun-form minimal, front gable cottage. Assessment form is for front house.

South and west elevations

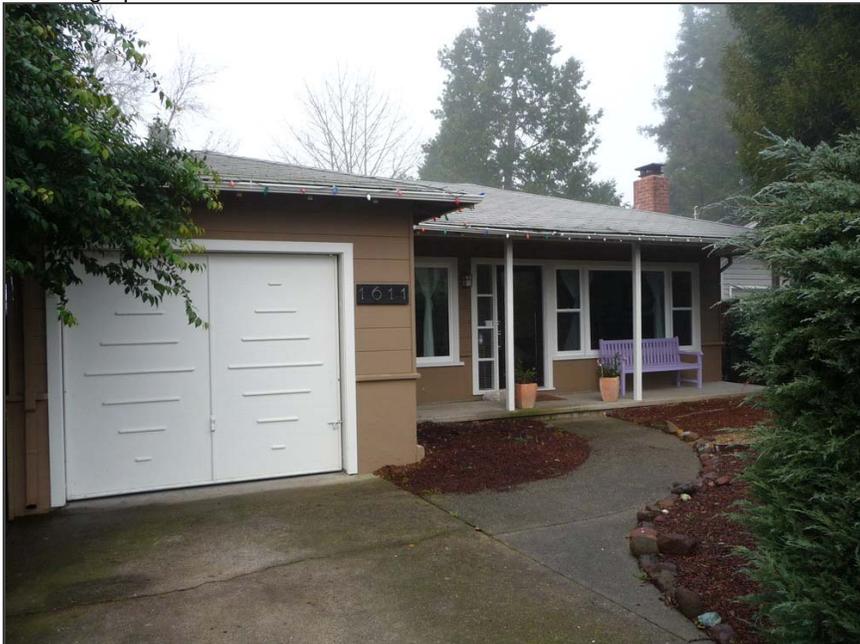
- Style(s): Minimal Traditional
- Stories: 1
- Cladding: smooth stucco, wood clapboards
- Porch: partial width, concrete steps, wood posts
- Door(s): single, wood, fully glazed, sidelights
- Windows: Type 1 - single, casement, vinyl; Type 2 - tripartite, double hung, vinyl, fixed, vinyl
- Roof: cross hipped, composition sheets, open eaves
- Chimney: brick, exterior
- Related Features: attached 1-car garage
- Alterations: door opening remodeled, some windows replaced
- Notes:

East elevation
ARG, January 2011

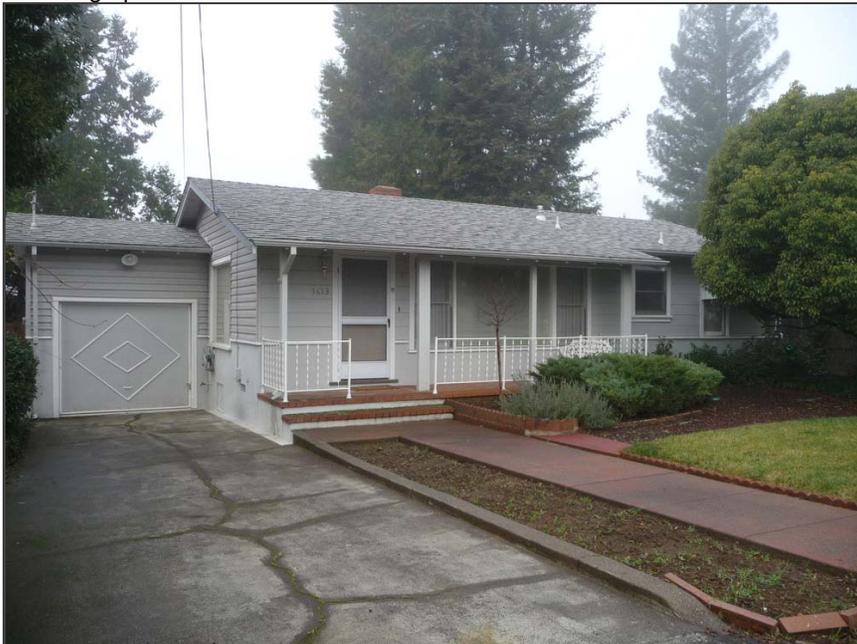
- Style(s): Minimal Traditional / American Colonial Revival
- Stories: 1
- Cladding: smooth stucco, wood lap
- Porch: partial width, brick steps, wood posts, pierced iron rail
- Door(s): single, wood, metal screen
- Windows: Type 1 - single, double hung, wood; Type 2 - single, fixed, vinyl
- Roof: side gable, composition shingle, open eaves
- Chimney: brick, exterior
- Related Features: attached 1-car garage
- Alterations: awnings incompatible, some windows replaced
- Notes:

P5b. Description of Photo:
East elevation
ARG, January 2011

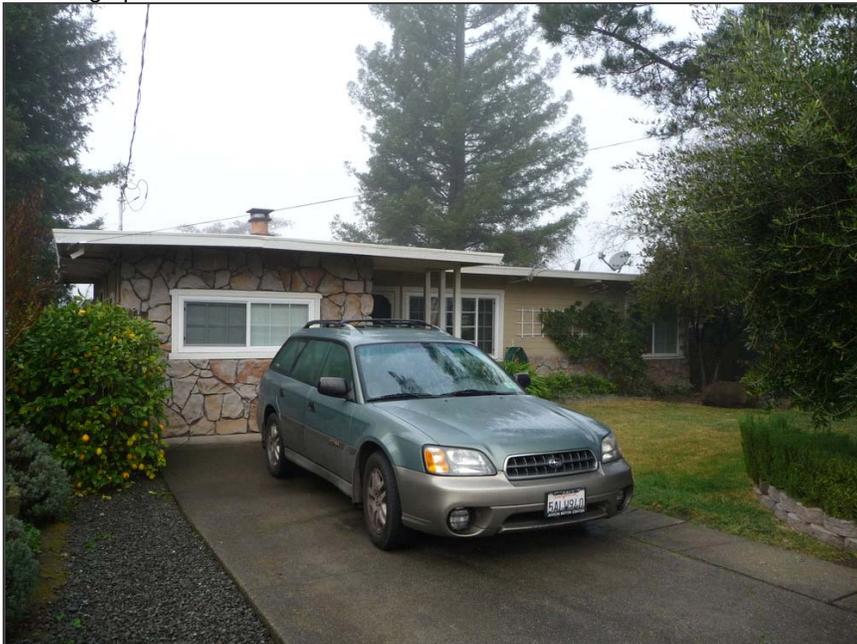
- Style(s): Modernism, Mid-Century / Ranch, Minimal
- Stories: 1
- Cladding: fieldstone, wood clapboards
- Porch: entrance porch, wood posts
- Door(s): single, door material unknown, wood screen
- Windows: Type 1 - single, sliding, vinyl
- Roof: flat, material not visible, exposed rafter tails, open eaves
- Chimney: none visible
- Related Features:
- Alterations: windows replaced
- Notes:

East elevation

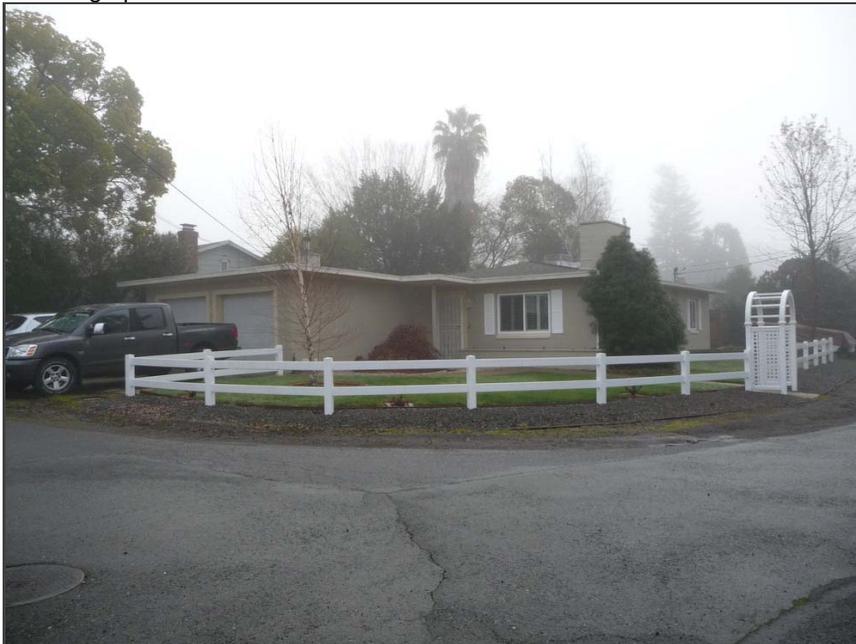
P5b. Description of Photo:
North elevation
ARG, January 2011

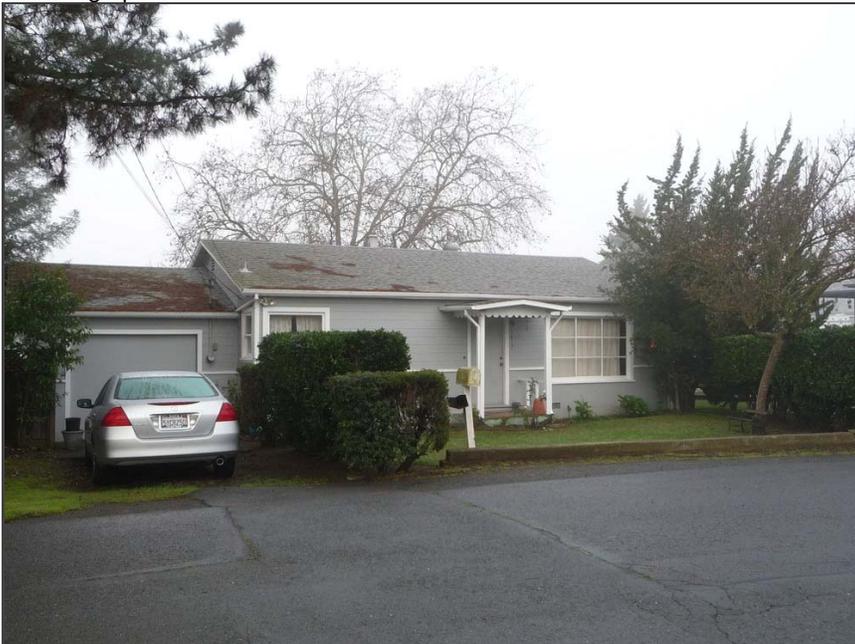
- Style(s): American Colonial Revival
- Stories: 1
- Cladding: smooth stucco, wood clapboards
- Porch: entrance porch, concrete steps, wood posts, wood rail
- Door(s): single, wood
- Windows: Type 1 - single, fixed, vinyl; Type 2 - single, double hung, vinyl
- Roof: side gable, composition shingle, open eaves
- Chimney: none visible
- Related Features: attached 1-car garage
- Alterations: windows replaced
- Notes:

East elevation

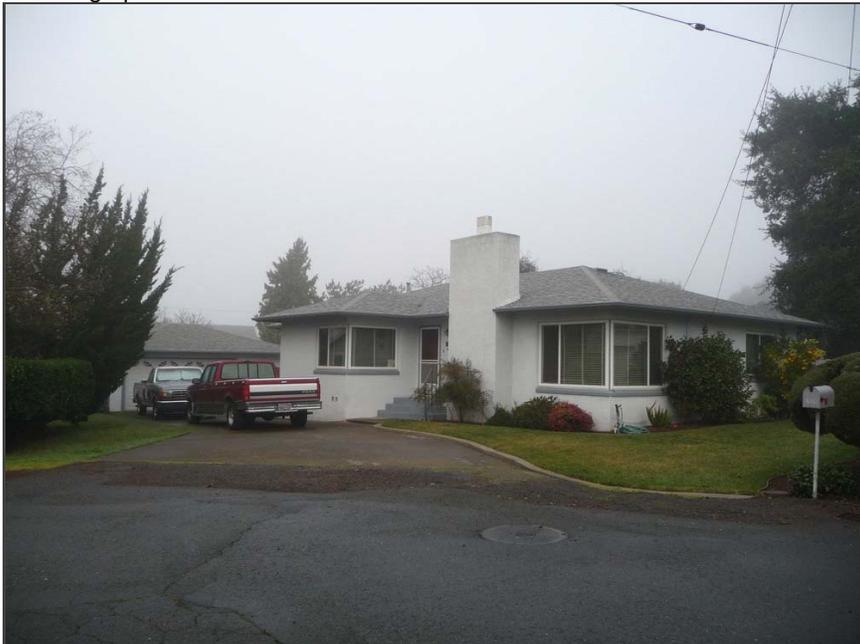
South and east elevations

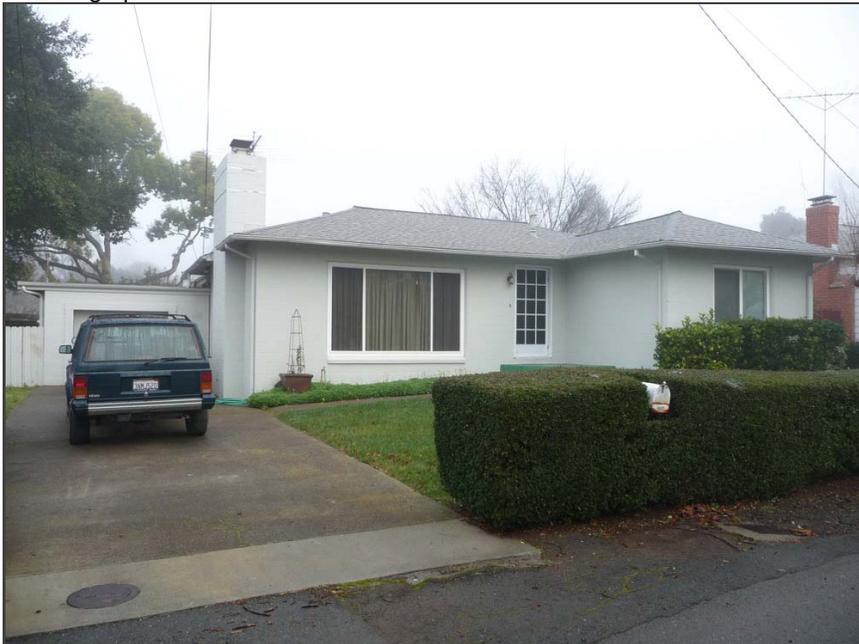
- Style(s): Minimal Traditional
- Stories: 1
- Cladding: concrete block
- Porch: none, concrete steps
- Door(s): single, wood, divided lights, fully glazed
- Windows: Type 1 - tripartite, sliding, vinyl; Type 2 - single, sliding, vinyl
- Roof: cross hipped, composition shingle, open eaves
- Chimney: brick, exterior
- Related Features: attached 1-car garage
- Alterations: door opening remodeled, door replaced, some windows replaced, porch altered
- Notes: Concrete brick chimney

South elevation
ARG, January 2011

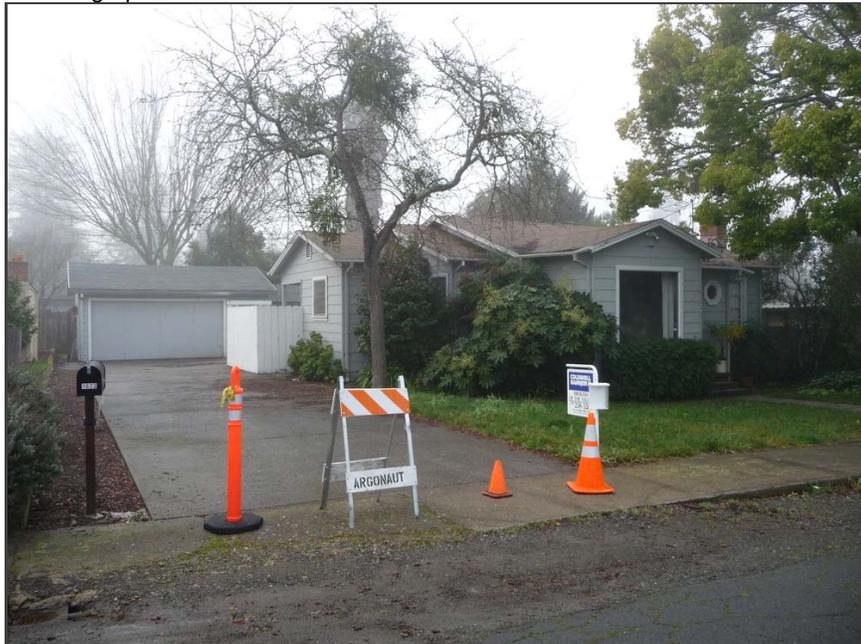
- Style(s): Minimal Traditional
- Stories: 1
- Cladding: wood clapboards
- Porch: entrance porch, recessed, concrete steps
- Door(s): single, wood, paneled
- Windows: Type 1 - single, fixed, wood; Type 2 - single, double hung, wood, multipane
- Roof: cross gable, composition sheets, open eaves
- Chimney: brick, exterior
- Related Features: detached 2-car garage
- Alterations: door replaced, some windows replaced
- Notes:

North elevation

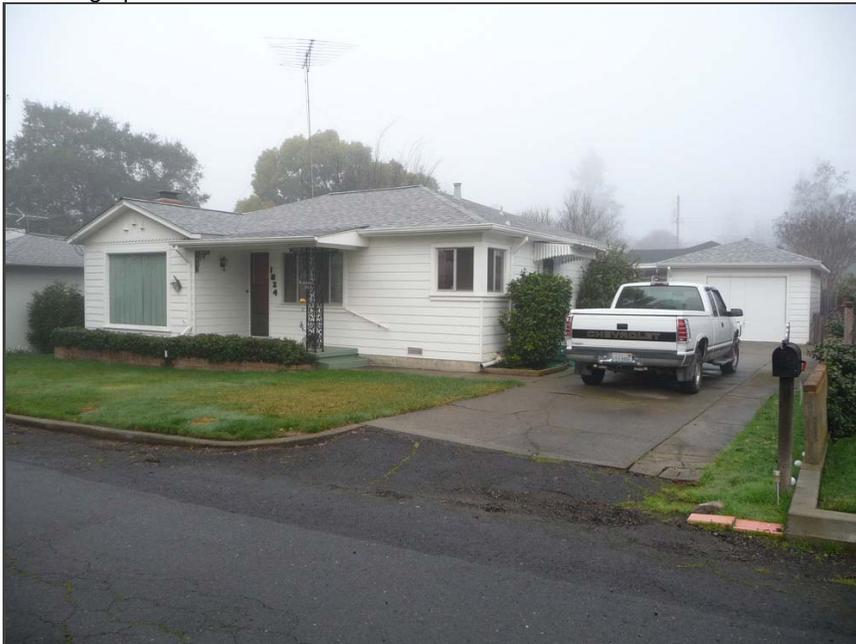
- Style(s): Minimal Traditional
- Stories: 1
- Cladding: wood lap, wood vertical boards
- Porch: entrance porch, partial width, concrete steps, iron brackets, supports, wood rail
- Door(s): single, wood, paneled, metal screen; Secondary - single, door material unknown
- Windows: Type 1 - single, fixed, wood; Type 2 - tripartite, sliding, aluminum; Type 3 - paired, sliding, aluminum
- Roof: cross hipped, composition shingle, boxed eaves, open eaves
- Chimney: brick, exterior
- Related Features: detached 1-car garage
- Alterations: awnings incompatible, some windows replaced
- Notes:

P5b. Description of Photo:
South elevation
ARG, January 2011

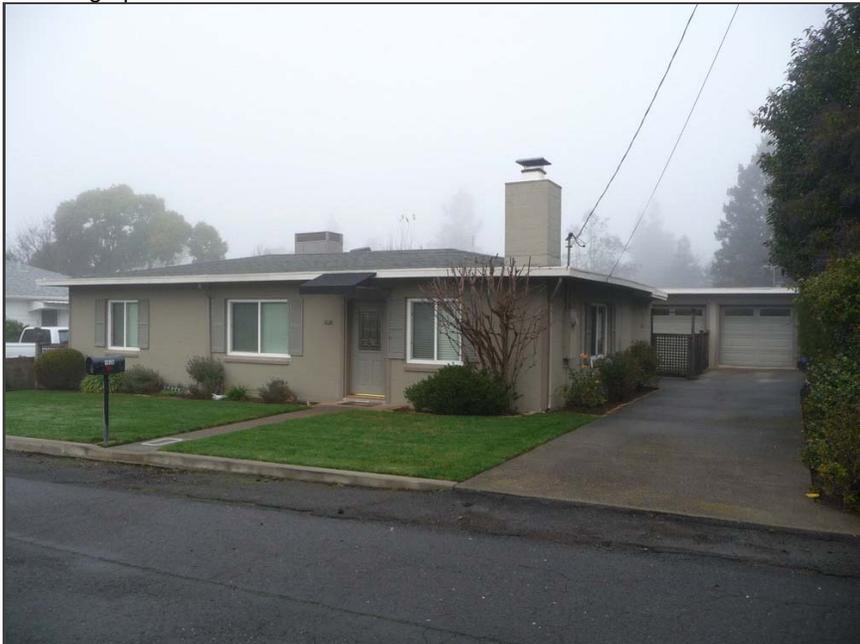
- Style(s): No style
- Stories: 1
- Cladding: concrete block
- Porch: none
- Door(s): single, wood, partially glazed
- Windows: Type 1 - single, sliding, aluminum, shutters
- Roof: hipped, composition shingle, boxed eaves
- Chimney: brick, exterior
- Related Features: detached 2-car garage
- Alterations: awnings incompatible, door replaced, some windows replaced
- Notes: Chimney is painted concrete brick

P5b. Description of Photo:
South elevation
ARG, January 2011

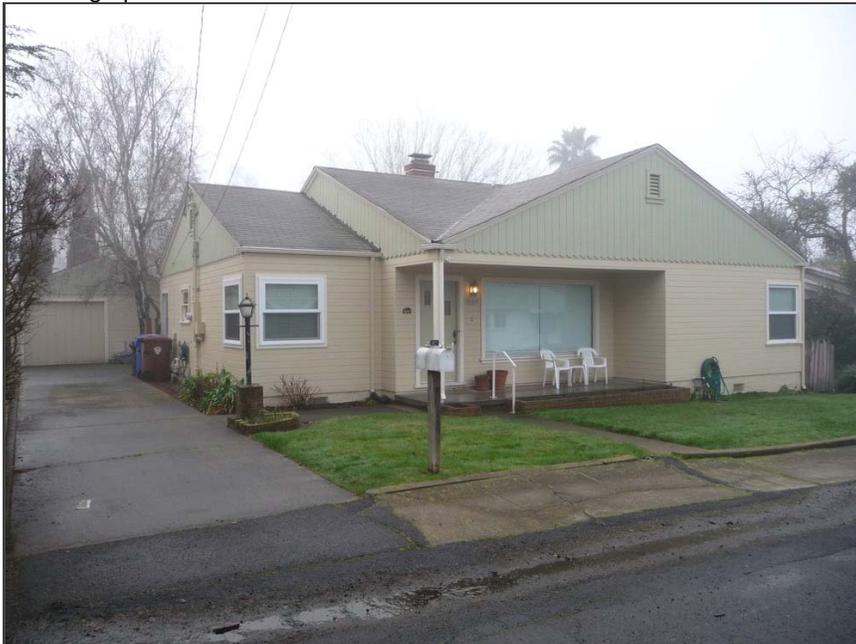
- Style(s): No style
- Stories: 1
- Cladding: vinyl
- Porch: partial width, concrete steps, wood posts, iron rail
- Door(s): single, wood, divided lights, partially glazed; Secondary - single, door material unknown
- Windows: Type 1 - single, double hung, vinyl; Type 2 - single, fixed, vinyl
- Roof: cross gable, composition sheets
- Chimney: brick, exterior
- Related Features: detached 1-car garage
- Alterations: cladding altered, some window openings resized, windows replaced
- Notes: Possible that cladding is wood. Porch enclosure possible.

P5b. Description of Photo:
North elevation
ARG, January 2011

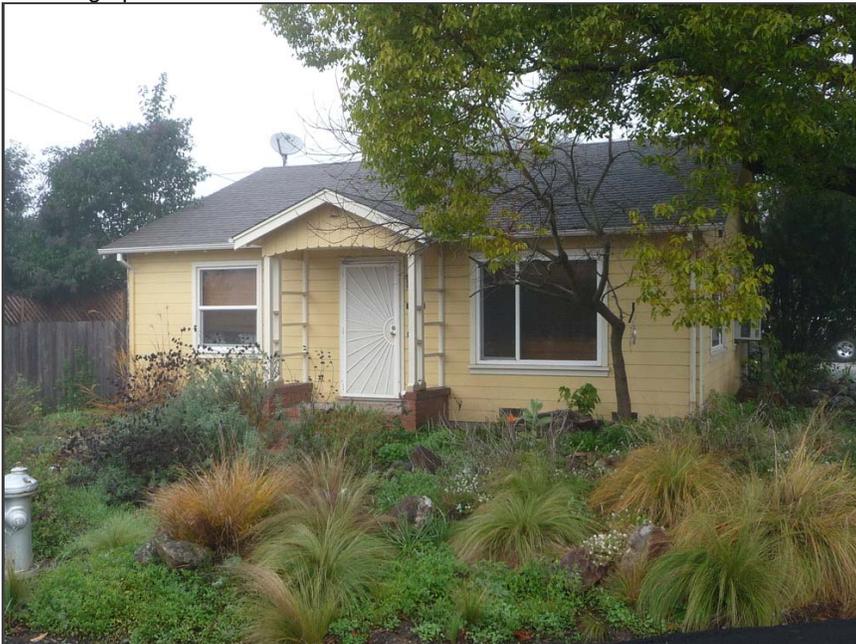
- Style(s): American Colonial Revival
- Stories: 1
- Cladding: wood clapboards
- Porch: entrance porch, brick steps, wood piers, brick solid rail
- Door(s): single, security door, door material unknown
- Windows: Type 1 - single, double hung, vinyl; Type 2 - single, casement, aluminum
- Roof: side gable, composition sheets, open eaves
- Chimney: none visible
- Related Features:
- Alterations: security door added, windows replaced
- Notes:

East elevation

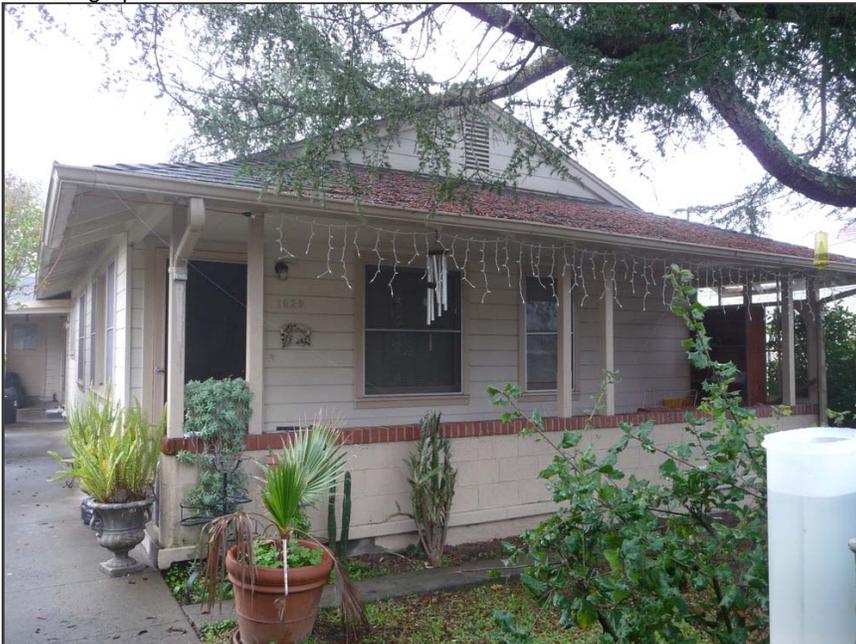
North elevation
ARG, January 2011

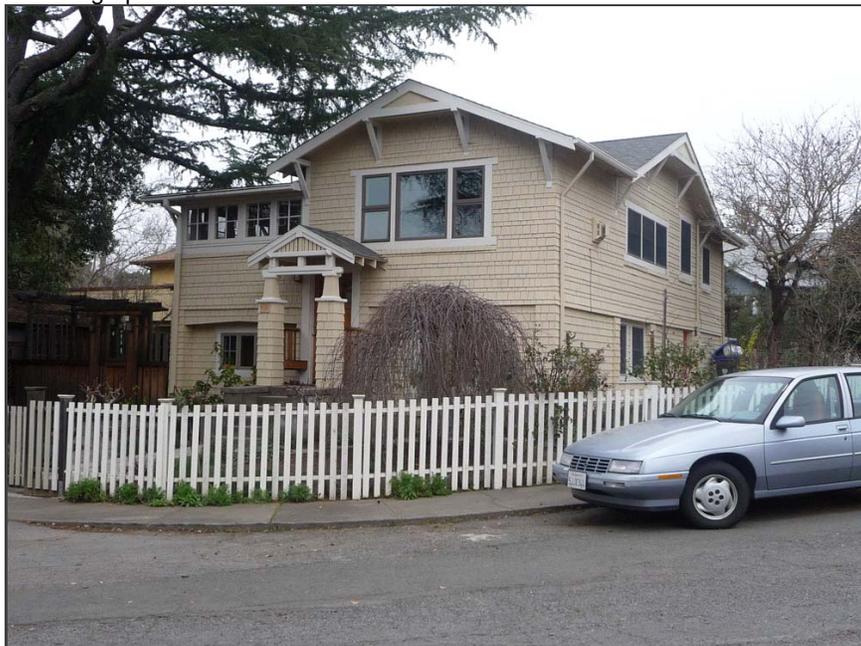
- Style(s): Craftsman / Shingle
- Stories: 2
- Cladding: wood shingles
- Porch: entrance porch, concrete steps, wood battered posts, wood pedestals, wood rail
- Door(s): single, wood, divided lights, partially glazed
- Windows: Type 1 - grouped, double hung, fixed, vinyl; Type 2 - grouped, casement, fixed, vinyl; Type 3 - grouped, double hung, vinyl
- Roof: combination, brackets, open eaves, wide eaves
- Chimney: none visible
- Related Features: detached 1-car garage
- Alterations: some windows replaced
- Notes:

South and east elevations
ARG, January 2011

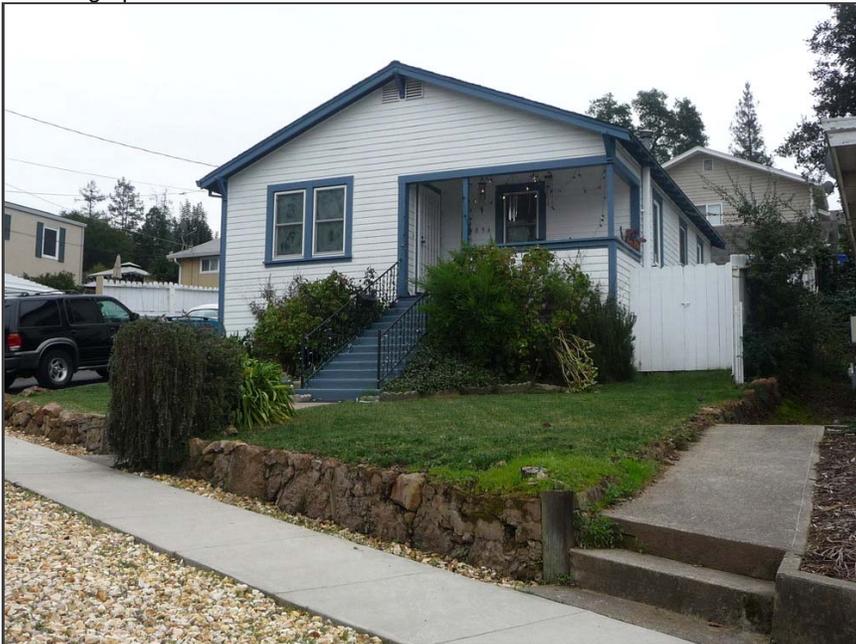
- Style(s): Craftsman
- Stories: 1
- Cladding: wood clapboards
- Porch: partial width, concrete steps, wood posts, iron rail
- Door(s): single, door material unknown, metal screen
- Windows: Type 1 - paired, double hung, vinyl; Type 2 - single, double hung, vinyl
- Roof: front gable, composition shingle, exposed rafter tails, open eaves
- Chimney: none visible
- Related Features: detached 1-car garage
- Alterations: windows replaced
- Notes:

P5b. Description of Photo:
West elevation
ARG, January 2011

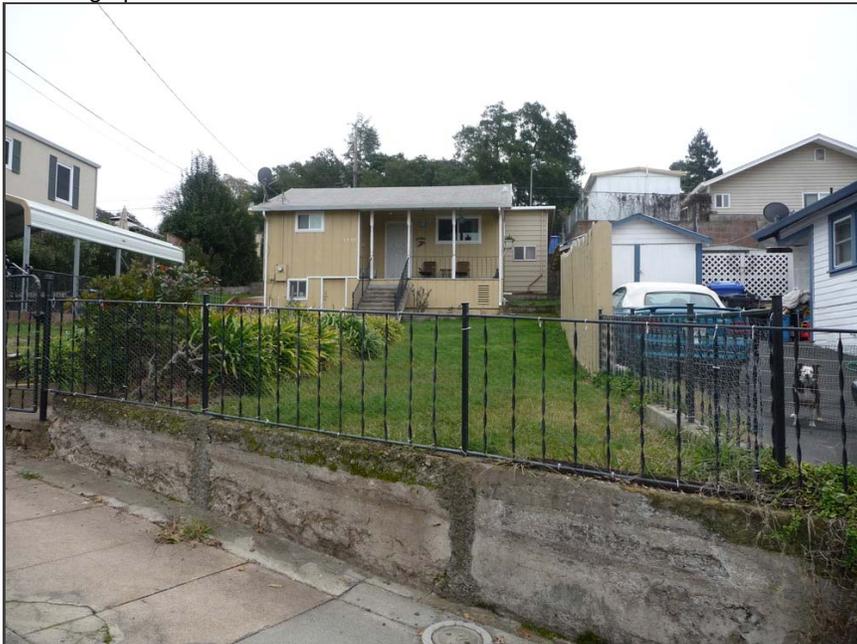
- Style(s): No style
- Stories: 1
- Cladding: wood vertical boards
- Porch: concrete steps, wood spindles, concrete rail
- Door(s): single, door material unknown, metal screen
- Windows: Type 1 - single, sliding, vinyl
- Roof: side gable, composition sheets, open eaves
- Chimney: none visible
- Related Features:
- Alterations: cladding altered, windows replaced, porch rails altered, carport added
- Notes:

West elevation
ARG, January 2011
