PRIMARY RECORD

Page 1 of 1 *Resource Name or #: (Assigned by Recorder) 1700 MEEK AVE

c. Address 1700 MEEK AVE City NAPA Zip 945591518

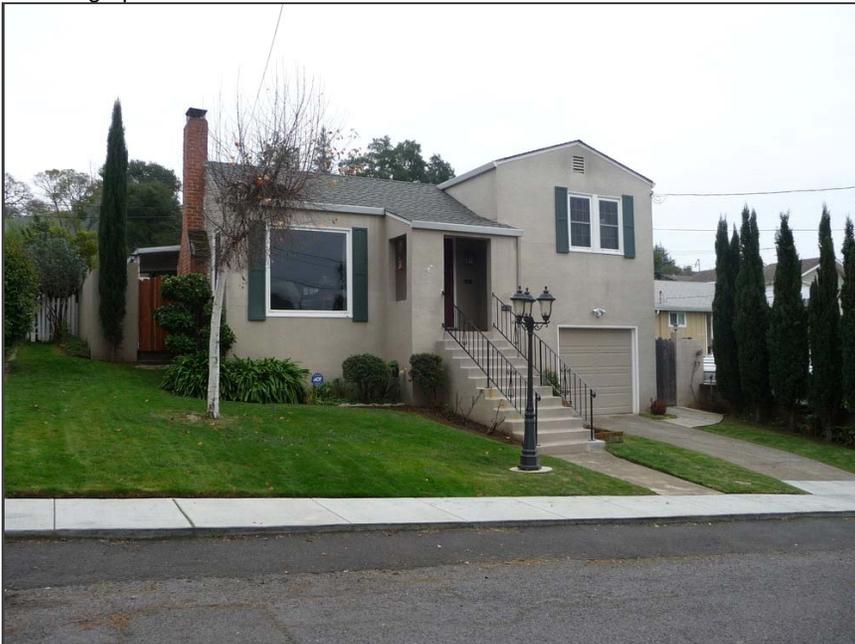
- Style(s): Minimal Traditional
- Stories: 1 1/2
- Cladding: smooth stucco
- Porch: entrance porch, concrete steps, stucco supports, iron rail
- Door(s): single, wood, paneled, wood screen
- Windows: Type 1 - single, fixed, vinyl; Type 2 - paired, double hung, vinyl
- Roof: cross gable, composition shingle
- Chimney: brick, exterior
- Related Features: attached 1-car garage
- Alterations: windows replaced, garage door replaced
- Notes:

P5b. Description of Photo:
West elevation
ARG, January 2011

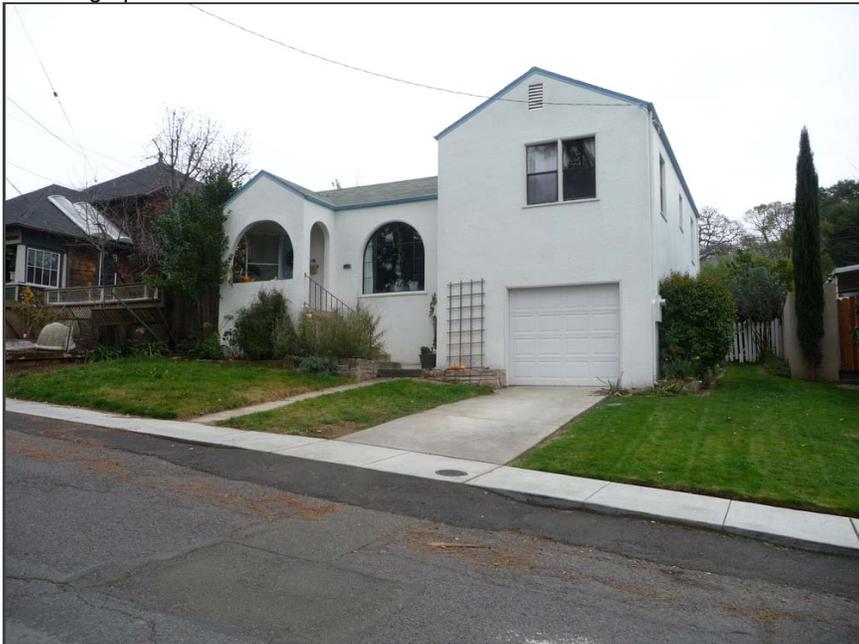
- Style(s): Spanish Colonial Revival
- Stories: 1 1/2
- Cladding: smooth stucco
- Porch: partial width, concrete steps, iron rail
- Door(s): single, wood
- Windows: Type 1 - single, fixed, vinyl, arched opening; Type 2 - paired, double hung, vinyl
- Roof: cross gable, composition sheets
- Chimney: none visible
- Related Features: attached 1-car garage
- Alterations: windows replaced, garage door replaced
- Notes:

West elevation
ARG, January 2011

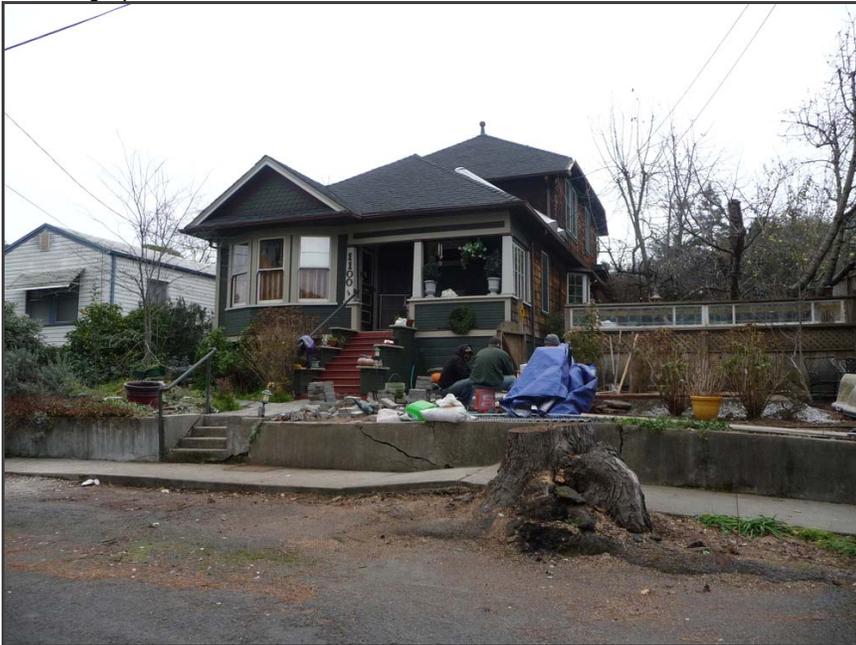
West elevation

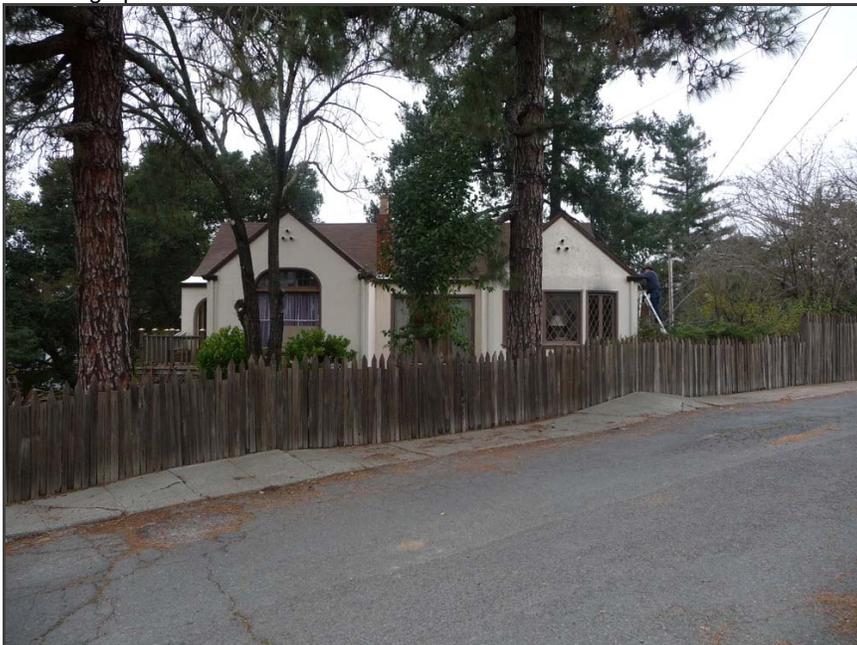
South elevation

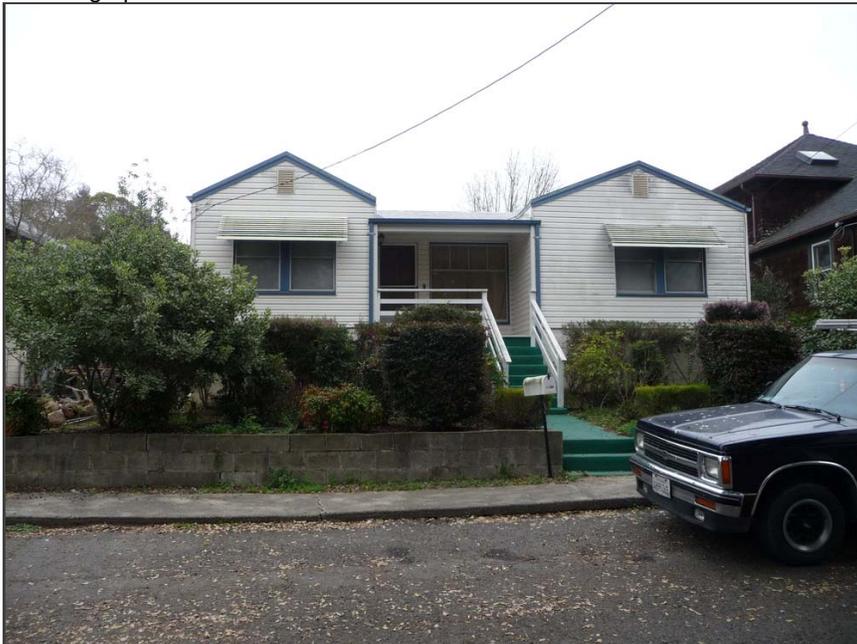
- Style(s): Mediterranean Revival
- Stories: 1 1/2
- Cladding: aluminum
- Porch: partial width, recessed, concrete steps
- Door(s): single, wood, paneled
- Windows: Type 1 - paired, double hung, vinyl; Type 2 - single, fixed, vinyl
- Roof: cross gable, composition sheets
- Chimney: none visible
- Related Features: rear dwelling
- Alterations: cladding altered, windows replaced
- Notes:

P5b. Description of Photo:
West elevation
ARG, January 2011

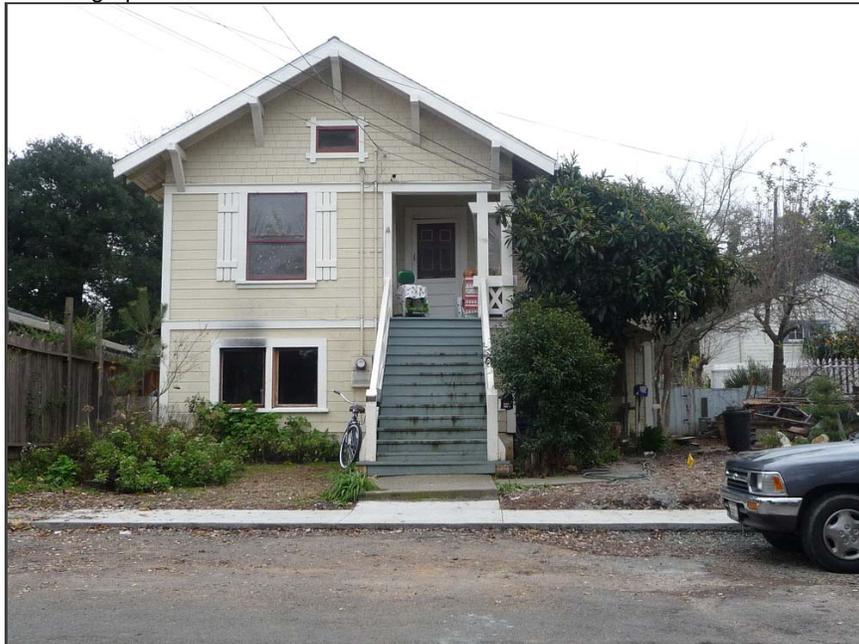
West elevation

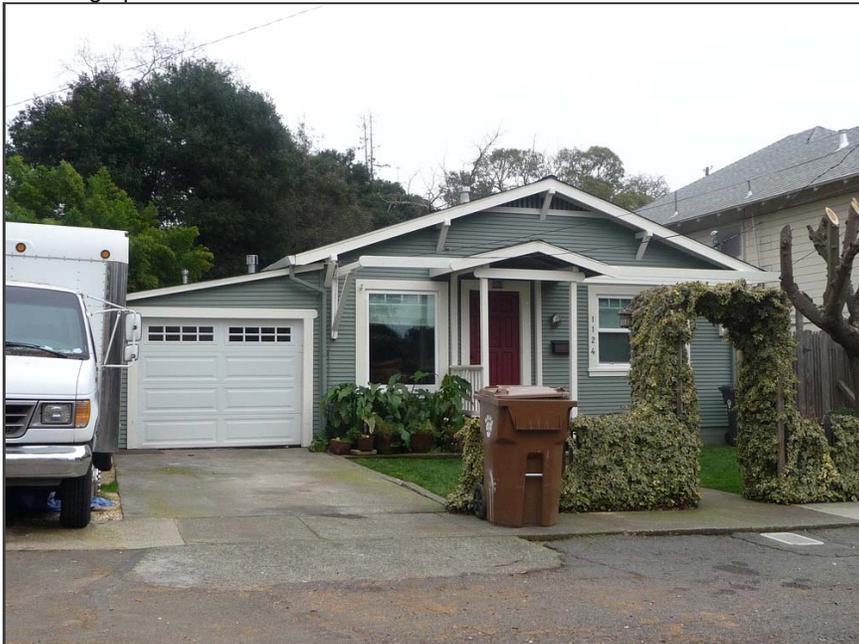
- Style(s): Craftsman
- Stories: 1
- Cladding: wood clapboards
- Porch: entrance porch, concrete steps, wood steps, wood posts, wood rail
- Door(s): single, wood, paneled
- Windows: Type 1 - single, fixed, vinyl; Type 2 - paired, double hung, vinyl
- Roof: front gable, composition shingle, brackets, exposed rafter tails, open eaves
- Chimney: none visible
- Related Features: pergola at main façade., attached 1-car garage
- Alterations: windows replaced, garage added to main façade
- Notes:

West elevation
ARG, January 2011

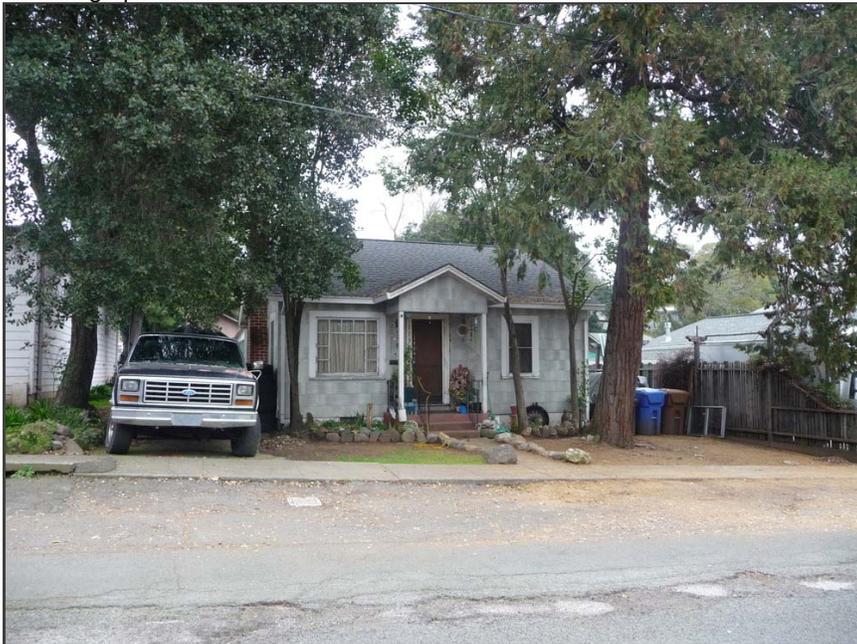
West elevation

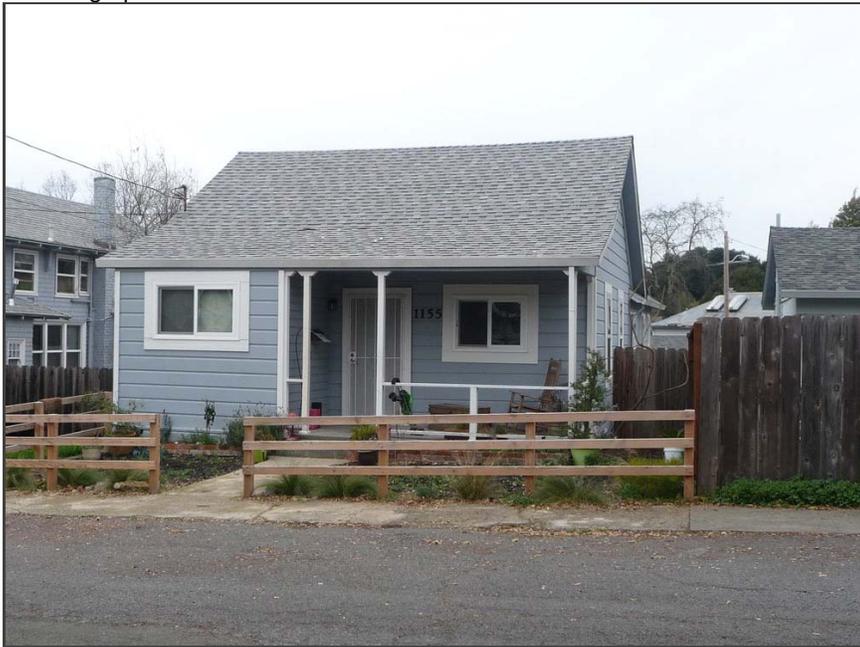
- Style(s): Victorian, Vernacular cottage, gable roof
- Stories: 1
- Cladding: wood drop channel
- Porch: partial width, concrete steps, wood posts, wood rail
- Door(s): single, door material unknown, metal screen
- Windows: Type 1 - single, sliding, vinyl; Type 2 - single, double hung, vinyl
- Roof: side gable, composition shingle
- Chimney: none visible
- Related Features:
- Alterations: windows replaced, porch partially enclosed
- Notes:

P5b. Description of Photo:
North and west elevations
ARG, January 2011

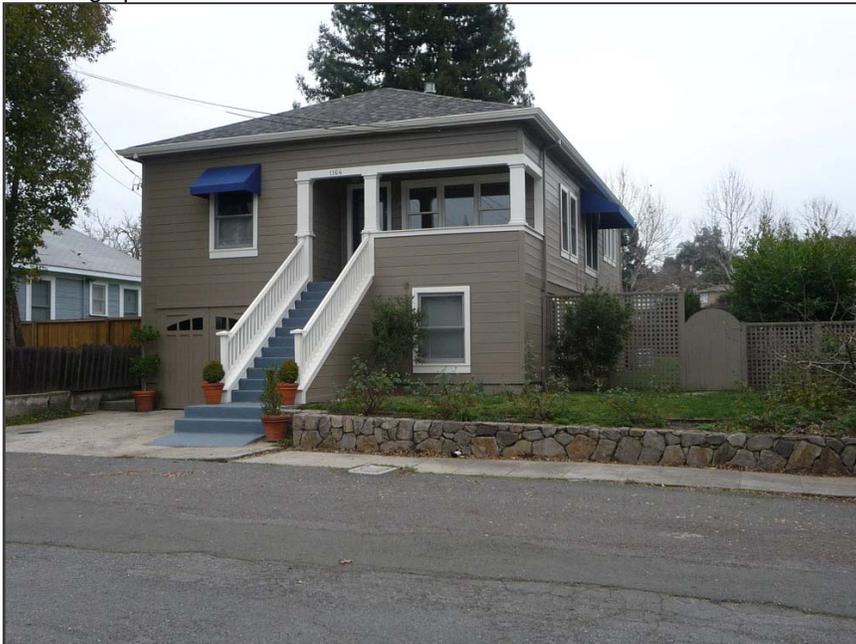
- Style(s): Victorian, Vernacular Cottage, hip roof
- Stories: 1
- Cladding: wood clapboards
- Porch: partial width, concrete steps, wood posts, wood rail
- Door(s): single, wood, divided lights
- Windows: Type 1 - tripartite, double hung, fixed, vinyl; Type 2 - single, double hung, vinyl
- Roof: pyramidal hipped, composition shingle, open eaves
- Chimney: none visible
- Related Features: attached 1-car garage
- Alterations: windows replaced, incompatible awnings
- Notes:

West elevation

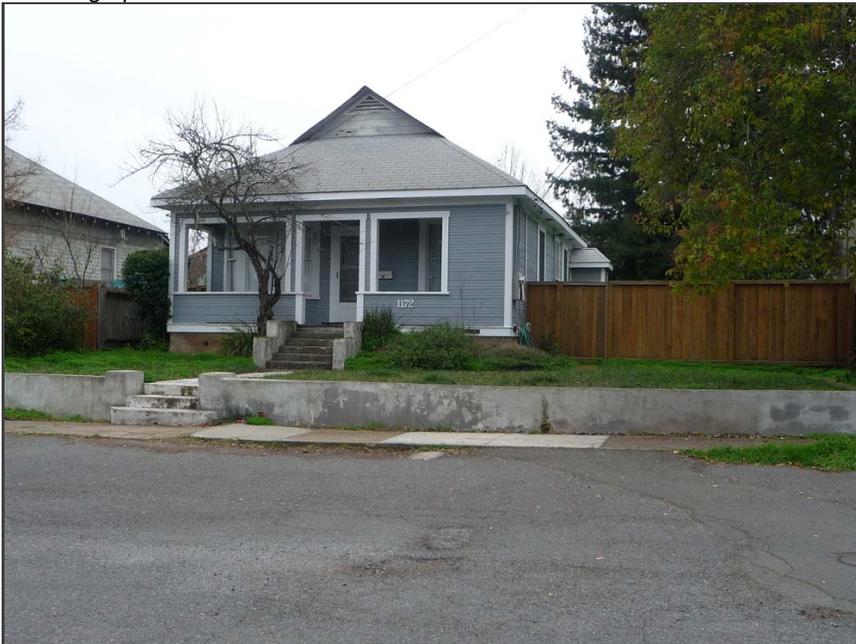
- Style(s): Victorian, Vernacular Cottage, hip roof
- Stories: 1
- Cladding: wood clapboards
- Porch: partial width, concrete steps, wood supports, wood solid rail
- Door(s): single, wood, partially glazed, wood screen
- Windows: Type 1 - canted bay, double hung, vinyl, historic surround; Type 2 - single, double hung, vinyl
- Roof: hipped, composition sheets, boxed eaves
- Chimney: none visible
- Related Features:
- Alterations: windows replaced
- Notes:

P5b. Description of Photo:
West elevation
ARG, January 2011

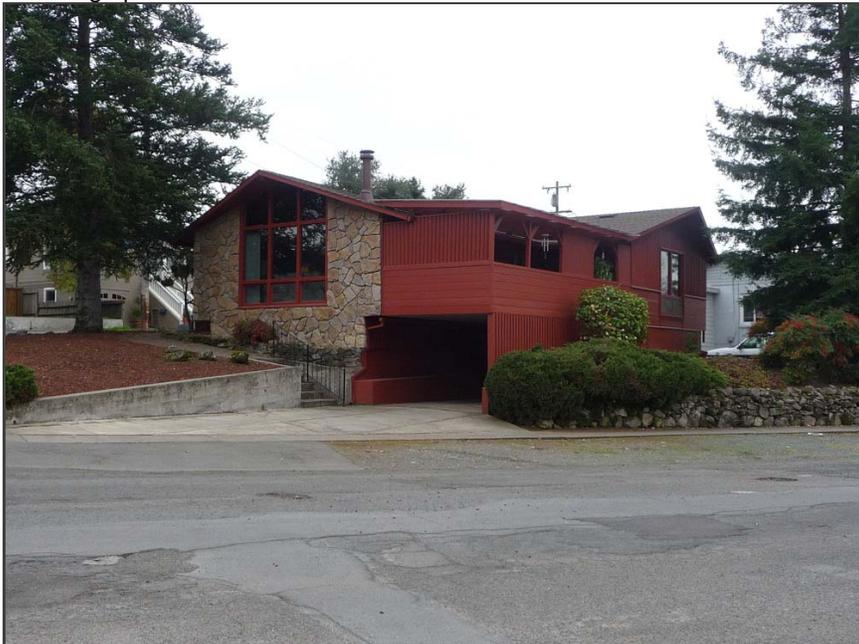
P5b. Description of Photo:
South and east elevations
ARG, January 2011

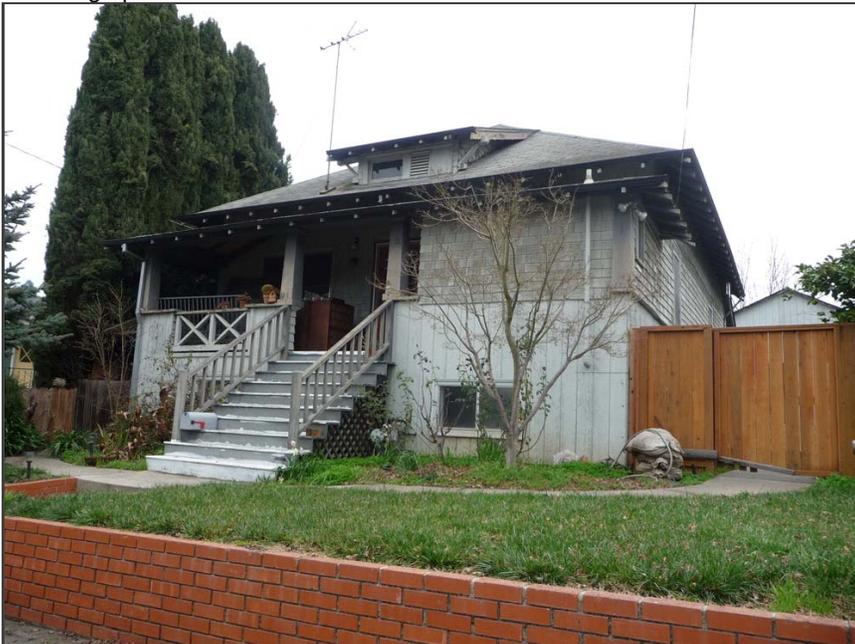
West elevation

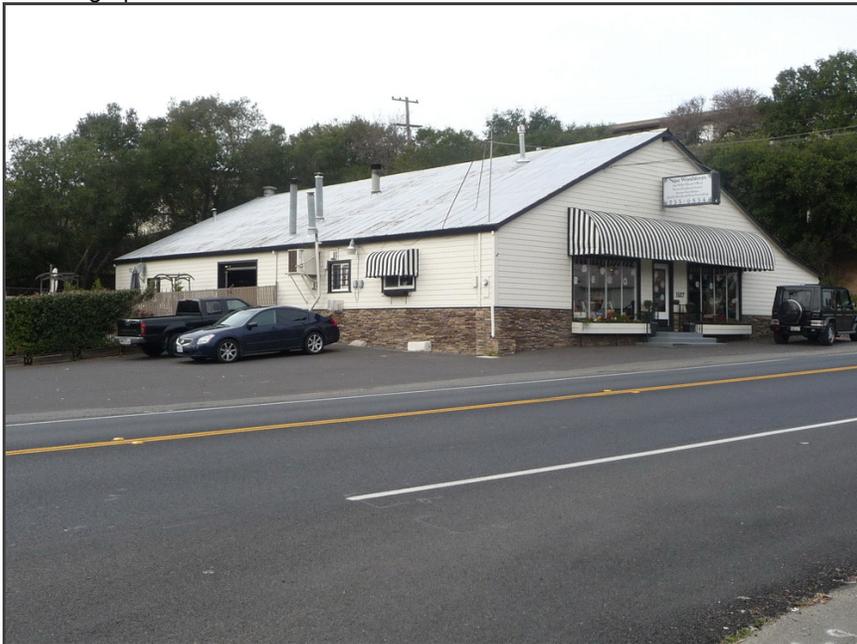
- Style(s): Commercial, Vernacular
- Stories: 1
- Cladding: fieldstone, vinyl
- Porch: entrance porch, concrete steps, iron rail
- Door(s): single, wood, fully glazed
- Windows: Type 1 - fixed, metal; Type 2 - single, sliding, vinyl
- Roof: front gable, corrugated metal, vergeboards
- Chimney: none visible
- Related Features: Parking lot.
- Alterations: cladding altered, windows replaced
- Notes:

South and west elevations

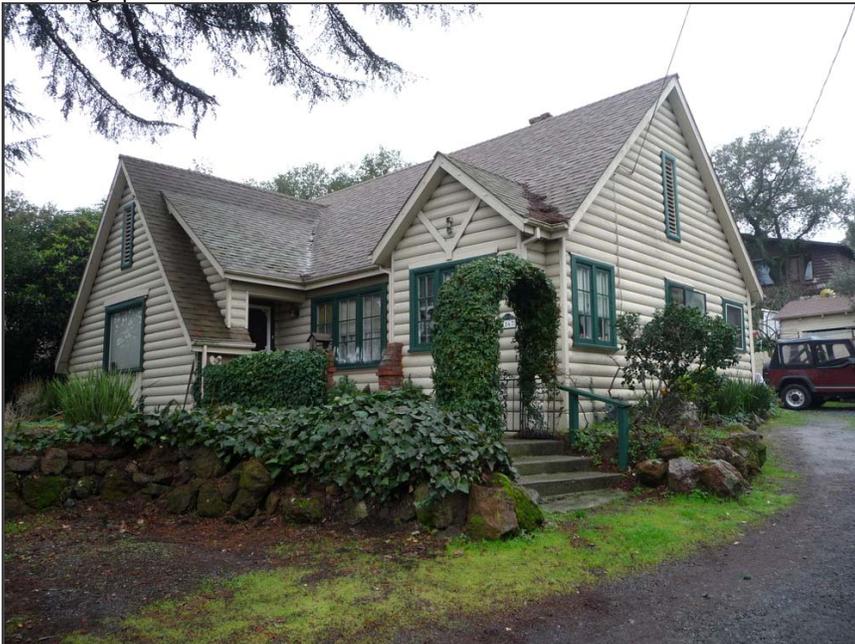
- Style(s): English Revival, Tudor
- Stories: 1
- Cladding: see notes
- Porch: entrance porch, recessed, concrete steps
- Door(s): single, wood, wood screen
- Windows: Type 1 - grouped, casement, wood, multipane; Type 2 - single, fixed, wood; Type 3 - single, double hung, wood
- Roof: cross gable
- Chimney: brick, interior
- Related Features: detached 1-car garage
- Alterations: One window replaced, side façade
- Notes: Log construction

East elevation
ARG, January 2011

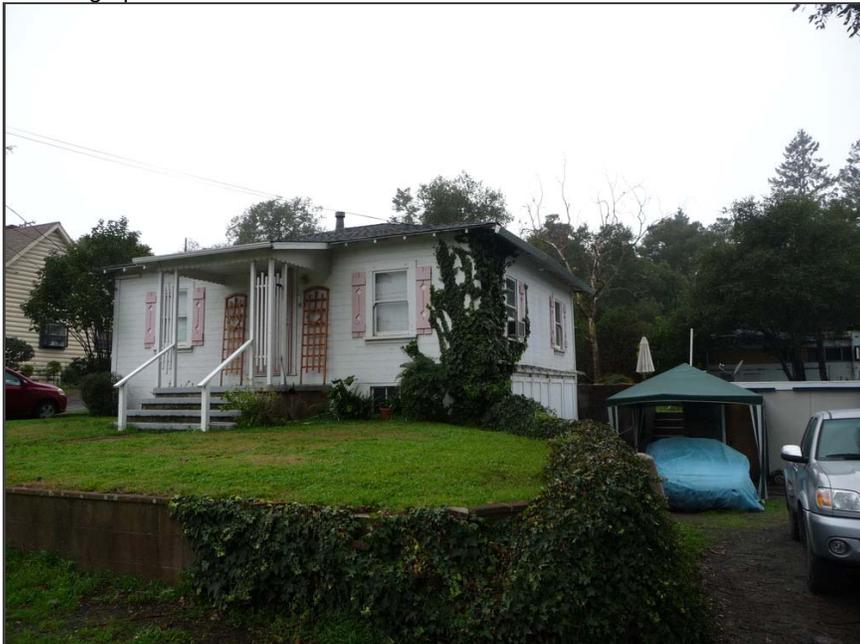
East elevation
ARG, January 2011

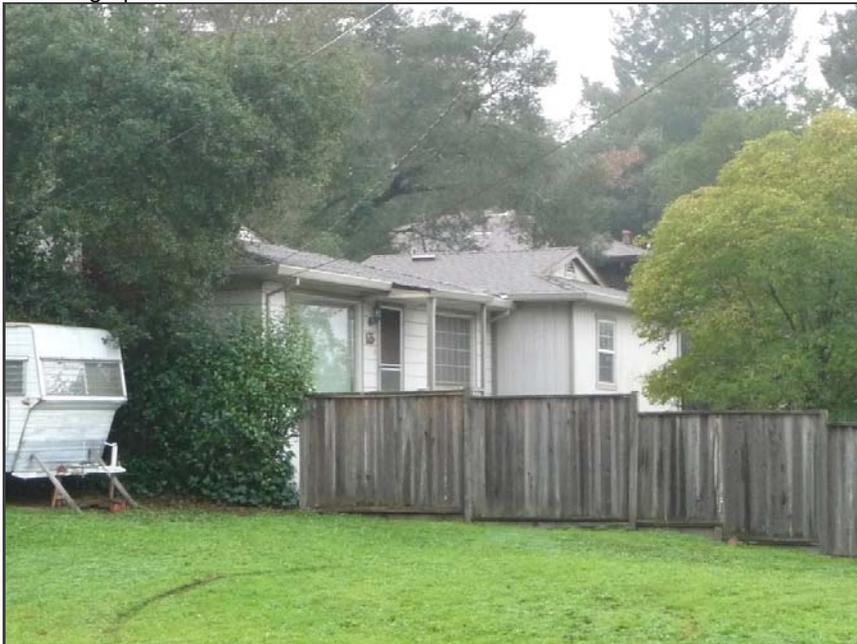
P5b. Description of Photo:
North elevation
ARG, January 2011

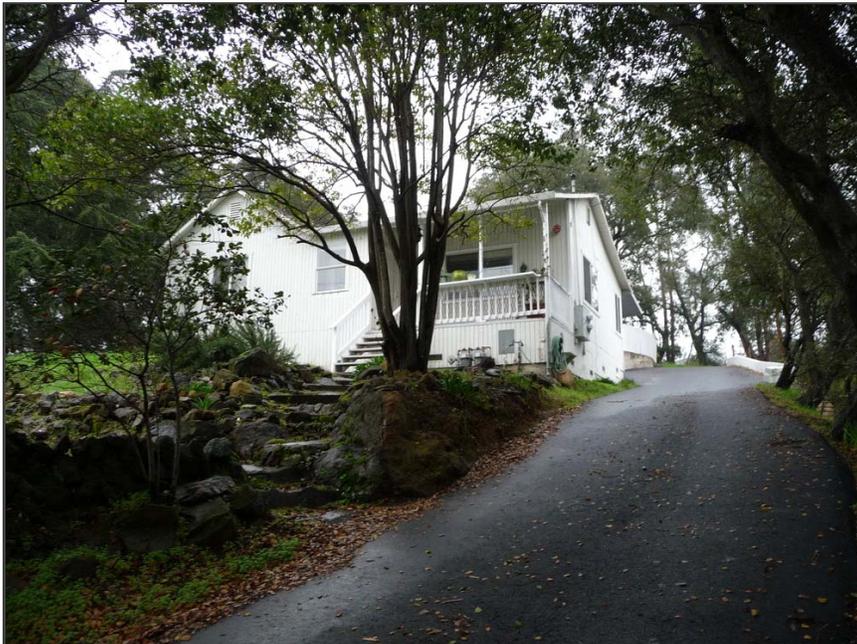
P5b. Description of Photo:
West elevation
ARG, January 2011

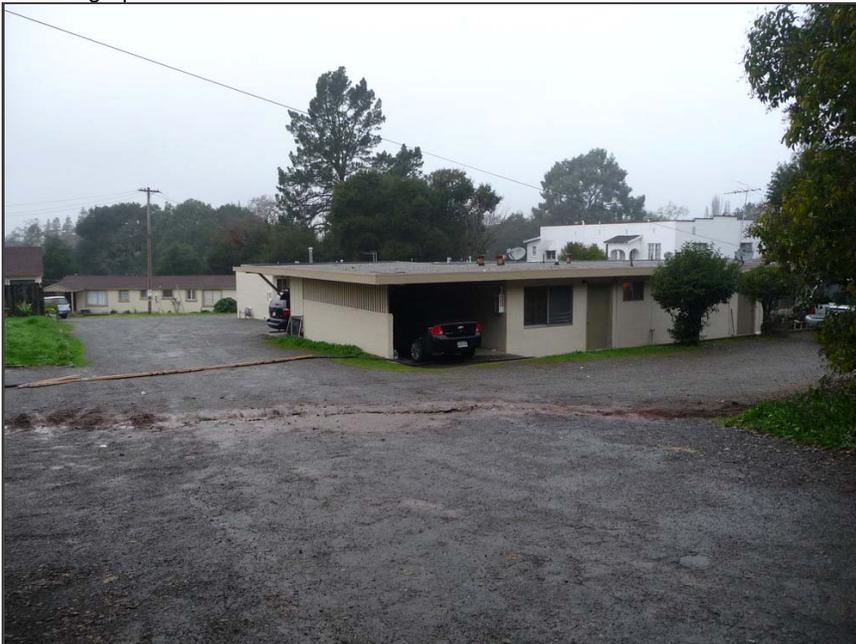
East elevation

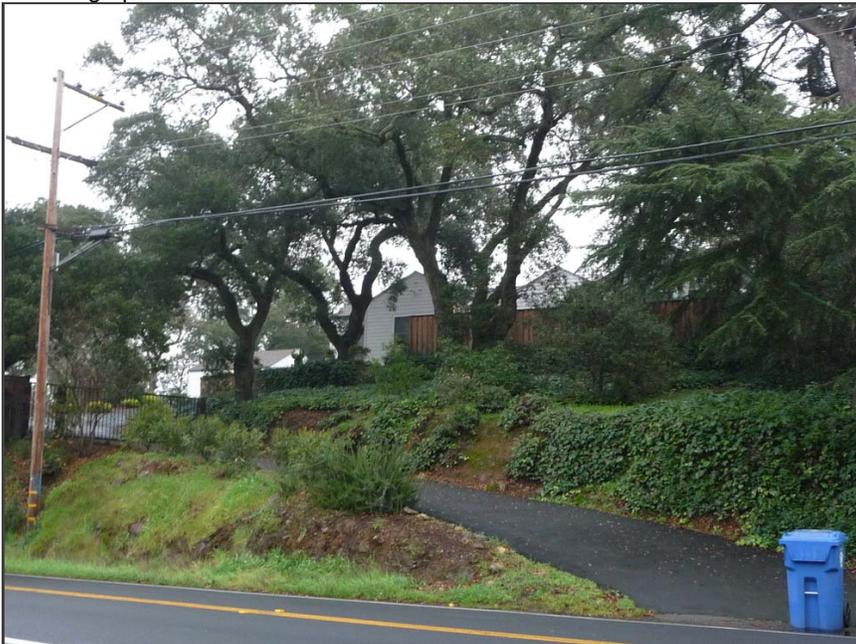
West elevation
ARG, January 2011

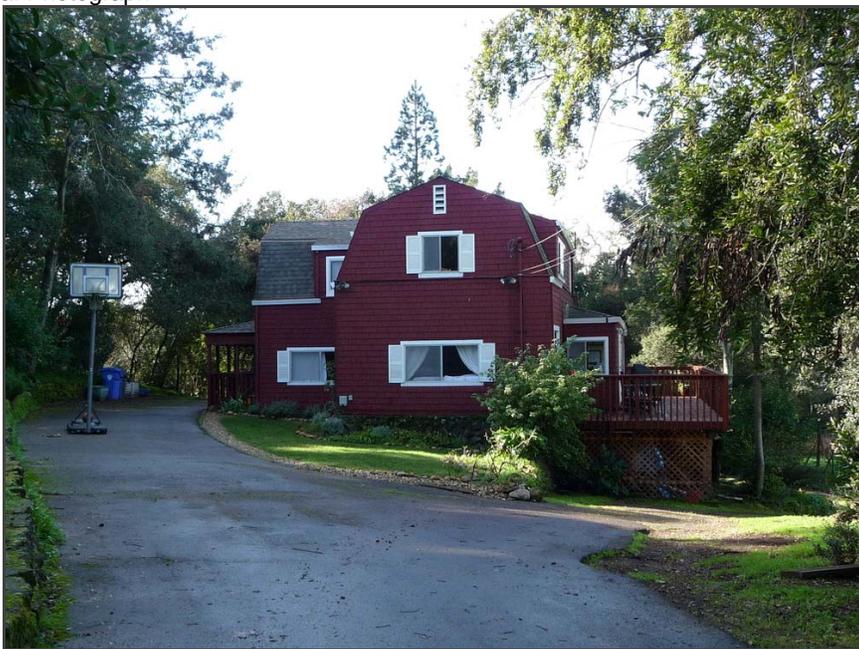
P5b. Description of Photo:
South elevation
ARG, January 2011

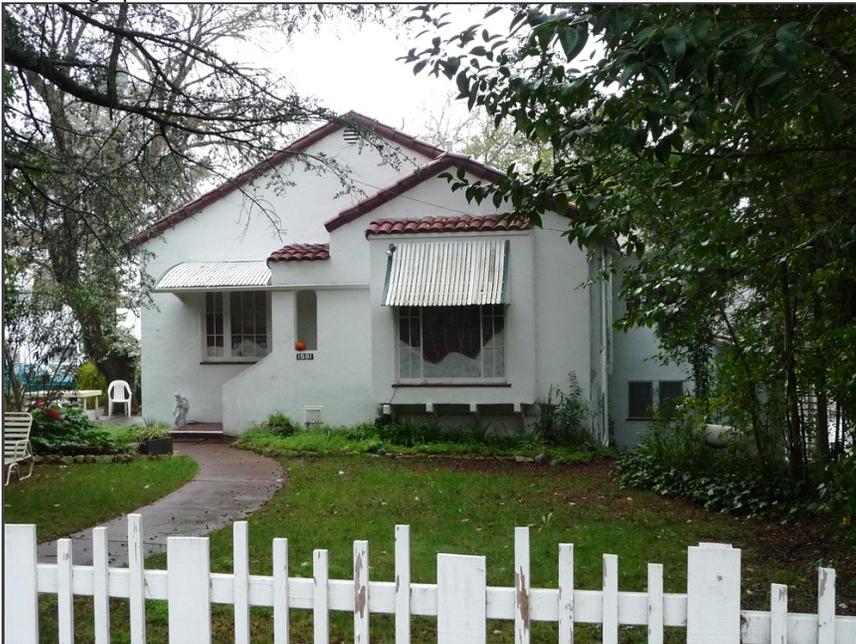
P5a. Photograph

East elevation

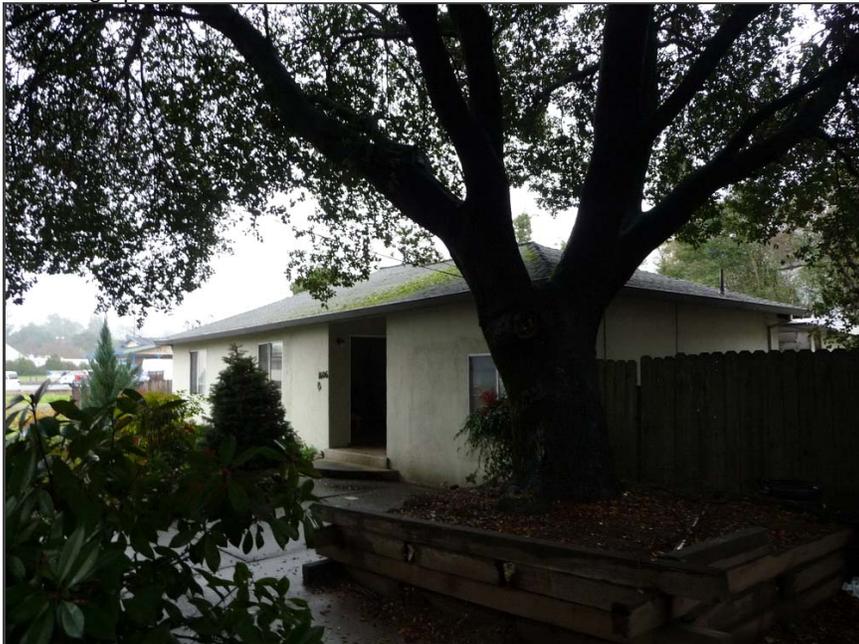
P5a. Photograph

- Style(s): No style
- Stories: 1
- Cladding: smooth stucco
- Porch: entrance porch, recessed, concrete steps
- Door(s): single, wood
- Windows: Type 1 - single, sliding, aluminum
- Roof: hipped, composition shingle, open eaves
- Chimney: none visible
- Related Features: carport
- Alterations: completely remodeled, cladding altered, windows replaced, window openings resized
- Notes:

West elevation

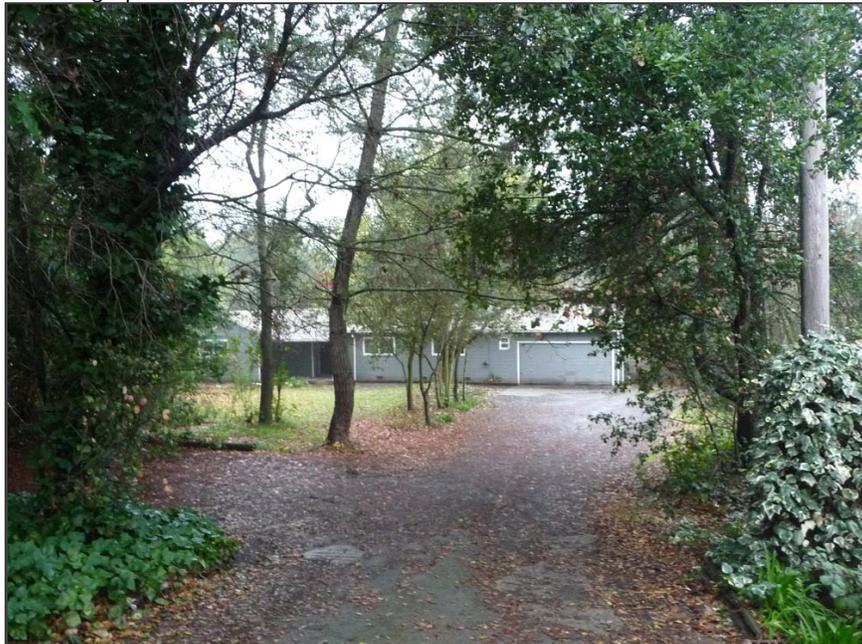
P5a. Photograph

- Style(s): Ranch, Traditional
- Stories: 1
- Cladding: wood clapboards
- Porch: entrance porch, concrete steps, wood posts
- Door(s): single, door material unknown
- Windows: Type 1 - single, sliding, material unknown; Type 2 - single, double hung, material unknown
- Roof: cross gable, composition sheets
- Chimney: none visible
- Related Features: attached 2-car garage
- Alterations: windows replaced
- Notes:

East elevation

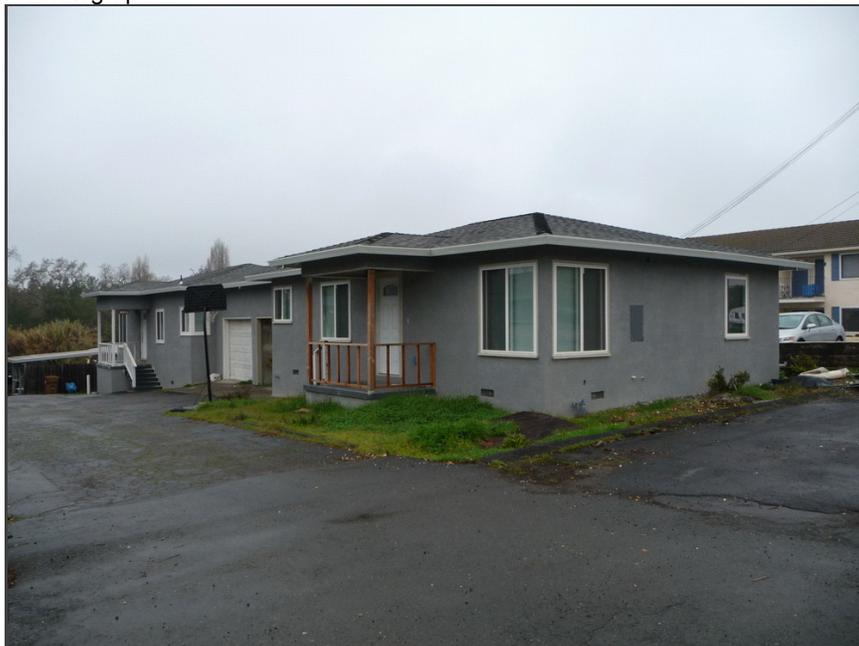
P5a. Photograph

- Style(s): Minimal Traditional
- Stories: 1
- Cladding: textured stucco
- Porch: entrance porch, concrete steps, wood posts, wood rail
- Door(s): single, wood, paneled
- Windows: Type 1 - single, sliding, vinyl; Type 2 - single, casement, vinyl
- Roof: hipped, open eaves, wide eaves
- Chimney: none visible
- Related Features: attached 1-car garage
- Alterations: windows replaced, Wall-through a/c units
- Notes: Two identical apartment buildings facing a central driveway, and two buildings at rear (not visible from public right-of-way)

South and east elevations of north building
ARG, January 2011

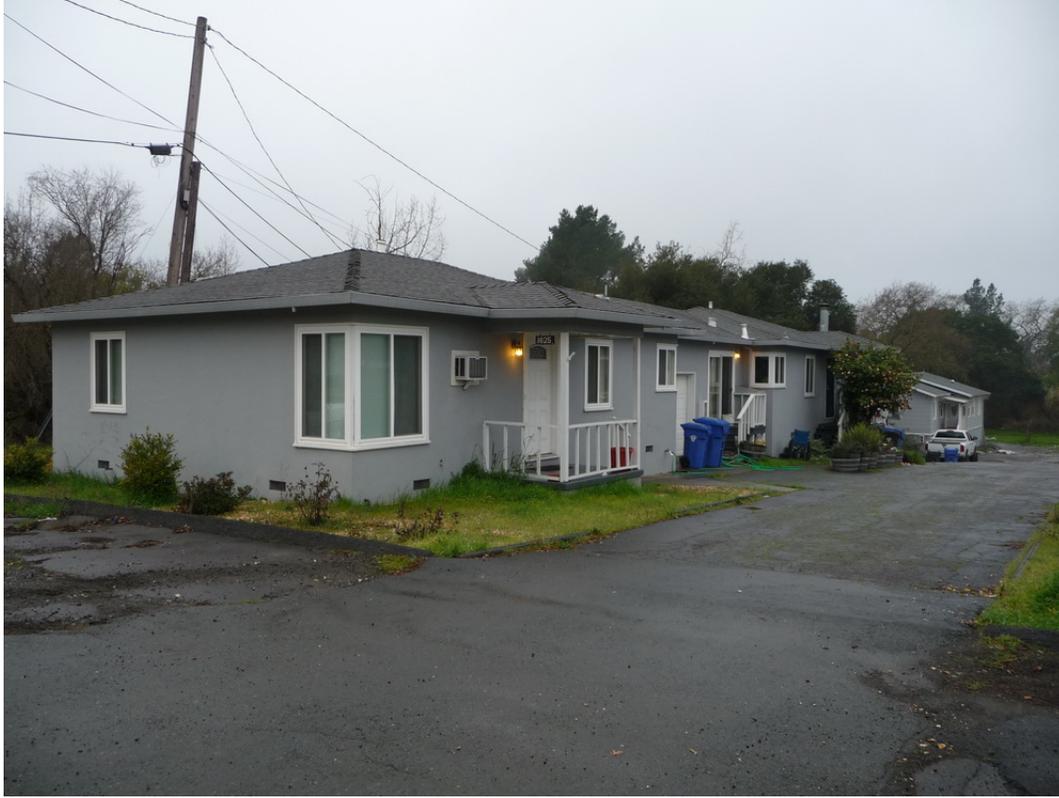
Image 2. East and north elevations of south building. (Architectural Resources Group, January 2011.)

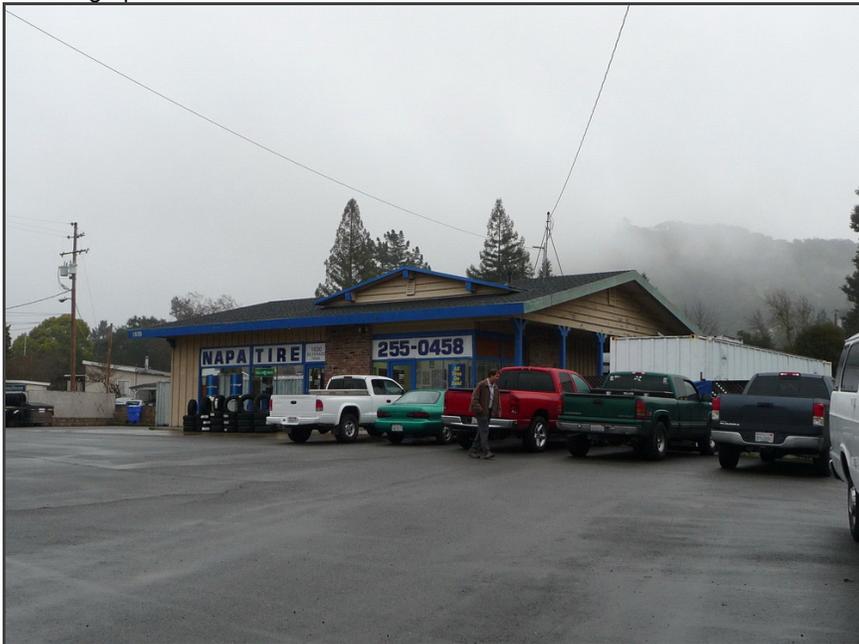
P5a. Photograph

West elevation

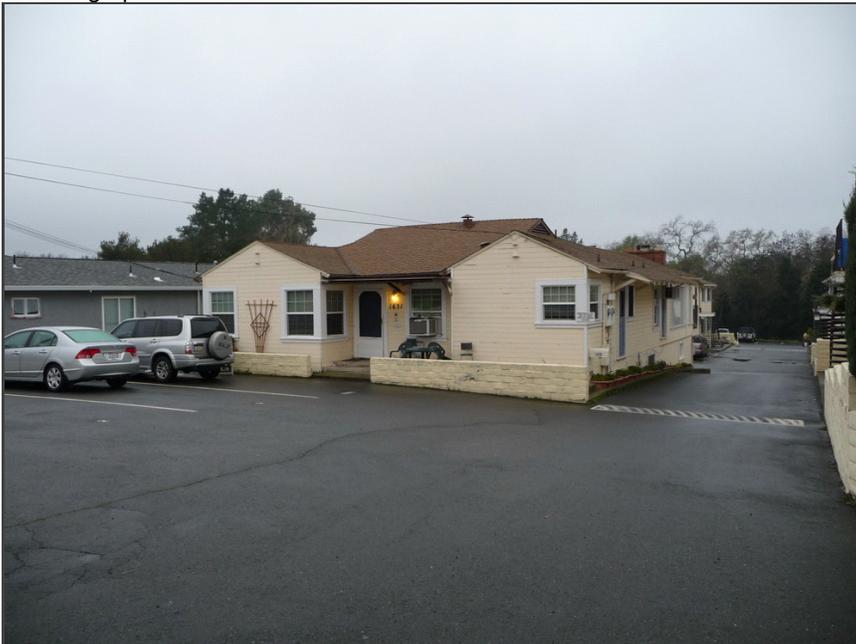
P5a. Photograph

- Style(s): Minimal Traditional
- Stories: 1
- Cladding: wood clapboards
- Porch: entrance porch, concrete steps
- Door(s): single, wood, wood screen
- Windows: Type 1 - single, double hung, vinyl
- Roof: cross gable, composition shingle, exposed rafter tails, open eaves
- Chimney: none visible
- Related Features: Additional 2-story apt. building on lot
- Alterations: windows replaced
- Notes: Building shares parcel with large post-1965 apartment building (excluded from survey)

East elevation
