PRIMARY RECORD

Page 1 of 1 *Resource Name or #: (Assigned by Recorder) 1027 SUMMIT AVE

*P11. Report Citation: Alta Heights Historic

Context Statement and Survey Report

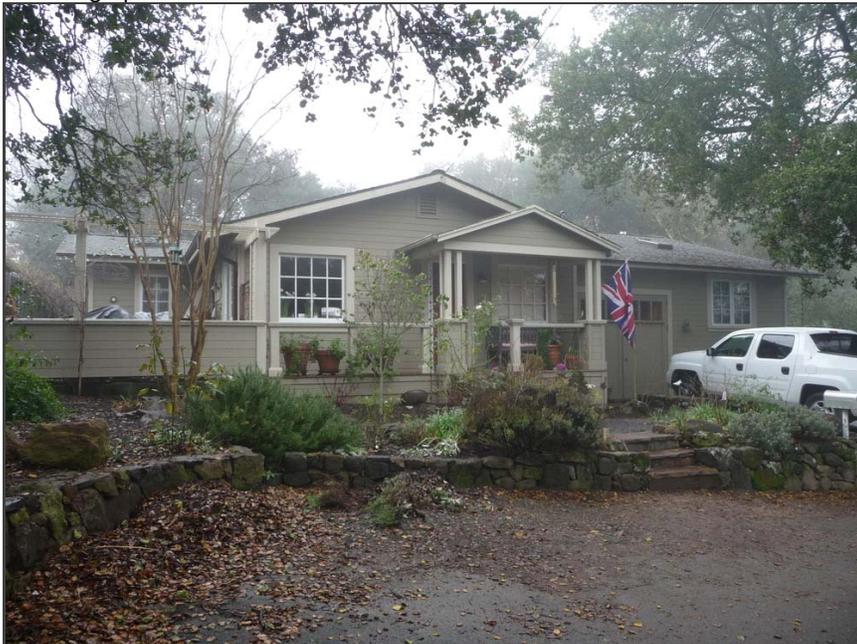
P5a. Photograph

- Style(s): Minimal Traditional
- Stories: 1
- Cladding: wood clapboards
- Porch: entrance porch, partial width, wood steps, wood posts, wood rail, solid rail
- Door(s): single, wood
- Windows: Type 1 - single, fixed, wood, multipane; Type 2 - single, sliding, vinyl, multipane
- Roof: cross gable, composition shingle, open eaves
- Chimney: none visible
- Related Features: attached 1-car garage
- Alterations: some window openings resized, windows replaced, porch altered, deck added to side elevation
- Notes:

North elevation

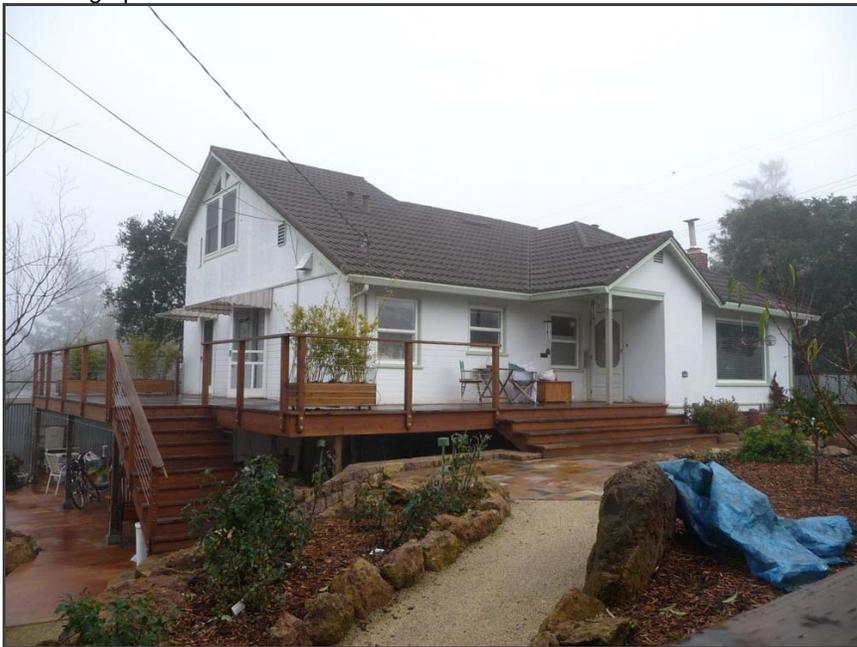
P5a. Photograph

South elevation

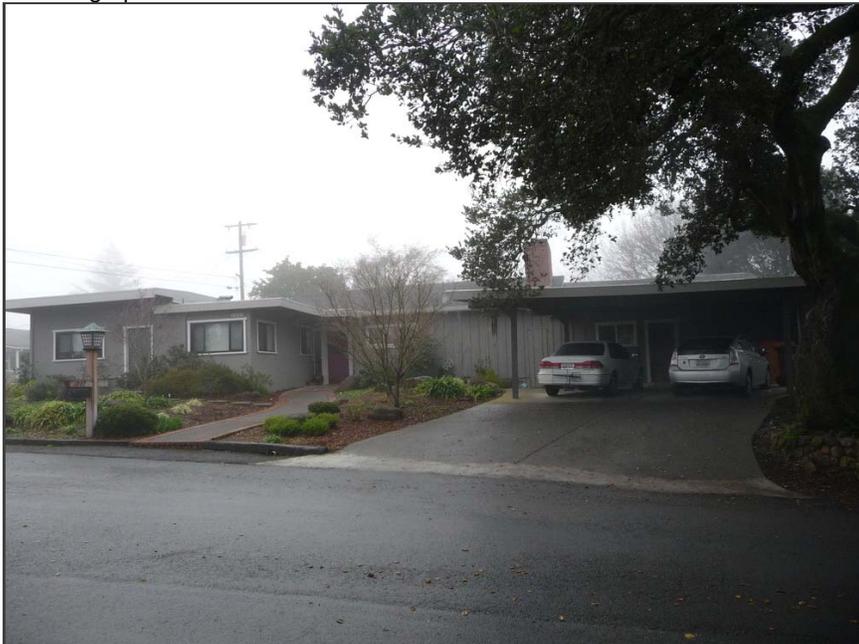
P5a. Photograph

North elevation

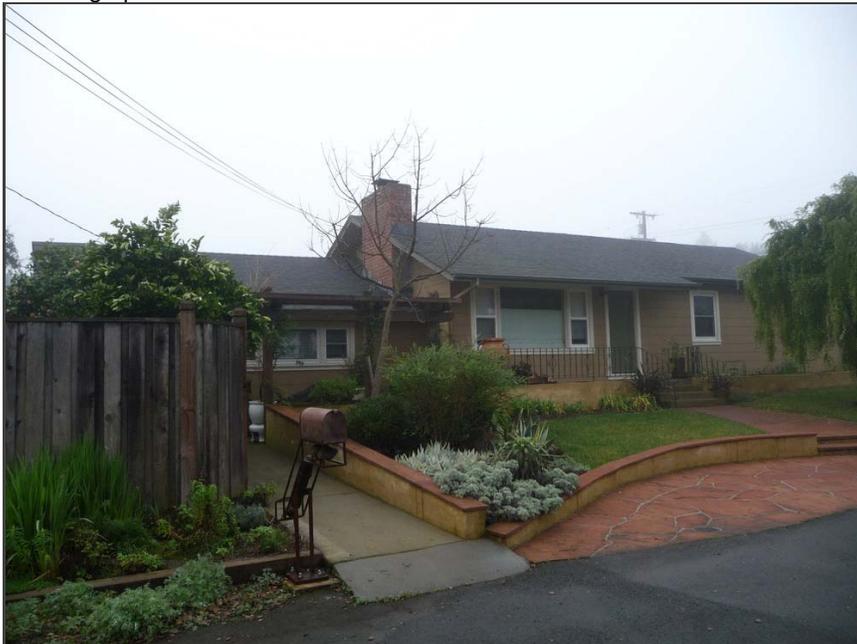
P5a. Photograph

- Style(s): Ranch, Minimal
- Stories: 1
- Cladding: wood lap
- Porch: partial width, concrete steps, pierced iron rail
- Door(s): single, wood, paneled
- Windows: Type 1 - tripartite, fixed, vinyl, double hung, vinyl; Type 2 - single, double hung, vinyl
- Roof: side gable, composition shingle, open eaves
- Chimney: brick, exterior
- Related Features:
- Alterations: some windows replaced, appears that an attached single car garage was converted to inhabitable space.
- Notes:

North elevation

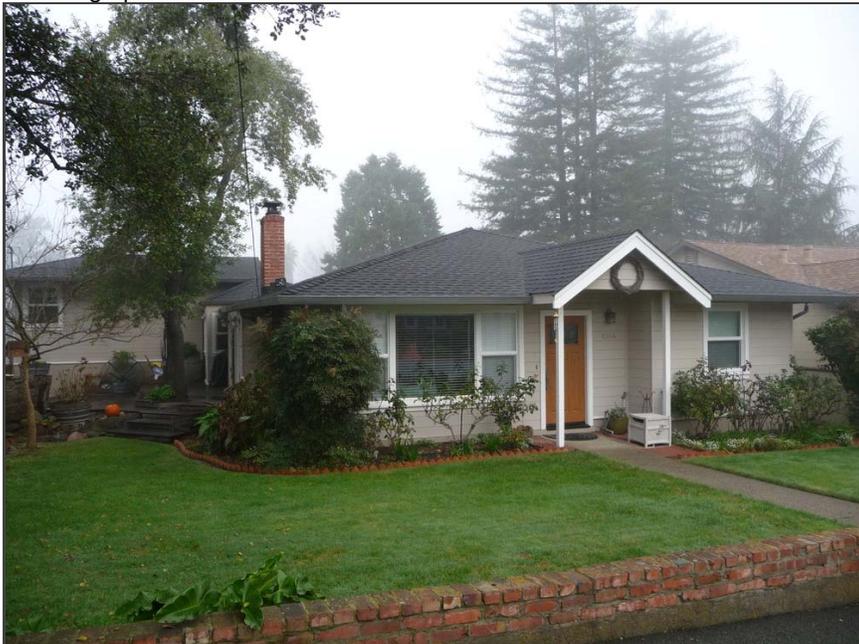
P5a. Photograph

- Style(s): American Colonial Revival
- Stories: 2
- Cladding: vinyl, wood clapboards
- Porch: entrance porch, wood posts
- Door(s): single, wood, partially glazed, paneled
- Windows: Type 1 - tripartite, double hung, vinyl, fixed, vinyl; Type 2 - single, double hung, vinyl
- Roof: hipped, open eaves
- Chimney: brick, exterior
- Related Features: side porch and rear addition (possible attached garage)
- Alterations: addition to rear elevation, cladding altered, door replaced
- Notes: Gabled hood on entrance porch

South elevation

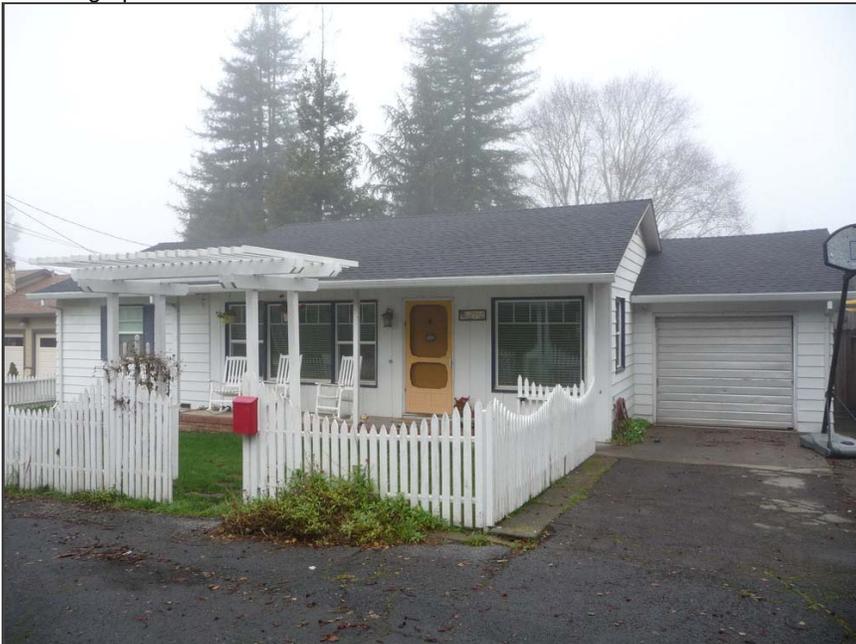
P5a. Photograph

- Style(s): American Colonial Revival
- Stories: 1
- Cladding: wood lap, wood vertical boards
- Porch: partial width, brick steps, wood posts
- Door(s): single, wood, wood screen
- Windows: Type 1 - single, double hung, vinyl, shutters; Type 2 - tripartite, fixed, vinyl, double hung, vinyl
- Roof: side gable, composition shingle, open eaves
- Chimney: none visible
- Related Features: attached 1-car garage
- Alterations: some windows replaced
- Notes:

South elevation
ARG, January 2011

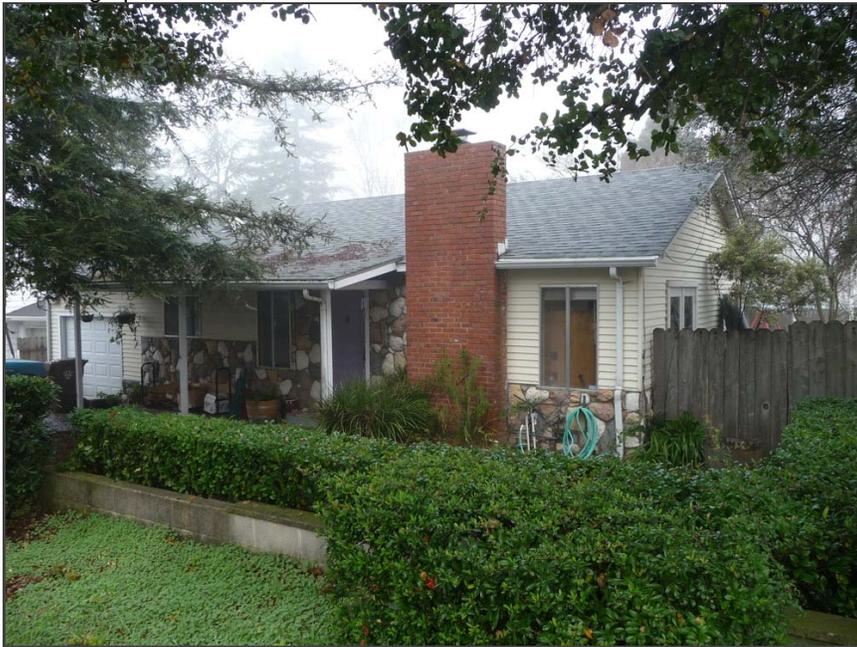
P5a. Photograph

- Style(s): No style
- Stories: 1
- Cladding: permastone, vinyl
- Porch: partial width, concrete steps
- Door(s): single, wood
- Windows: Type 1 - single, sliding, aluminum
- Roof: side gable, composition shingle, open eaves
- Chimney: brick, exterior
- Related Features: attached 1-car garage
- Alterations: cladding altered, windows replaced
- Notes:

South elevation
ARG, January 2011

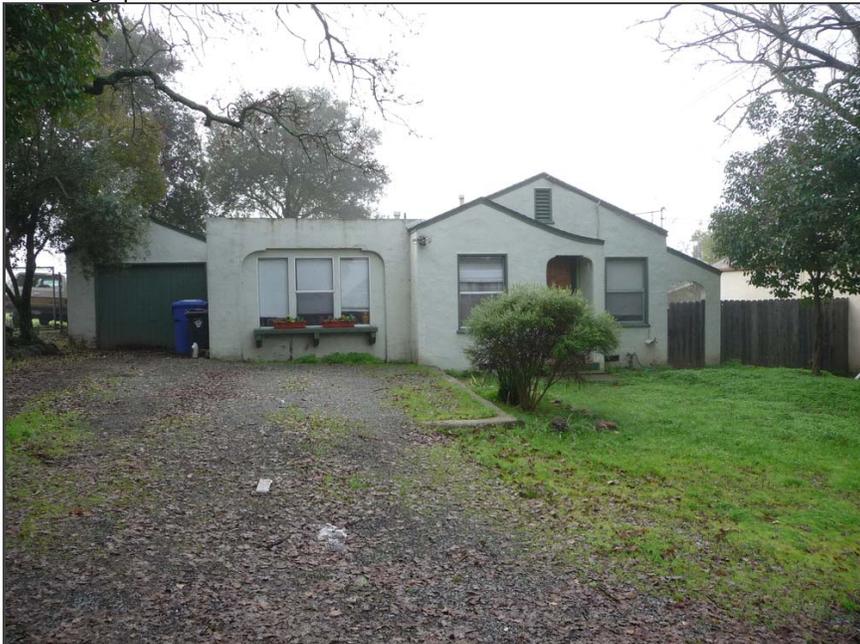
P5a. Photograph

- Style(s): Spanish Colonial Revival
- Stories: 1
- Cladding: textured stucco
- Porch: entrance porch, brick steps, stucco arches
- Door(s): single, wood, paneled
- Windows: Type 1 - single, double hung, aluminum; Type 2 - grouped, tripartite, fixed, aluminum, double hung, aluminum
- Roof: side gable, composition shinglecomposition sheetsflat
- Chimney: none visible
- Related Features: attached 1-car garage
- Alterations: some windows replaced, roof likely originally clay tile, possible porch infill or other modification at northern part of main façade.
- Notes:

North elevation

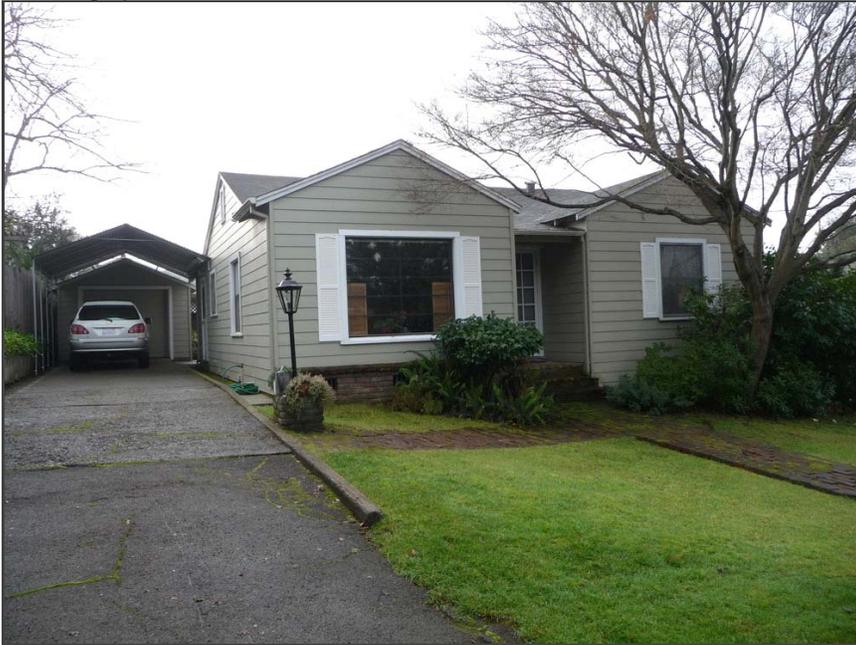
P5a. Photograph

- Style(s): Minimal Traditional
- Stories: 1
- Cladding: wood lap
- Porch: entrance porch, recessed, brick steps
- Door(s): single, door material unknown, wood screen; Secondary - none, single, wood, partially glazed
- Windows: Type 1 - single, fixed, vinyl, shutters; Type 2 - single, double hung, vinyl, shutters
- Roof: combination, cross hipped, front gable, composition shingle, exposed rafter tails, open eaves
- Chimney: none visible
- Related Features: detached 1-car garage
- Alterations: some windows replaced
- Notes:

P5b. Description of Photo:
North elevation
ARG, January 2011

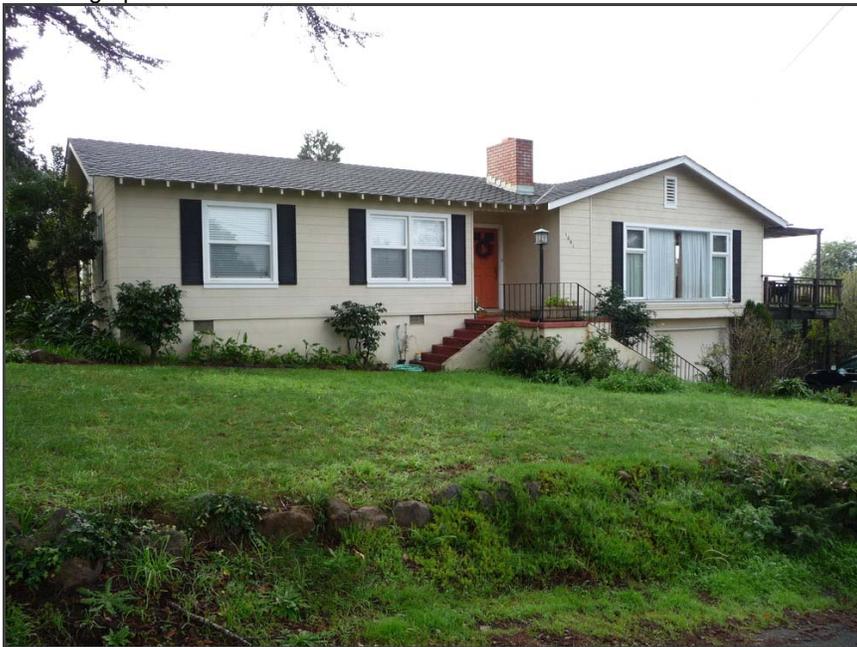
P5a. Photograph

- Style(s): Minimal Traditional
- Stories: 1
- Cladding: wood clapboards
- Porch: entrance porch, concrete steps, pierced iron rail
- Door(s): single, wood, partially glazed, paneled
- Windows: Type 1 - single, double hung, vinyl, shutters; Type 2 - paired, double hung, vinyl, shutters; Type 3 - tripartite, casement, vinyl, fixed, vinyl, shutters
- Roof: cross gable, composition shingle, exposed purlins
- Chimney: brick, exterior
- Related Features: carport
- Alterations: windows replaced
- Notes:

East elevation

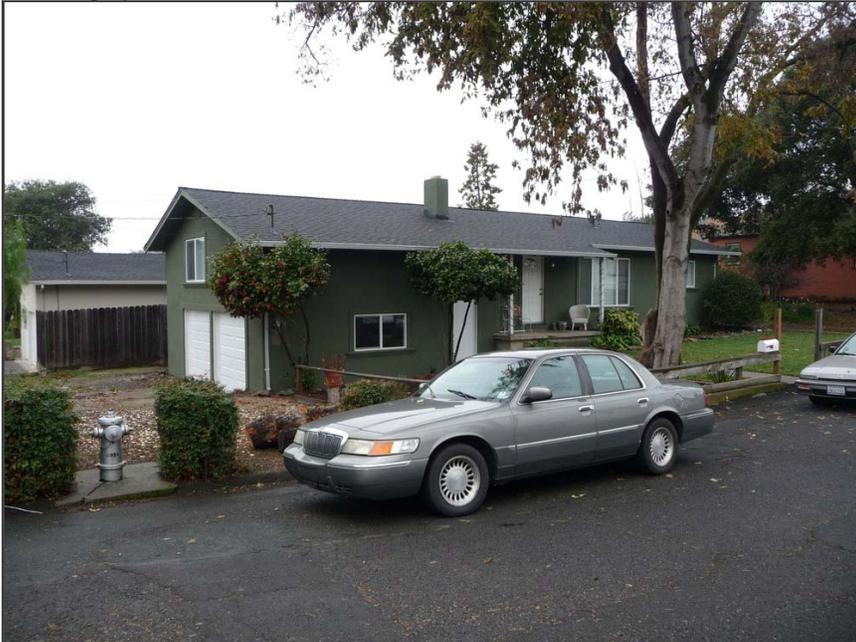
P5a. Photograph

- Style(s): Ranch, Minimal
- Stories: 1
- Cladding: smooth stucco
- Porch: entrance porch, partial width, concrete steps, wood posts
- Door(s): single, wood, divided lights, paneled; Secondary - single, wood
- Windows: Type 1 - single, sliding, vinyl
- Roof: side gable, composition shingle, open eaves
- Chimney: stucco, exterior
- Related Features: attached 2-car garage
- Alterations: door replaced, some windows replaced, some window openings resized
- Notes:

East elevation

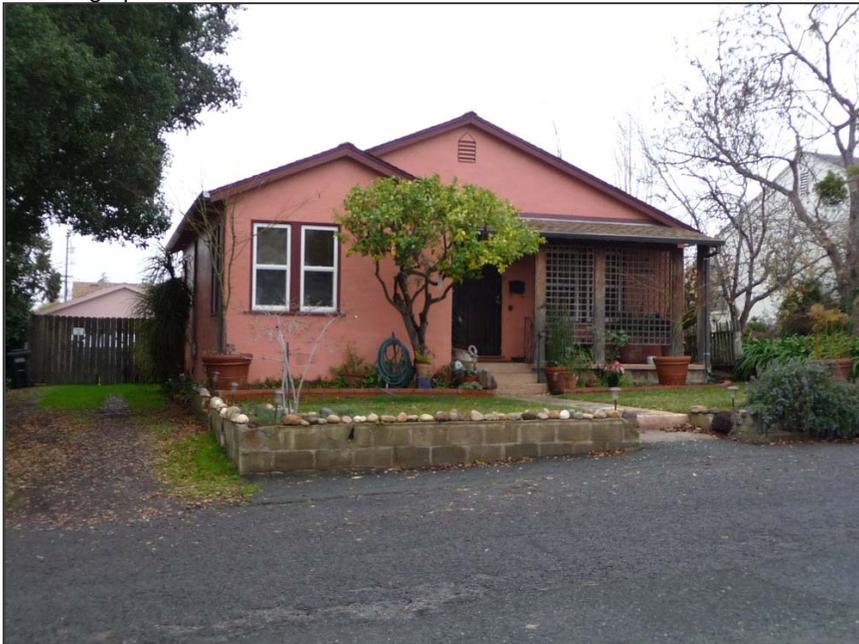
P5a. Photograph

- Style(s): Minimal Traditional
- Stories: 1
- Cladding: smooth stucco
- Porch: partial width, concrete steps, wood posts
- Door(s): single, security door, door material unknown
- Windows: Type 1 - paired, double hung, vinyl; Type 2 - single, double hung, vinyl
- Roof: front gable, material not visible, open eaves
- Chimney: none visible
- Related Features: detached 2-car garage
- Alterations: some windows replaced
- Notes:

East elevation

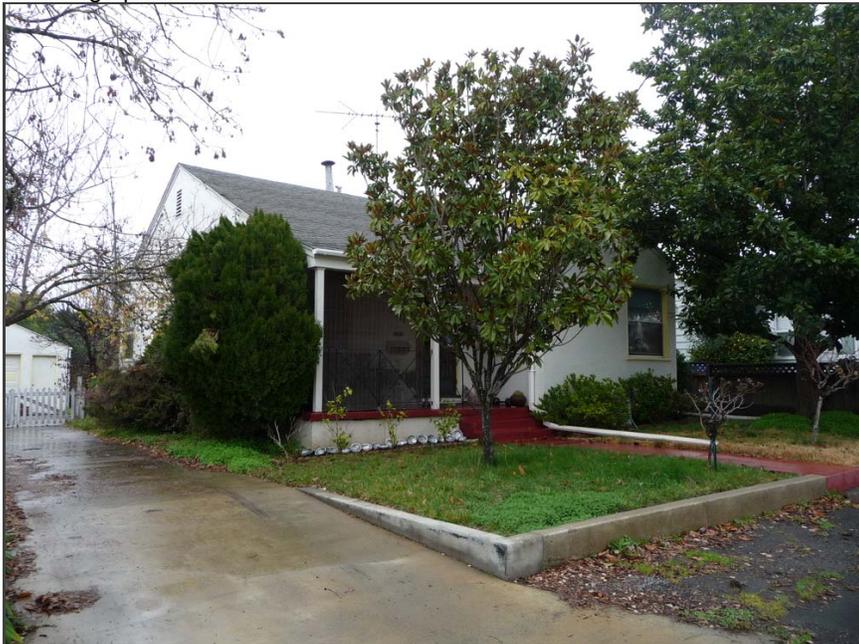
P5a. Photograph

- Style(s): Minimal Traditional
- Stories: 1
- Cladding: smooth stucco
- Porch: partial width, concrete steps, wood posts, pierced iron rail
- Door(s): single, door material unknown
- Windows: Type 1 - single, double hung, aluminum
- Roof: cross gable, composition shingle
- Chimney:
- Related Features: detached 1-car garage
- Alterations: some windows replaced, some window openings resized, porch rails altered
- Notes: Metal pipe chimney

East elevation

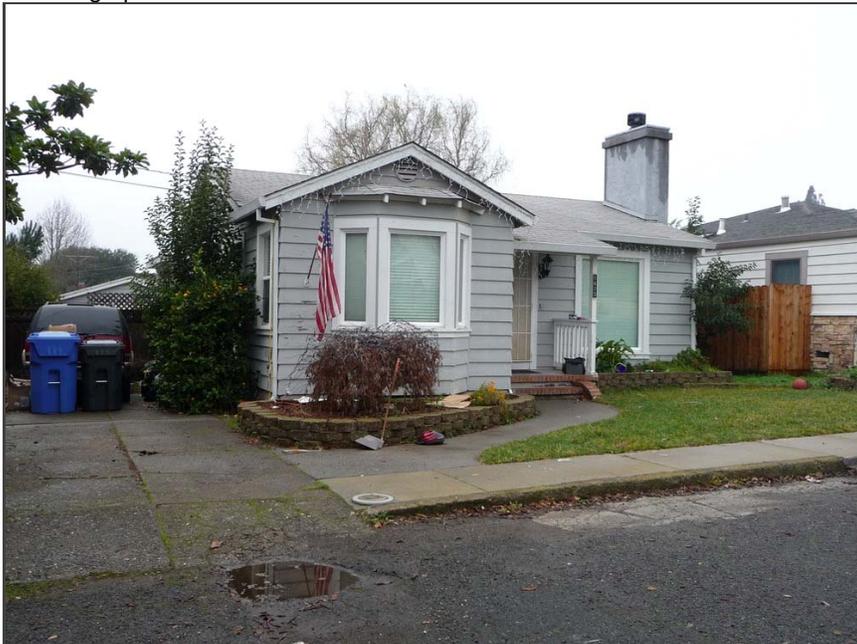
P5a. Photograph

- Style(s): Minimal Traditional
- Stories: 1
- Cladding: wood lap
- Porch: entrance porch, brick steps, wood posts, wood rail
- Door(s): single, security door, door material unknown
- Windows: Type 1 - canted bay, casement, vinyl, fixed, vinyl; Type 2 - single, fixed, vinyl; Type 3 - single, double hung, material unknown
- Roof: cross gable, composition shingle, open eaves
- Chimney: stucco, exterior
- Related Features: detached 1-car garage
- Alterations: security door added, some windows replaced, some window openings resized
- Notes:

East elevation

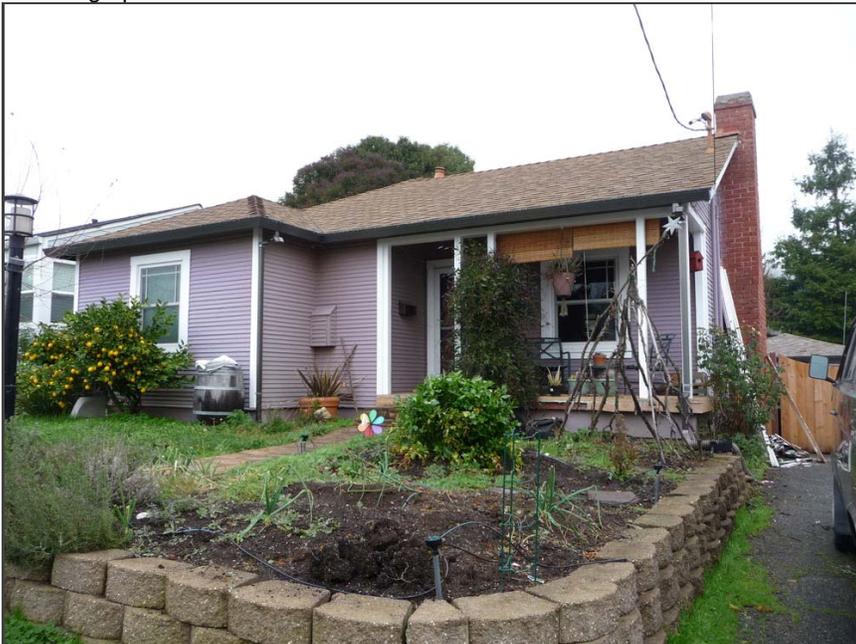
P5a. Photograph

- Style(s): Minimal Traditional
- Stories: 1
- Cladding: wood lap
- Porch: partial width, recessed, stone steps, wood posts
- Door(s): single, door material unknown, metal screen
- Windows: Type 1 - single, double hung, vinyl
- Roof: combination, hipped, side gable, composition shingle, open eaves
- Chimney: brick, exterior
- Related Features: detached 1-car garage
- Alterations: windows replaced
- Notes:

West elevation
ARG, January 2011

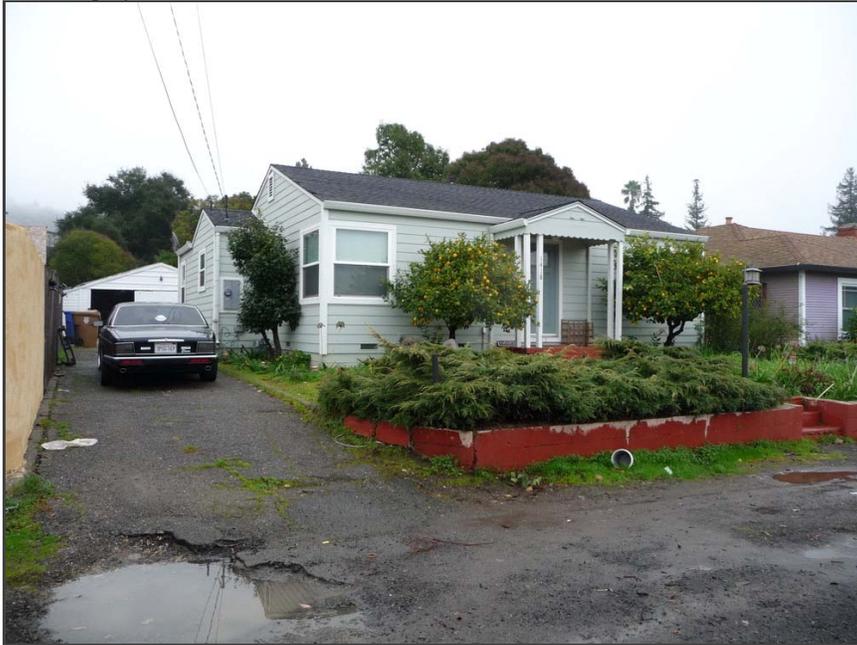
P5a. Photograph

- Style(s): Minimal Traditional
- Stories: 1
- Cladding: wood lap
- Porch: entrance porch, concrete steps, wood posts
- Door(s): single, wood, partially glazed, paneled
- Windows: Type 1 - single, double hung, vinyl
- Roof: side gable, composition shingle
- Chimney: none visible
- Related Features: detached 2-car garage
- Alterations: some window openings resized, windows replaced
- Notes:

West elevation
ARG, January 2011

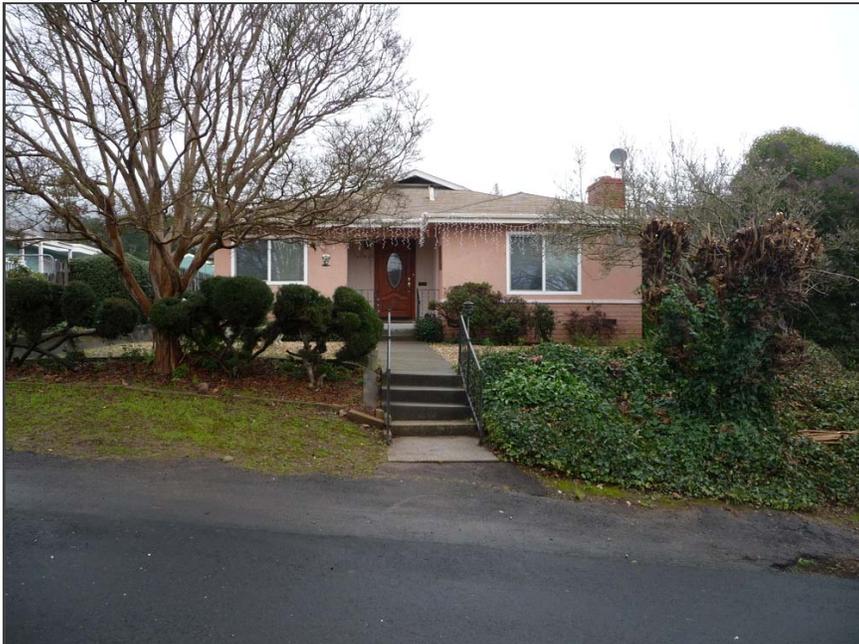
P5a. Photograph

- Style(s): Minimal Traditional
- Stories: 1
- Cladding: brick, smooth stucco
- Porch: entrance porch, recessed, concrete steps, pierced iron rail
- Door(s): single, wood, partially glazed, paneled
- Windows: Type 1 - single, sliding, vinyl
- Roof: cross hipped, composition shingle, intersecting gable at ridgeline, boxed eaves
- Chimney: brick, exterior
- Related Features:
- Alterations: door replaced, windows replaced
- Notes:

West elevation

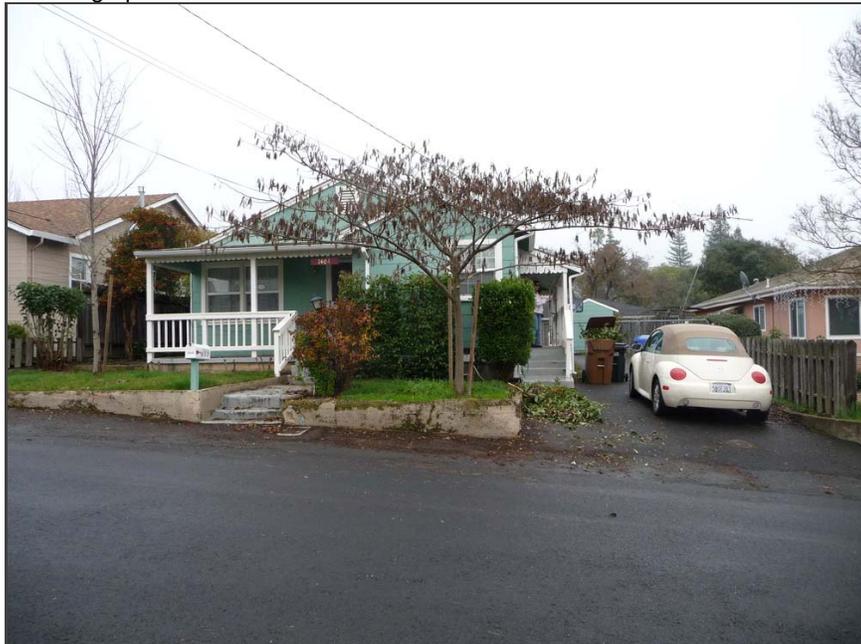
P5a. Photograph

- Style(s): Minimal Traditional
- Stories: 1
- Cladding: wood lap
- Porch: partial width, concrete steps, wood posts, wood rail
- Door(s): single, door material unknown, metal screen; Secondary - not visible
- Windows: Type 1 - paired, double hung, vinyl; Type 2 - single, double hung, vinyl
- Roof: front gable, composition shingle, vergeboards, open eaves
- Chimney: none visible
- Related Features: detached 1-car garage
- Alterations: windows replaced, porch added along side elevation
- Notes: Second porch along entire side elevation. Materials identical to front, partial width porch.

West elevation

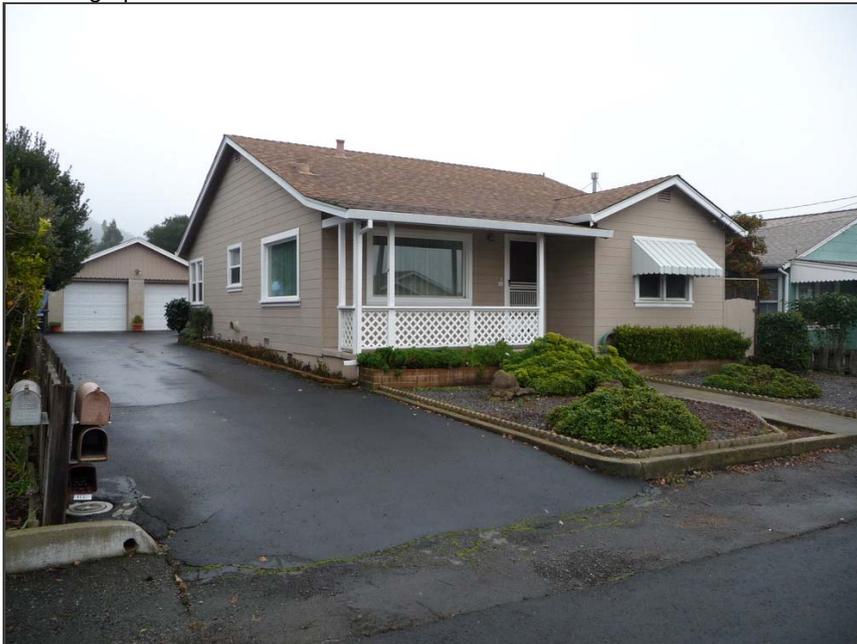
P5a. Photograph

- Style(s): Minimal Traditional
- Stories: 1
- Cladding: wood clapboards
- Porch: partial width, concrete steps, wood posts, wood rail
- Door(s): single, door material unknown, metal screen
- Windows: Type 1 - single, fixed, vinyl; Type 2 - paired, double hung, vinyl
- Roof: cross gable, composition shingle, open eaves
- Chimney: none visible
- Related Features: detached 2-car garage
- Alterations: awnings incompatible, some window openings resized, windows replaced, porch rails altered
- Notes:

West elevation

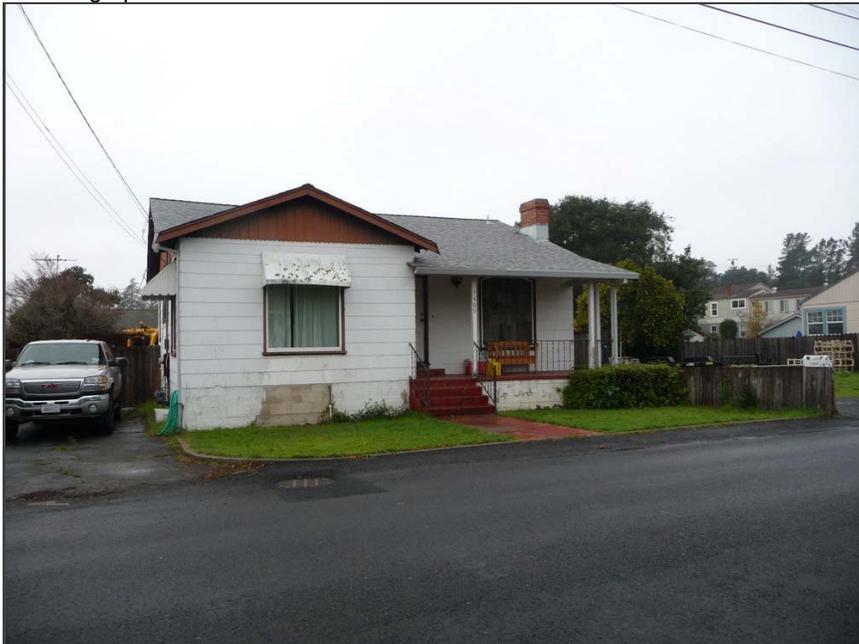
P5a. Photograph

- Style(s): Minimal Traditional
- Stories: 1
- Cladding: wood lap
- Porch: partial width, recessed, wood posts, pierced iron rail
- Door(s): not visible
- Windows: Type 1 - single, sliding, aluminum
- Roof: side gable, composition sheets, open eaves
- Chimney: brick, exterior
- Related Features:
- Alterations: windows replaced
- Notes:

East elevation

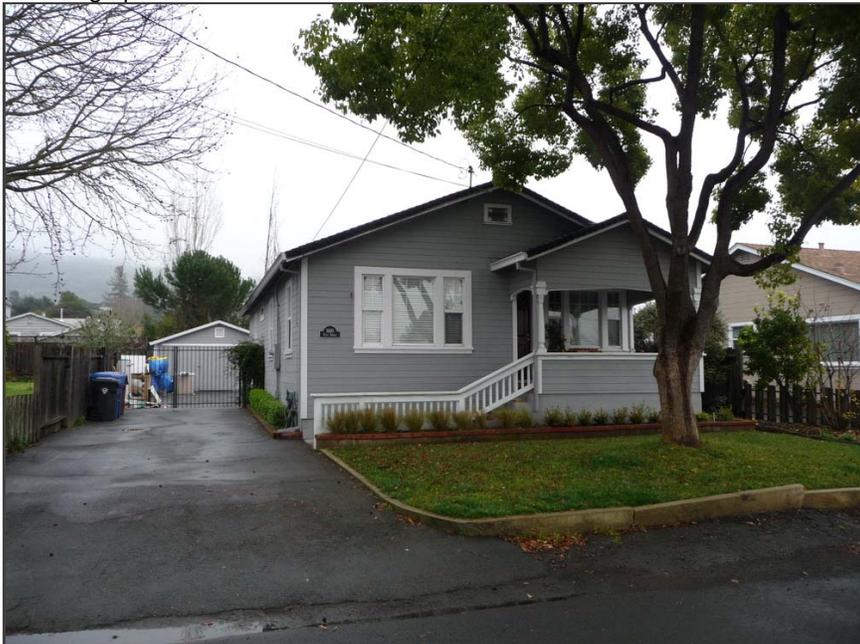
P5a. Photograph

- Style(s): Minimal Traditional
- Stories: 1
- Cladding: wood clapboards
- Porch: partial width, concrete steps, wood spindles, wood solid rail
- Door(s): single, wood, paneled
- Windows: Type 1 - tripartite, double hung, wood, fixed, wood; Type 2 - single, double hung, wood
- Roof: front gable, composition shingle, open eaves
- Chimney: none visible
- Related Features: detached 2-car garage
- Alterations: some windows replaced, porch altered
- Notes:

West elevation

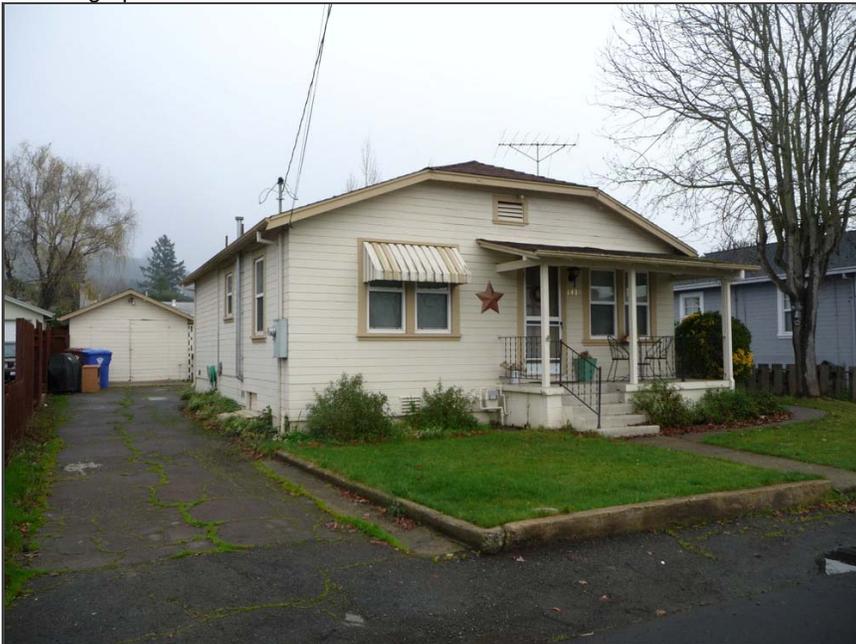
P5a. Photograph

- Style(s): Minimal Traditional / Craftsman
- Stories: 1
- Cladding: wood clapboards
- Porch: partial width, concrete steps, wood posts, pierced iron rail
- Door(s): single, wood, divided lights, fully glazed, metal screen
- Windows: Type 1 - paired, double hung, aluminum; Type 2 - single, double hung, aluminum
- Roof: jerkinhead, composition shingle, open eaves
- Chimney: none visible
- Related Features: detached 1-car garage
- Alterations: awnings incompatible, windows replaced, porch rails altered, Front porch added
- Notes:

West elevation
ARG, January 2011

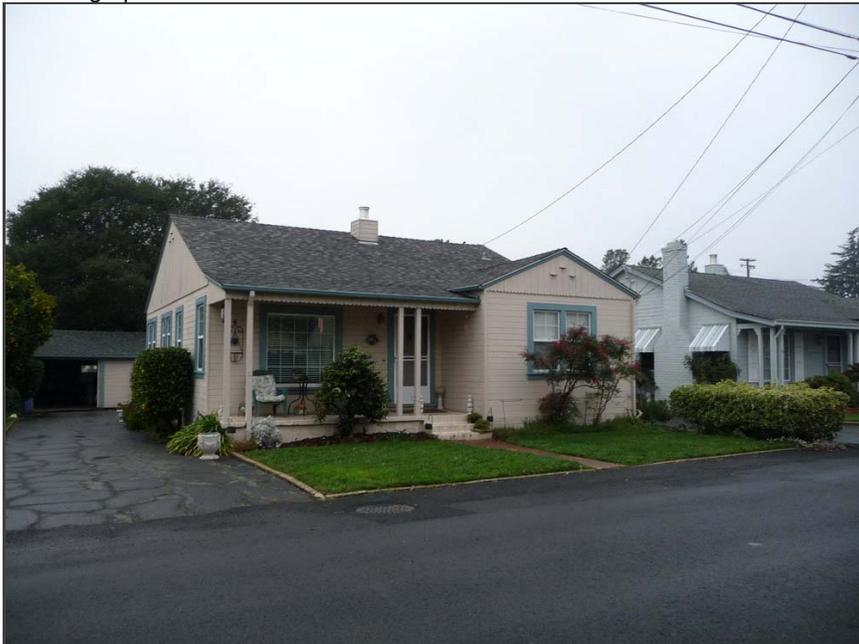
P5a. Photograph

- Style(s): Minimal Traditional
- Stories: 1
- Cladding: wood clapboards, wood vertical boards
- Porch: partial width, concrete steps, wood posts
- Door(s): single, wood, metal screen
- Windows: Type 1 - single, fixed, vinyl; Type 2 - paired, double hung, vinyl; Type 3 - single, double hung, vinyl
- Roof: cross gable, composition shingle
- Chimney: wood, exterior
- Related Features: detached 2-car garage
- Alterations: windows replaced
- Notes:

East elevation
ARG, January 2011

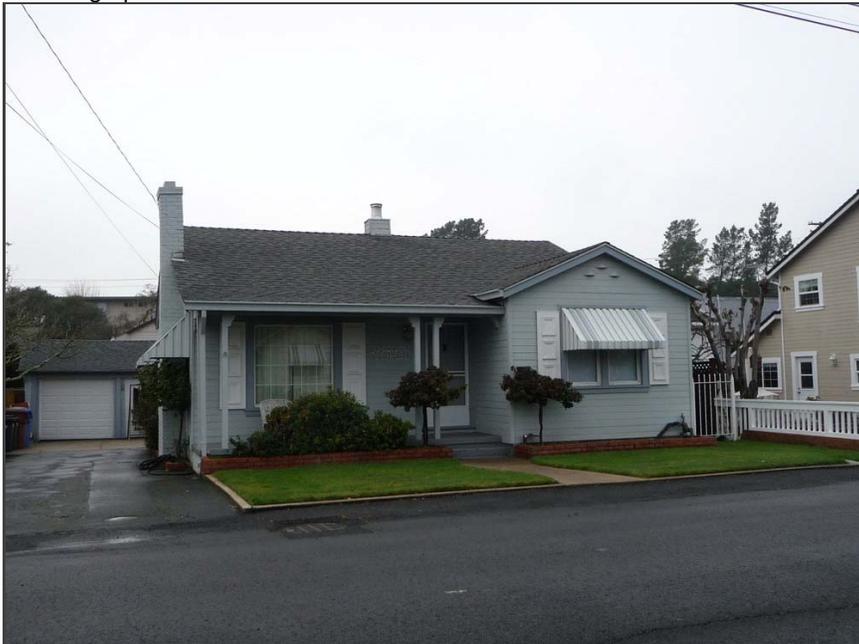
P5a. Photograph

- Style(s): Minimal Traditional
- Stories: 1
- Cladding: wood clapboards
- Porch: partial width, concrete steps, wood posts
- Door(s): single, wood, metal screen
- Windows: Type 1 - single, fixed, vinyl, shutters; Type 2 - paired, casement, material unknown, shutters
- Roof: cross hipped, composition shingle, open eaves
- Chimney: brick, exterior
- Related Features: detached 2-car garage
- Alterations: awnings incompatible, some windows replaced
- Notes:

East elevation
ARG, January 2011

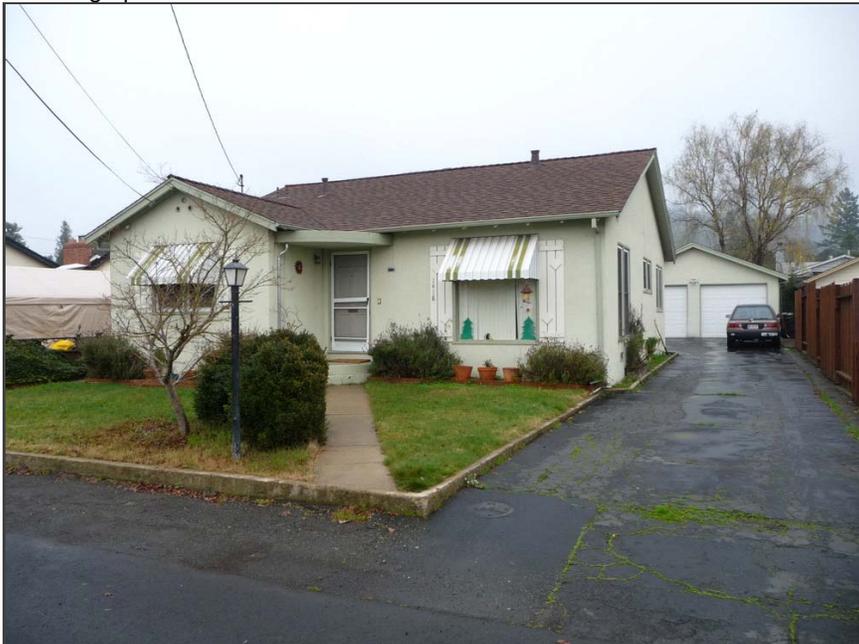
P5a. Photograph

- Style(s): Minimal Traditional
- Stories: 1
- Cladding: smooth stucco
- Porch: entrance porch, concrete steps
- Door(s): single, wood, paneled, metal screen
- Windows: Type 1 - paired, sliding, vinyl; Type 2 - single, fixed, vinyl, shutters
- Roof: cross gable, composition shingle, open eaves
- Chimney: none visible
- Related Features: detached 2-car garage
- Alterations: awnings incompatible, windows replaced
- Notes:

West elevation

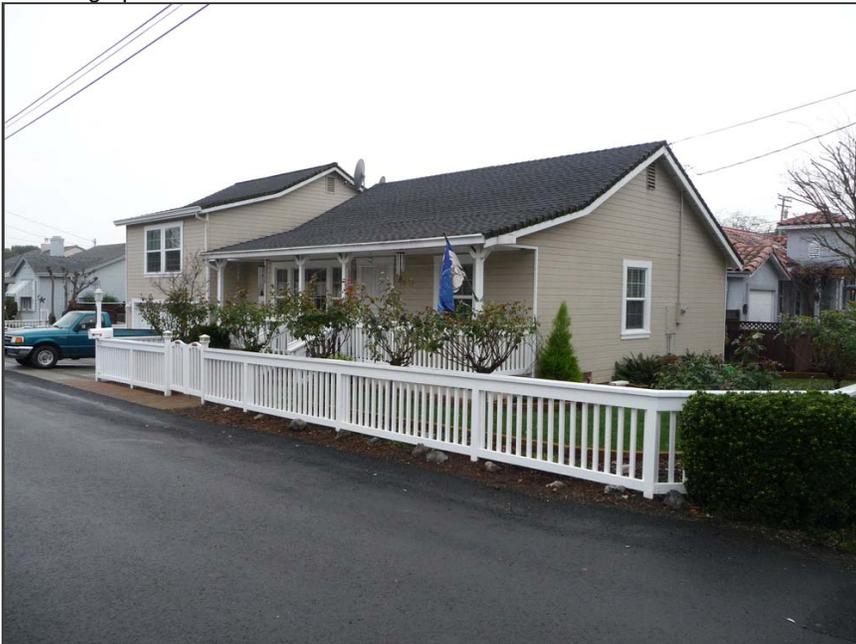
P5a. Photograph

- Style(s): Minimal Traditional
- Stories: 2
- Cladding:
- Porch: partial width, wood steps, wood posts, wood rail
- Door(s): single, door material unknown, metal screen
- Windows: Type 1 - single, double hung, vinyl; Type 2 - paired, double hung, vinyl; Type 3 - tripartite, double hung, vinyl
- Roof: side gable, composition shingle, open eaves
- Chimney: none visible
- Related Features: attached 2-car garage
- Alterations: addition to side elevation, security door added, windows replaced, porch rails altered, perimeter fence added
- Notes:

East and north elevations
ARG, January 2011

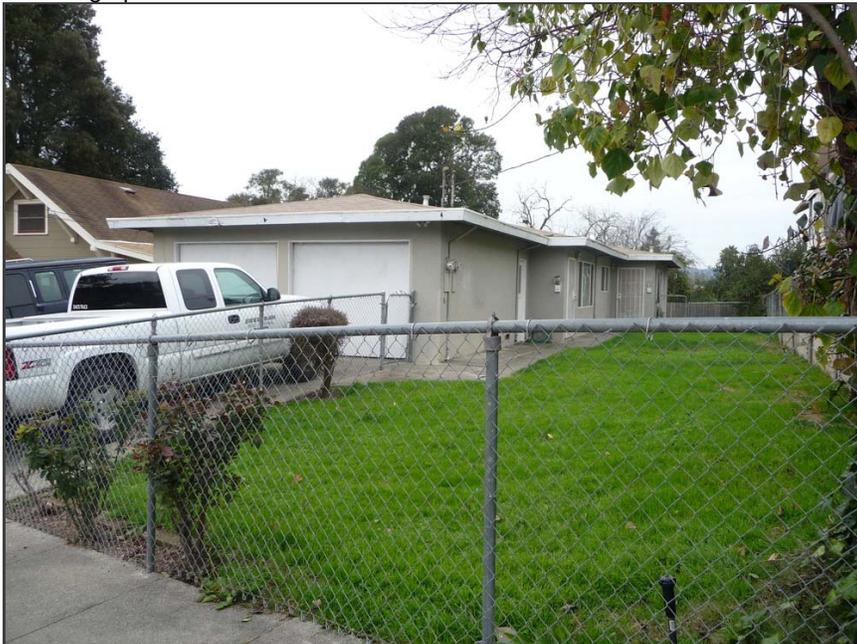
P5a. Photograph

- Style(s): Ranch, Minimal
- Stories: 1
- Cladding: smooth stucco
- Porch: none
- Door(s): single, wood, partially glazed; Secondary - single, door material unknown, metal screen
- Windows: Type 1 - single, sliding, aluminum
- Roof: hipped, composition shingle
- Chimney: none visible
- Related Features: attached 2-car garage
- Alterations: windows replaced
- Notes:

P5b. Description of Photo:
South and west elevations
ARG, January 2011

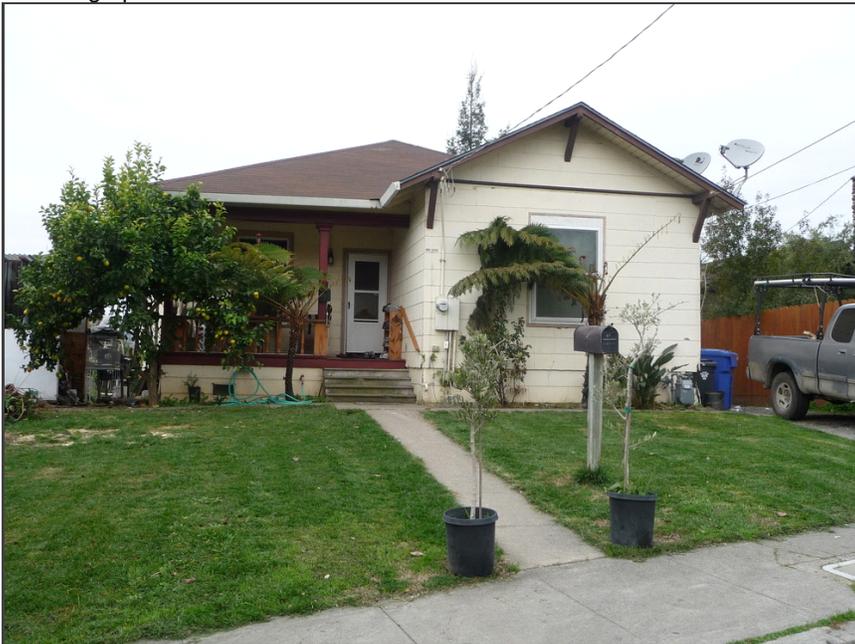
P5a. Photograph

- Style(s): Victorian, Vernacular Cottage, hip roof
- Stories: 1
- Cladding: asbestos
- Porch: partial width, wood steps, wood posts, wood rail
- Door(s): single, wood, paneled, metal screen
- Windows: Type 1 - single, double hung, aluminum
- Roof: cross hipped, brackets, exposed rafter tails, open eaves
- Chimney: none visible
- Related Features:
- Alterations: cladding altered, some window openings resized, windows replaced
- Notes:

East elevation

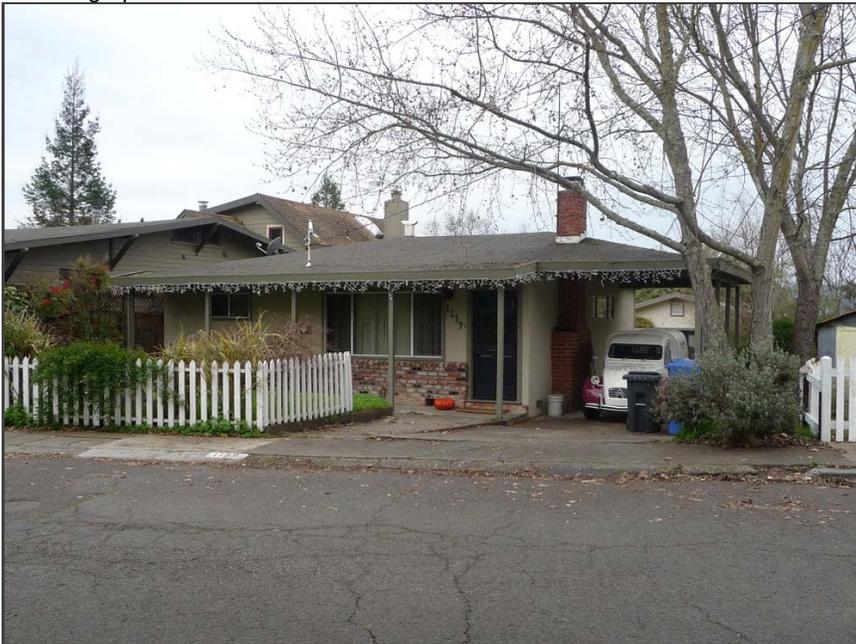
P5a. Photograph

- Style(s): Ranch, Minimal
- Stories: 1
- Cladding: brick, smooth stucco
- Porch: full width, wood posts
- Door(s): single, wood, divided lights, partially glazed
- Windows: Type 1 - single, sliding, aluminum
- Roof: hipped, built up, open eaves
- Chimney: brick, exterior
- Related Features: detached 1-car garage, porte cochere
- Alterations: windows replaced
- Notes:

East elevation

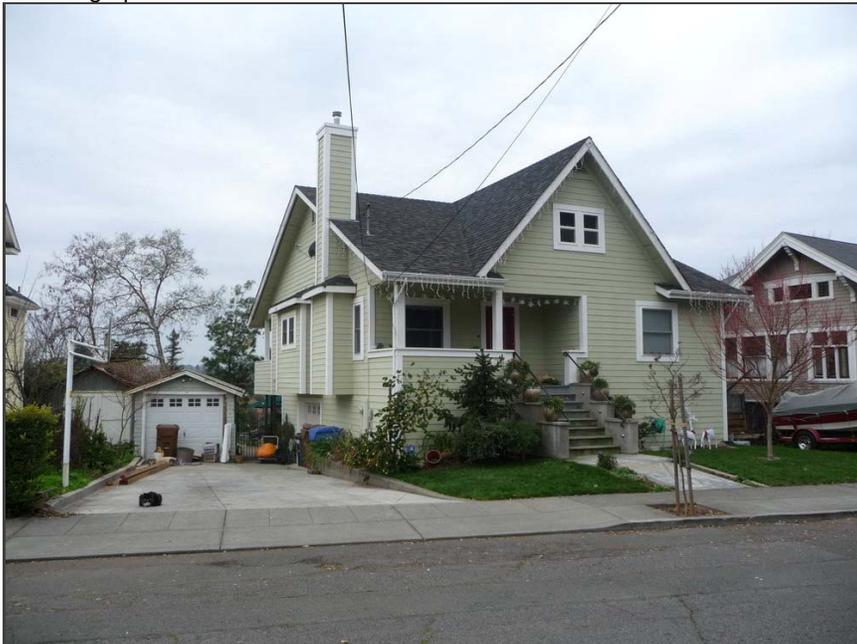
P5a. Photograph

- Style(s): American Colonial Revival
- Stories: 2
- Cladding: wood clapboards
- Porch: partial width, concrete steps, wood posts, wood solid rail
- Door(s): single, wood, divided lights, wood screen
- Windows: Type 1 - single, double hung, vinyl; Type 2 - paired, double hung, vinyl
- Roof: cross gable, composition shingle, open eaves
- Chimney: wood, exterior
- Related Features: detached 1-car garage
- Alterations: windows replaced
- Notes:

East elevation

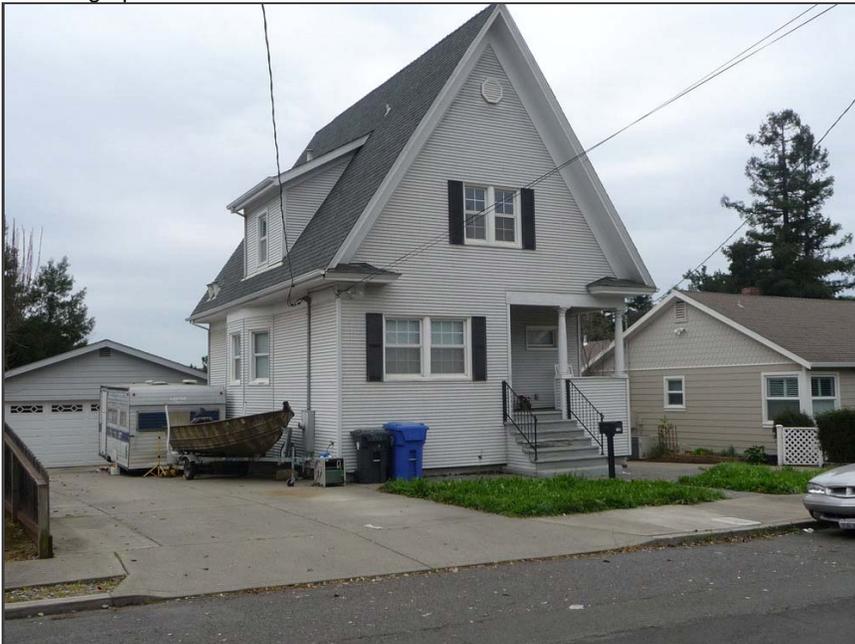
P5a. Photograph

- Style(s): American Colonial Revival
- Stories: 2
- Cladding: aluminum
- Porch: partial width, wood steps, wood columns, iron
- Door(s): single, partially glazed
- Windows: Type 1 - paired, double hung, vinyl, shutters; Type 2 - single, hopper, vinyl; Type 3 - canted bay, double hung, vinyl
- Roof: front gable, composition shingle, dormers
- Chimney: none visible
- Related Features: attached 2-car garage
- Alterations: cladding altered, door replaced, windows replaced
- Notes:

East elevation

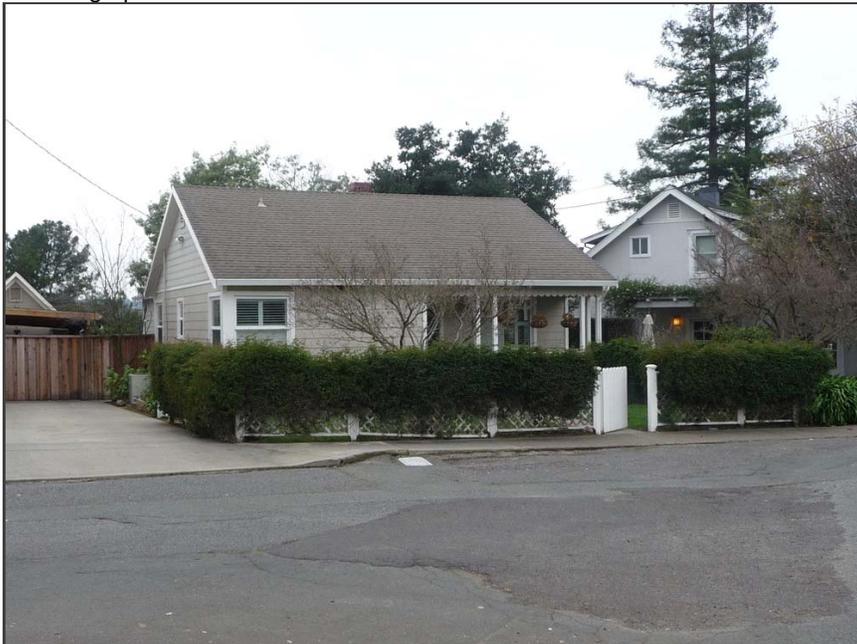
P5a. Photograph

- Style(s): Minimal Traditional
- Stories: 1
- Cladding: wood clapboards, wood decorative shingles
- Porch: partial width, concrete steps, wood posts, wood rail
- Door(s): single, wood, paneled
- Windows: Type 1 - single, fixed, material unknown; Type 2 - single, double hung, material unknown
- Roof: side gable, composition shingle, open eaves
- Chimney: brick, interior
- Related Features: detached 1-car garage
- Alterations: windows replaced
- Notes:

North elevation

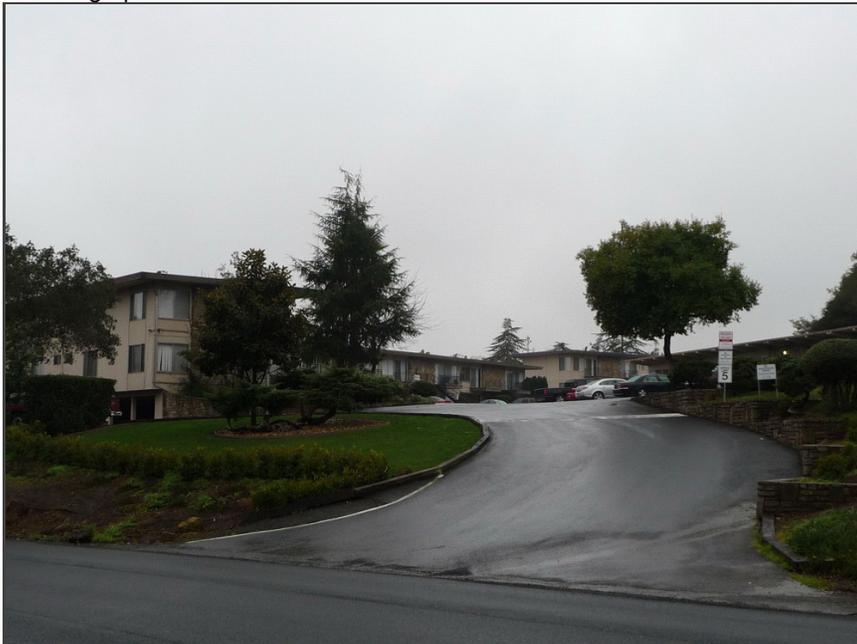
P5a. Photograph

- Style(s): Modernism, Mid-Century
- Stories: 2
- Cladding:
- Porch:
- Door(s): double, metal, fully glazed
- Windows: Type 1 - single, sliding, aluminum; Type 2 - casement, vinyl
- Roof: flat, wide eaves
- Chimney: none visible
- Related Features: Parking lots, integral landscape and hardscape
- Alterations: some windows replaced
- Notes: Large apartment complex with multiple buildings; other buildings not visible from public right-of-way

East elevation
ARG, January 2011
