Page 1 of 3 *Resource name(s) or number (assigned by recorder) 708 4th Street

*P8. Recorded by:
Page & Turnbull, Inc. (CPH)
724 Pine Street
San Francisco, CA 94108

*P11. Report Citation: (Cite survey report and other sources, or enter "none") Heritage Napa: Soscol Gateway/East Napa Historic Resource Survey

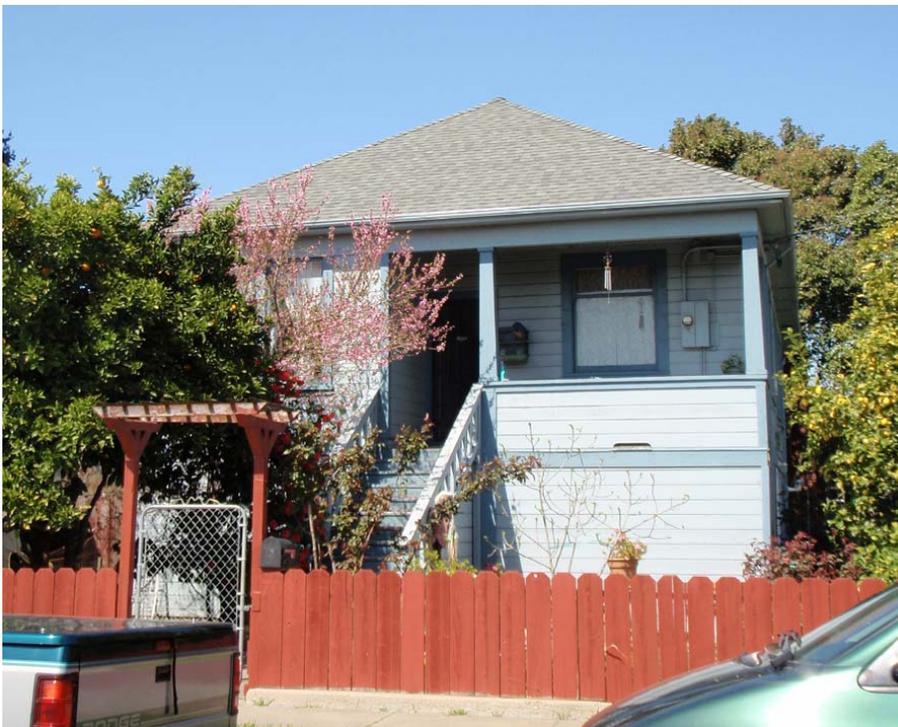
*P3a. Description: (Describe resource and its major elements. Include design, materials, condition, alterations, size, setting, and boundaries.)
708 4th Street is located on a rectangular lot on the northwest corner of 4th and Burnell streets. Built in circa 1905, 708 4th Street is a 1-story over raised basement, wood frame, single-family residence designed in the Simple Bungalow style. The building is rectangular in plan, clad in wood shiplap siding, and capped by a hip roof. The foundation is not visible. The primary facade faces south and features a recessed entry porch on the east. The porch is accessed by wood stairs with wood railings, and features a solid railing and tapered square columns support the overhang of the main roof. The primary entry is located at the center of the façade, and has a metal security gate and flat board trim. Typical fenestration consists of 1-over-1, double-hung, wood-sash windows with flat board trim. Architectural features include a plain wood water table and corner boards. The roofline features a wide plain frieze and shallow boxed eaves. A low wood fence encloses the lot, with a trellised gate providing access to the entry walkway.

P5b. Photo: (view and date)
Primary facade, looking north
from 4th Street
3/24/2009

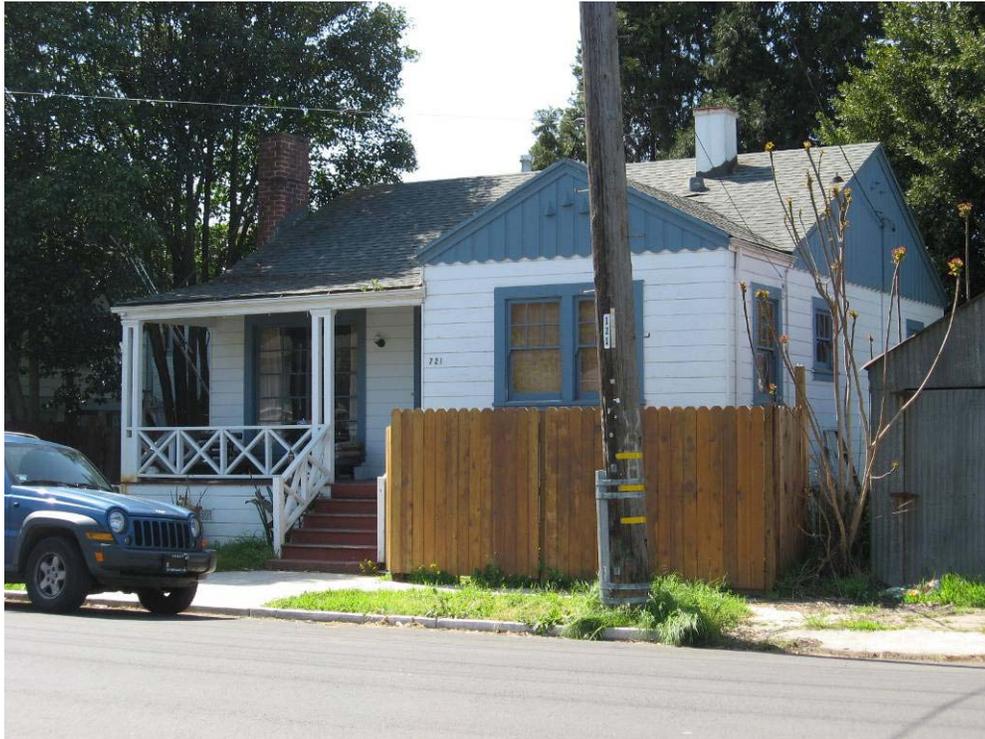
A secondary residential building, 721 Burnell Street, is located at the rear of the lot and appears to have been constructed circa 1940. (Continued)

721 Burnell Street; primary and north facades, looking southwest from Burnell Street.

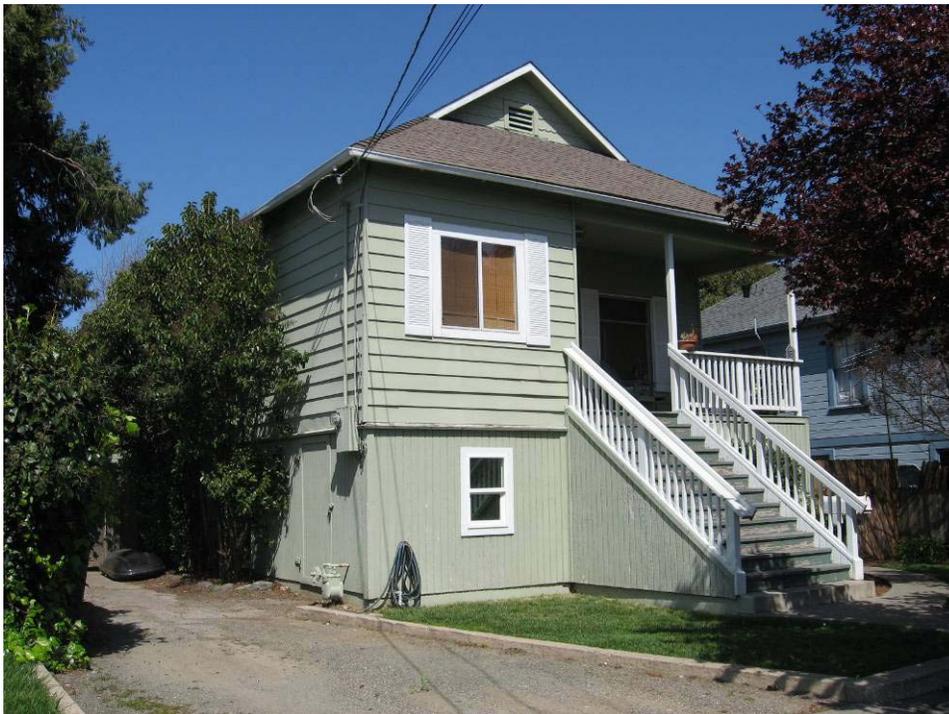
718 4th Street is located on a rectangular lot on the north side of 4th Street between Lawrence and Burnell streets. Built in 1908, 718 4th Street is a 1-story over raised basement, wood frame, single-family residence designed in the Simple Bungalow style. The building is rectangular in plan, clad in aluminum siding with vertical groove plywood at the basement level, and capped by a gable-on-hip roof. The foundation is concrete. The primary facade faces south and features a recessed entry porch on the east. The porch is accessed by wood stairs with wood railings, and features a wood railing and square posts that support the overhang of the main roof. The primary entry is located near the center of the façade, and is a paneled wood door with molded wood trim. Typical fenestration consists of sliding and double-hung, vinyl-sash replacements windows with flat board trim and decorative shutters. An original, one-over-one, double-hung, wood-sash window is located within the porch. Architectural features include a plain wood water table. The roofline features broad open eaves and the gable end contains wood fishscale shingles and a louvered attic vent. Concrete curbs front the lot and an unpaved driveway runs down the west side of the house. 718 4th Street appears to be in good condition.

P5b. Photo: (view and date)
Primary facade, looking
northeast from 4th Street
3/24/2009

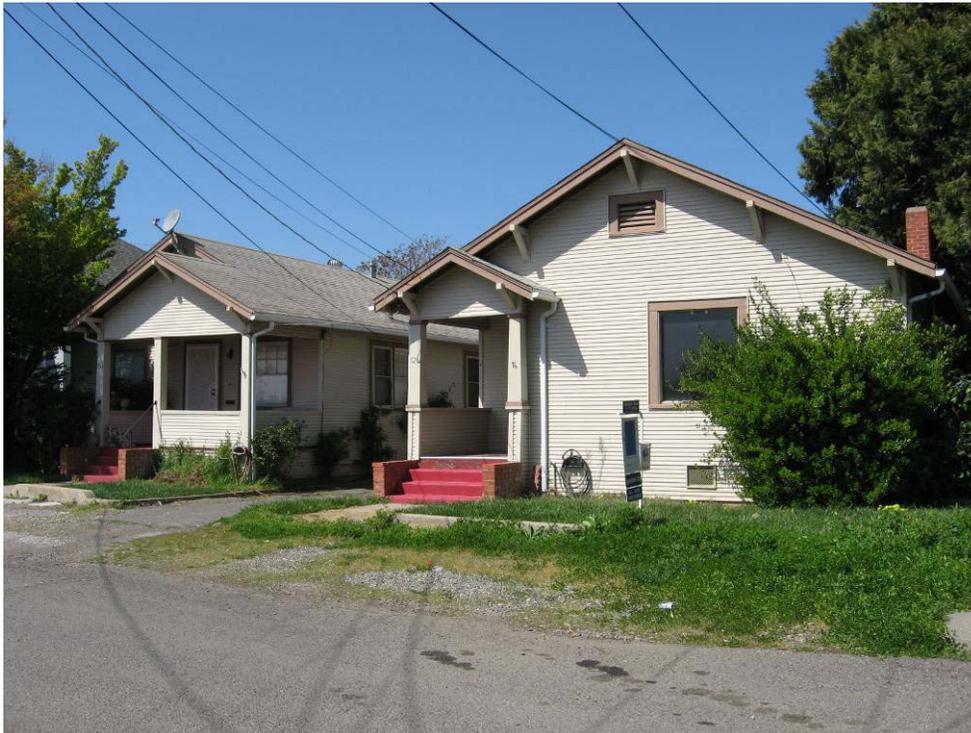
726 - 734 4th Street consists of two houses located on a rectangular lot on the north side of 4th Street between Lawrence and Burnell streets. Built circa 1910, 726 4th Street is a 1-story, wood frame, single-family residence designed in the Craftsman style. The building is rectangular in plan, clad in aluminum siding, and capped by a gable roof. The foundation is not visible. The primary facade faces south and features a recessed entry porch at the southwest corner. The porch is accessed by concrete steps with brick wing walls, and features a solid railing and tapered square columns that support a small gable roof. The primary entry is located on the east wall of the porch, and is covered by a metal security gate and surrounded by flat board trim. Typical fenestration consists of single-pane, fixed and six-over-one, double-hung, wood-sash windows with flat board trim. Architectural features include a brick exterior chimney on the east facade. The roofline features broad open eaves, with knee braces and the gable end contains a louvered attic vent in the gable end. 726 4th Street appears to be in good condition.

P5b. Photo: (view and date)
Primary facades, looking northwest from 4th Street
3/24/2009

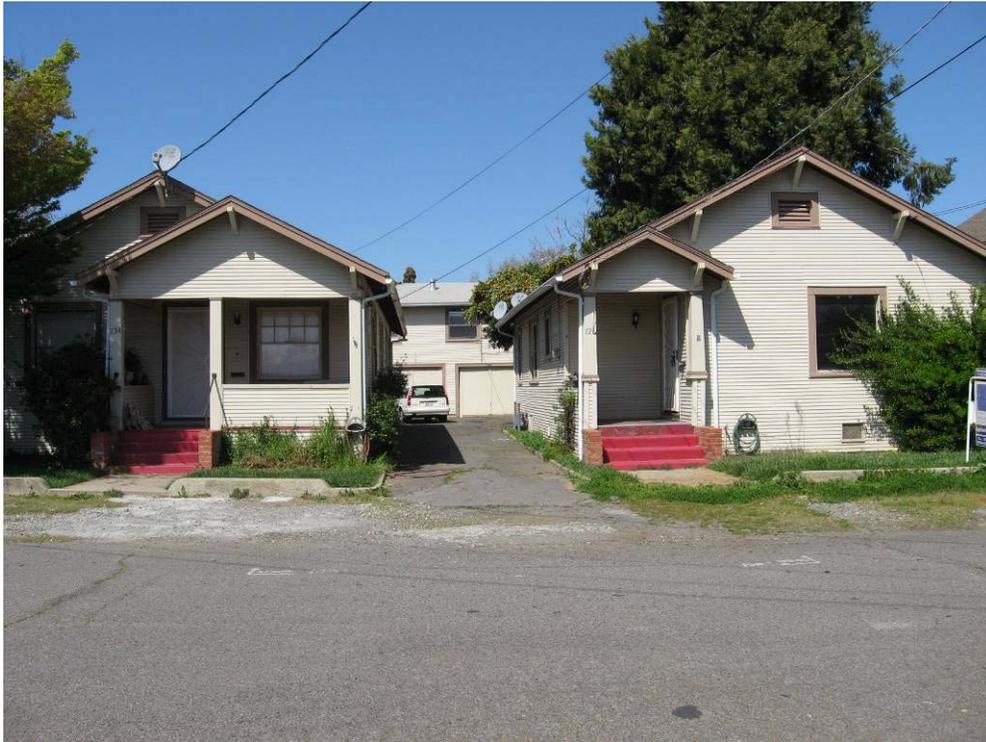
Also built circa 1910, 734 4th Street is a 1-story, wood frame, single-family residence designed in the Craftsman style. The building is rectangular in plan, clad in aluminum siding, and capped by a gable roof. The foundation is not visible. The primary facade faces south and features an entry porch on the east side. The porch is accessed by concrete steps with brick wing walls, and features a solid railing and square columns that support a gable roof. The primary entry is located near the center of the facade, and is covered by a metal security gate and surrounded by flat board trim. Typical fenestration consists of single-pane, fixed; and 8-over-1 and 6-over-1, double-hung; wood-sash windows with flat board trim. The roofline features broad open eaves, with knee braces and the gabled end contains a louvered attic vent. 734 4th Street appears to be in good condition.

Concrete curbs front the lot and a paved driveway runs down the center of the lot, between the two houses. A 2-story, auxiliary residential building is located at the rear of the lot. It appears to have been constructed sometime between 1924 and 1949 and is rectangular in plan, clad in aluminum siding, and capped by a hip roof. It features two garage entrances with flush wood awning doors on the first story. Fenestration consists of 1-over-1, double-hung, aluminum-sash replacement windows.

736 (left) and 726 (right) 4th Street, looking north from 4th Street. Auxiliary residential structure is visible at rear.

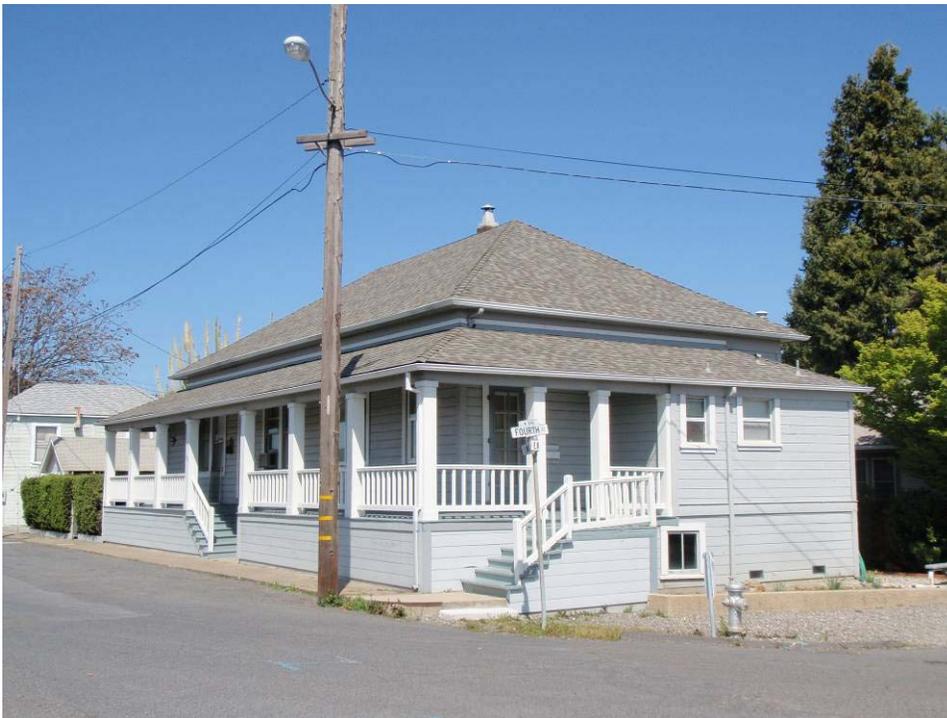
*P3a. Description: (Describe resource and its major elements. Include design, materials, condition, alterations, size, setting, and boundaries.)
744 4th Street is located on a rectangular lot on the northeast corner of 4th and Lawrence streets. Built circa 1905, 744 4th Street is a 1-story over raised basement, wood frame, residential duplex designed in a vernacular style with Greek Revival influences. The building is rectangular in plan, clad in wood shiplap siding, and capped by a hip roof. The foundation is concrete. The primary facade faces west and features a veranda that spans the façade and continues along the north and south facades. The veranda is interrupted at the center of the primary façade by a flight of wood stairs which provide access to the northern portion of the building. Another set of stairs on the south façade provide access to the building's southern portion. The veranda features a wood railing and square columns that support a hip roof. There are two primary entries; one (for 702 Lawrence St.) located near the center of the primary façade, and the other (744 4th St.) on the west side of the south façade. Both consist of fully-glazed, multi-pane, wood doors with flat board trim and molded hoods. Typical fenestration consists of 1-over-1, double-hung, wood-sash and replacement vinyl-sash windows with flat board trim. Architectural features include corner boards, a simple wood water table, an enclosed shed-roofed rear porch on the east façade, and a brick chimney with a metal cap near the roof ridge. The roofline features a plain frieze and shallow boxed eaves. (Continued)

P5b. Photo: (view and date)
Primary and west facades,
looking northeast from 4th St.
3/24/2009

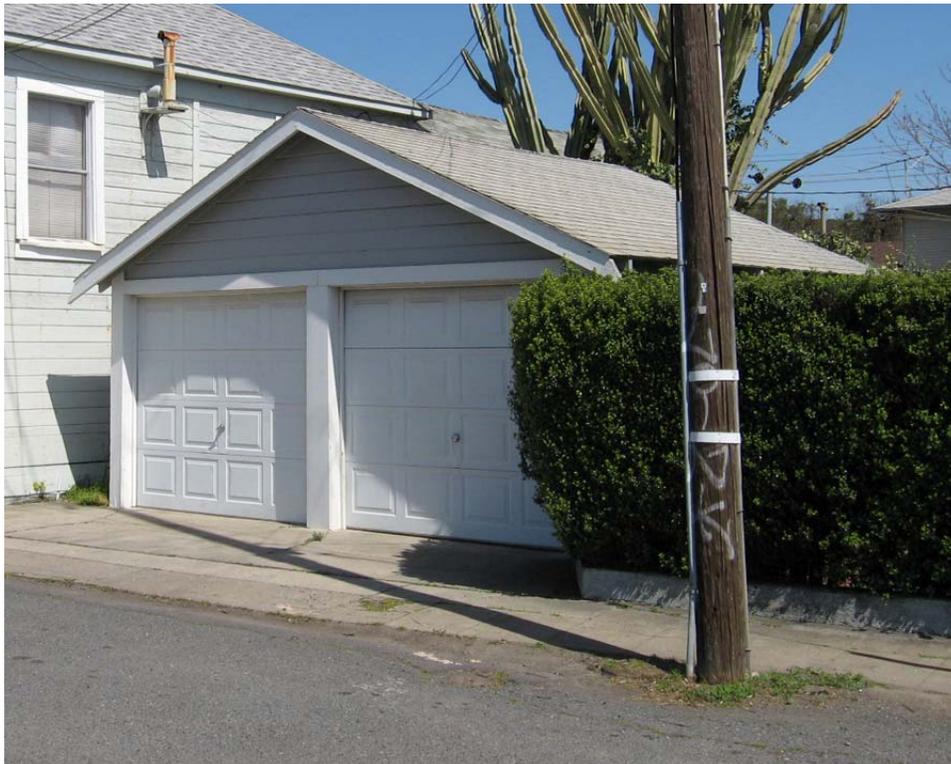
Concrete curbs enclose the lot and a detached garage at the northwest corner of the property is accessed from Lawrence Street. The garage is a 1-story, gable-roofed building, clad with wood shiplap siding, and features two roll up metal garage doors. It appears to have been constructed between 1924 and 1949. 744 4th Street appears to be in good condition.

Detached garage at rear of lot, looking northeast from Lawrence Street.

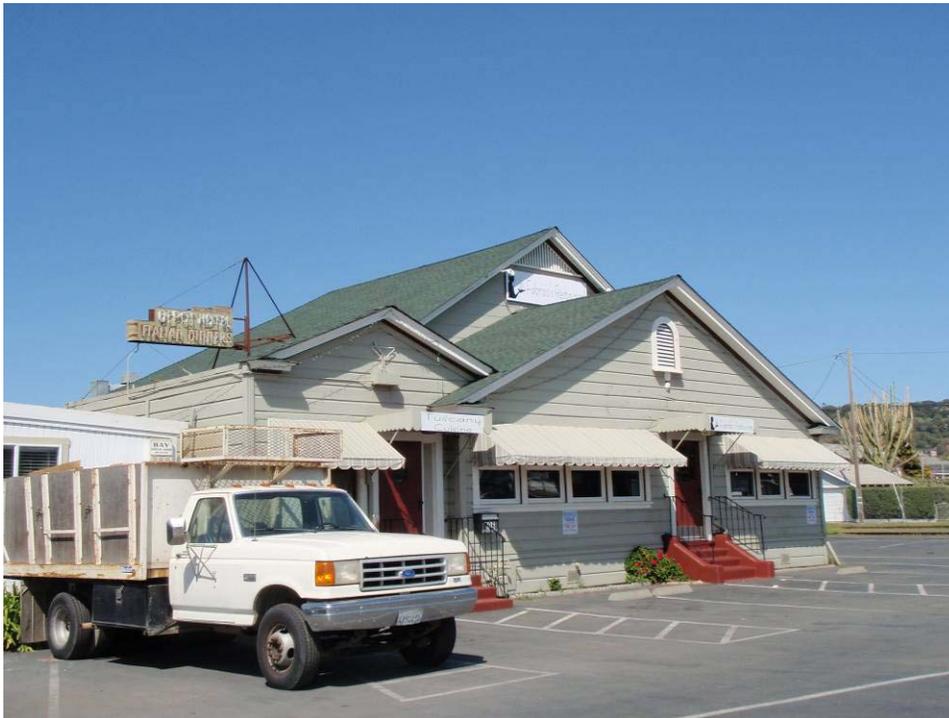
*P3a. Description: (Describe resource and its major elements. Include design, materials, condition, alterations, size, setting, and boundaries.)
806 4th Street is located on a rectangular lot on the north side of 4th Street, between Soscol Avenue and the Napa Valley Wine Trail railroad right-of-way. Built in 1881, 806 4th Street is a 1-story, wood frame, commercial building designed in a vernacular residential style with Greek Revival influences, but has been severely altered from its original form and appearance. The building is irregular in plan due to a number of additions, is clad in wood shiplap siding, and is capped by a compound gable and hip roof. The foundation is not visible. The primary facade faces south and features a wide projecting structural bay on the east, which appears to be an enclosed porch, and a smaller projecting structural bay on the west. Each bay is capped by a gable roof and features an entrance at the center. The entries are accessed by concrete steps with metal railings and are surmounted by flat canopies with scalloped trim supported by diagonal metal braces. They consist of partially-glazed, flush wood doors with flat board trim. Typical fenestration consists of one-over-one, double-hung, vinyl-sash replacement windows with flat board trim. Architectural features include corner boards, a historic neon sign on the southwest corner of the roof that reads "Depot Hotel Italian Dinners," and additions on the west and north facades. (Continued)

*P5b. Photo: (view and date)
Primary facade, looking
northeast from Soscol Ave.
3/24/2009

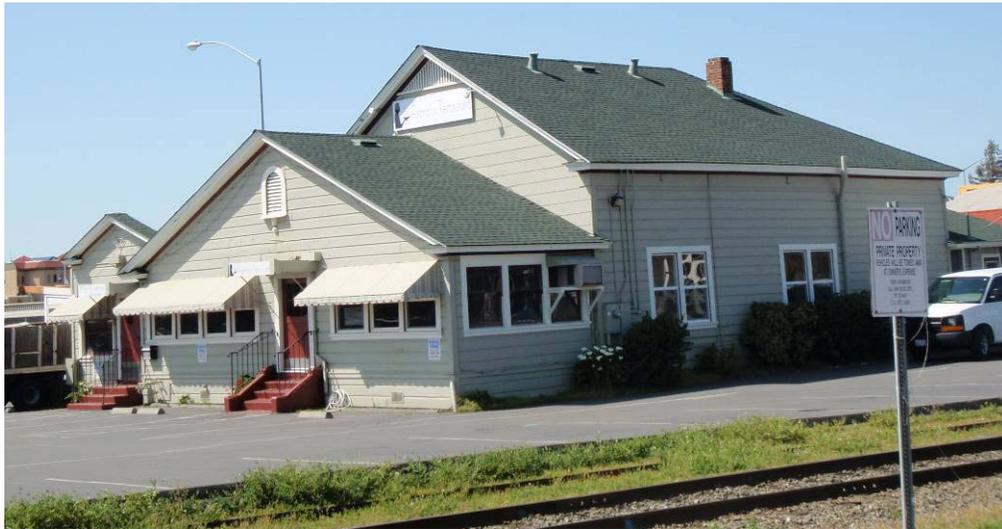
The roofline features a plain frieze on the east and north facades, shallow boxed eaves with rake boards, rake moldings, eave returns, and wood louvered and slatted attic vents in the gable ends. The building is surrounded by a paved parking lot. It appears to be in good condition.

Primary and east facades, looking northwest from Lawrence & 4th Streets.

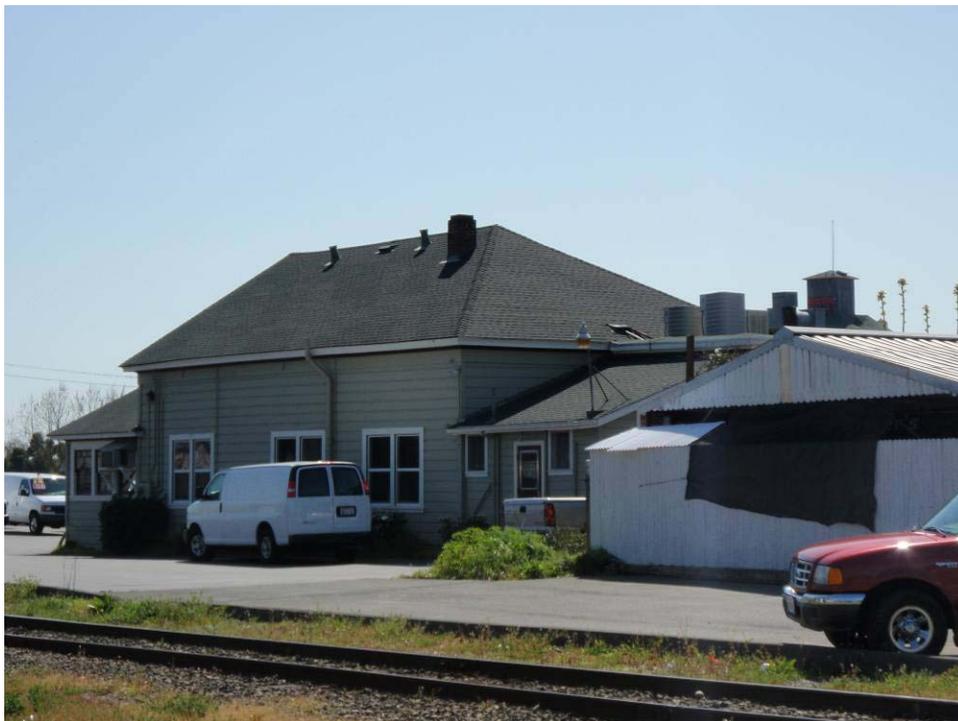
East and rear facades, including rear additions, looking southwest from Lawrence Street.
