Page 1 of 3 *Resource name(s) or number (assigned by recorder) 373 Silverado Trail

*P11. Report Citation: (Cite survey report and other sources, or enter "none") Heritage Napa: Soscol Gateway/East Napa Historic Resource Survey

Page 1 of 3 *Resource name(s) or number (assigned by recorder) 511 Silverado Trail

Page 1 of 2 *Resource name(s) or number (assigned by recorder) 801 Silverado Trail

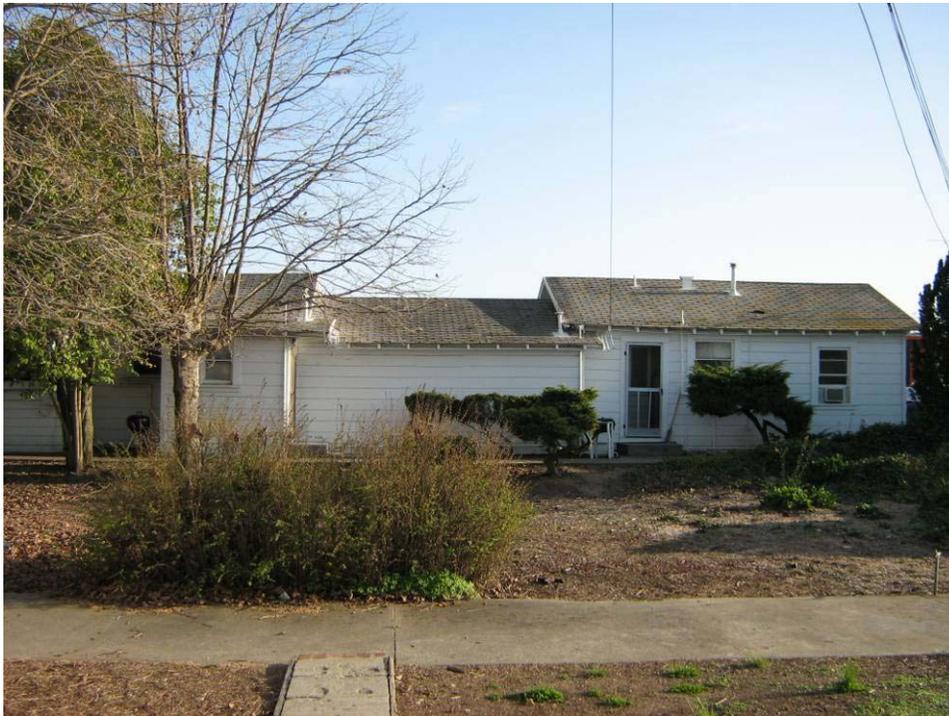
*P3a. Description: (Describe resource and its major elements. Include design, materials, condition, alterations, size, setting, and boundaries.)
373 Silverado Trail (also known as 488 Soscol Avenue) is located on a rectangular through lot between Silverado Trail and Soscol Avenue, south of Sousa Lane. Built circa 1925, 373 Silverado Trail is a collection of eight residential buildings located behind a non-historic commercial building (fronting on Soscol Avenue). The residences are primarily 1-story, wood frame, vernacular style buildings, with the exception of one 2-story, wood frame, Monterey Colonial Revival style house at the west end of the complex. The foundations are concrete. The 1-story buildings are all generally rectangular in plan. All are clad in wood shiplap siding and have hip and gable roofs. Visible entries feature partially-glazed, paneled, wood doors with flat board trim. Most entrances are approached by concrete steps and covered by shed-roofed porches supported by square wood or metal posts. Typical fenestration consists of one-over-one, double-hung, wood-sash windows with flat board trim. Architectural features include corner boards and the rooflines feature open eaves with exposed rafter tails and simple bargeboards in the gable ends.

P5b. Photo: (view and date)
North façade of 1-story residential bldg, looking south
3/24/2009

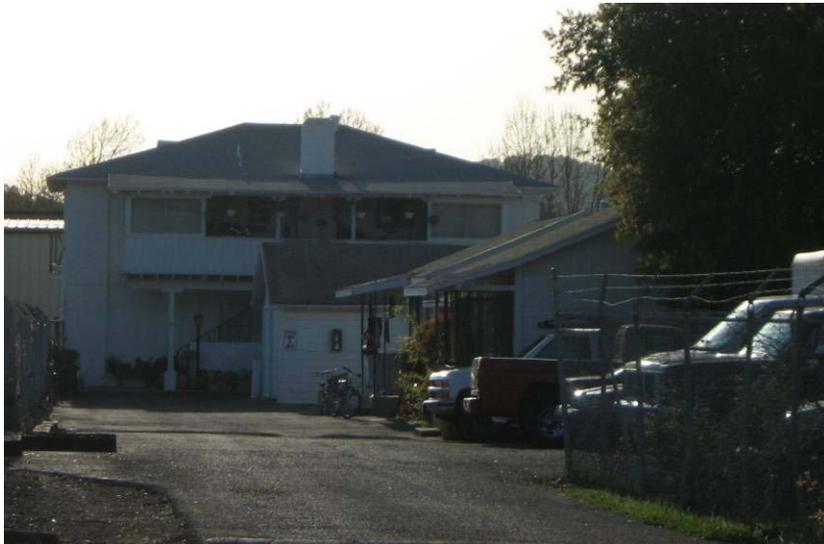
The 2-story residence is rectangular in plan, clad in stucco, and capped by a hip roof. The primary façade features east and includes a 2-story porch supported by square posts with block capitals and a thick horizontal beam. (Continued)

The upper story of the porch has a solid wood railing, is partially enclosed by windows on each end, and covered by a shed roof. Stairs with metal railings lead to the second story of the porch. The primary entry is not visible. Typical fenestration consists of one-over-one, double-hung, wood-sash windows flanked by decorative wood shutters and adorned with metal balconettes. Some sliding, aluminum-sash, replacement windows are also present. Architectural features include an exterior stuccoed chimney at the center of the primary façade, within the porch, and a slight overhang of the second story on the west façade. The roofline features open eaves with exposed rafter tails.

Primary façade of 2-story residence, looking west from Silverado Trail. 1-story residences visible at right.

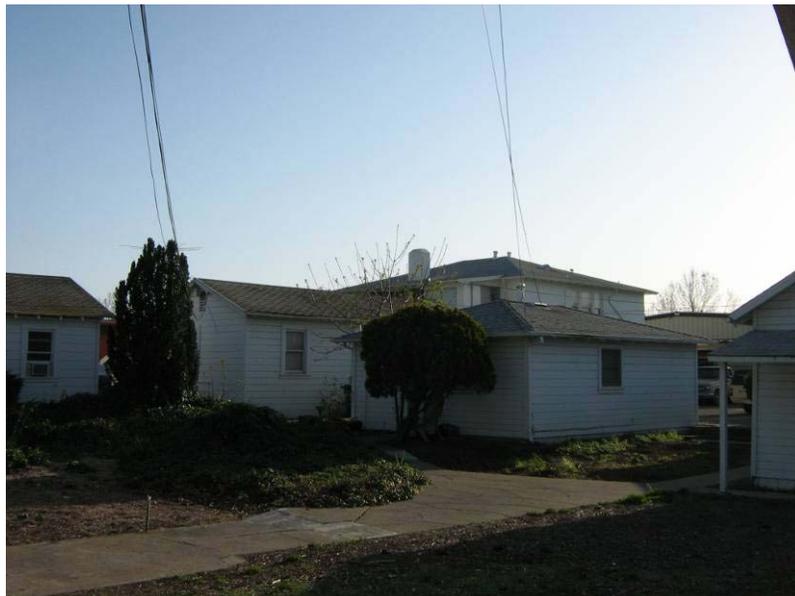
As noted, a non-historic commercial building is located to the southwest of the residential complex. A paved driveway approaches the residences from Silverado Trail and the rest of the lot is a paved parking area. All buildings appear to be in good condition.

Portion of residential complex, looking southwest. 2-story residence is visible at rear.

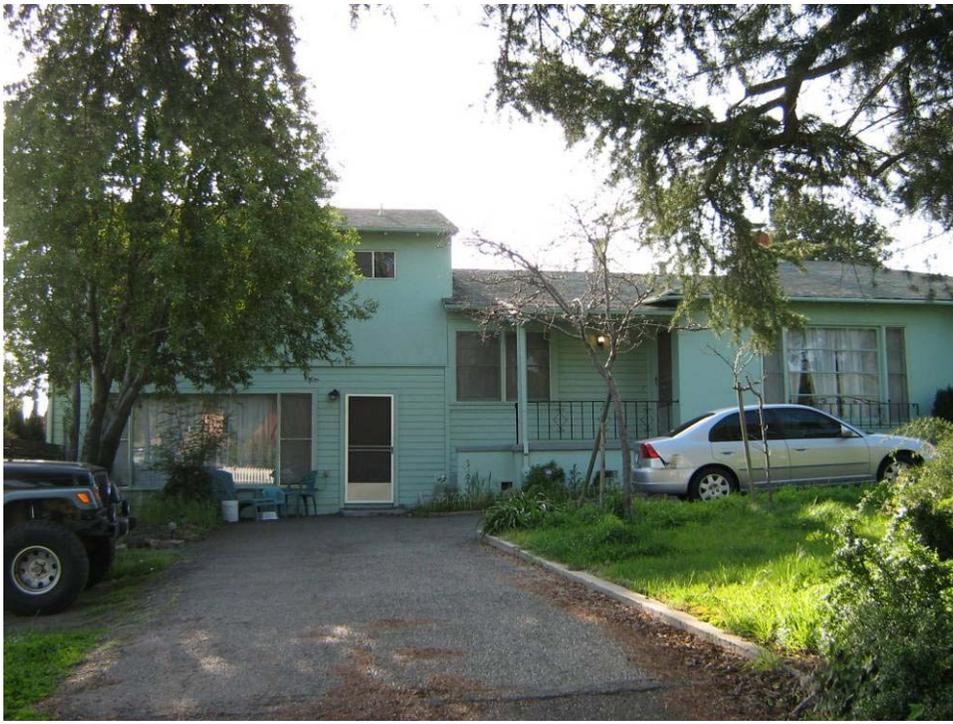
*P3a. Description: (Describe resource and its major elements. Include design, materials, condition, alterations, size, setting, and boundaries.)
 511 Silverado Trail is located on a rectangular lot on the west side of Silverado Trail, between the Napa County Fairgrounds and Sousa Lane. Built circa 1950, 511 Silverado Trail is a 2-story, wood frame, single-family residence designed in the Modern style. The building is irregular in plan with a split level configuration. It is capped by a compound gable and hip roof, and is clad with stucco and wood shiplap siding. The foundation is not visible. The primary facade faces east and features a 2-story block on the south, a central entry porch, and a slightly projecting structural bay on the north. The entry porch is approached from the south by concrete steps and has a metal railing and a square wood post that supports a shed roof. The primary entry is located on the north wall of the porch and is covered by a metal screen door. A secondary entry is located at the first story level of the southern portion of the house and is approached by a concrete step and covered by a metal screen door. Typical fenestration consists of two-over-two, double-hung, wood-sash windows with horizontal muntins. A large multi-pane, fixed, wood-sash window, flanked by two of these double-hung windows and adorned with a metal balconette, is located on the north side of the primary façade. A picture window flanked by two double-hung, aluminum-sash windows is located at the first story on the south side of the primary façade. Sliding, aluminum-sash windows are located at the second story level of the primary facade. (Continued)

*P5b. Photo: (view and date)
 Primary facade, looking west
 from Silverado Trail
3/24/2009

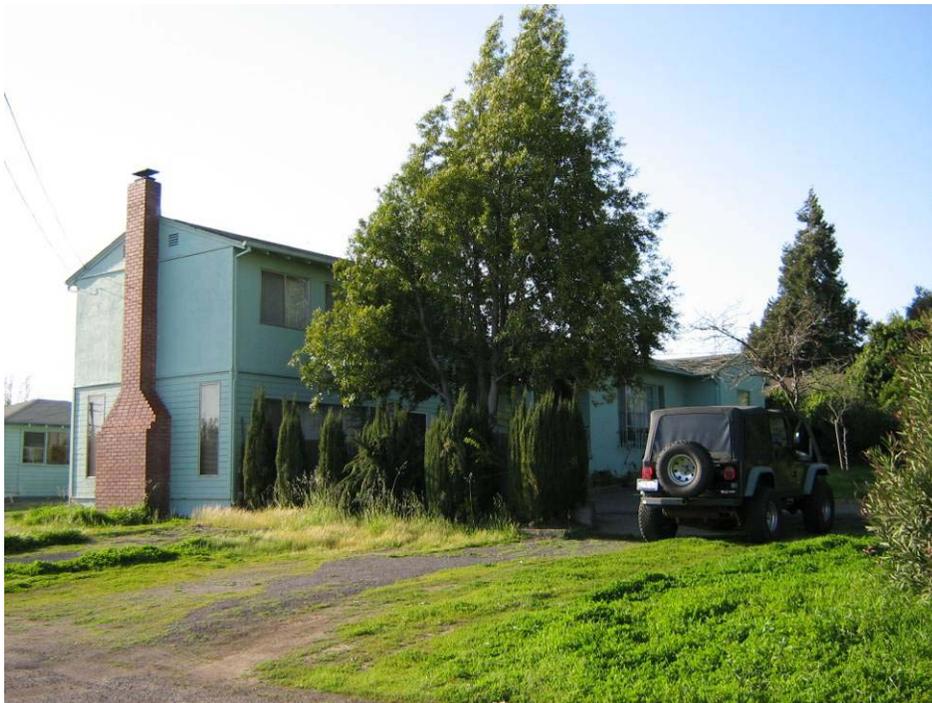
Architectural features include an exterior brick chimney on the south façade and an interior brick chimney at the north end of the roof. The roofline features open eaves with exposed rafter tails, and eaveless gable ends with eave moldings and triangular metal attic vents.

An unpaved driveway is located on the south side of the lot, with a turn-around at the rear of the lot. All three buildings appear to be in good condition.

South and primary facades, looking northwest from Silverado Trail. Secondary residence visible at far left.

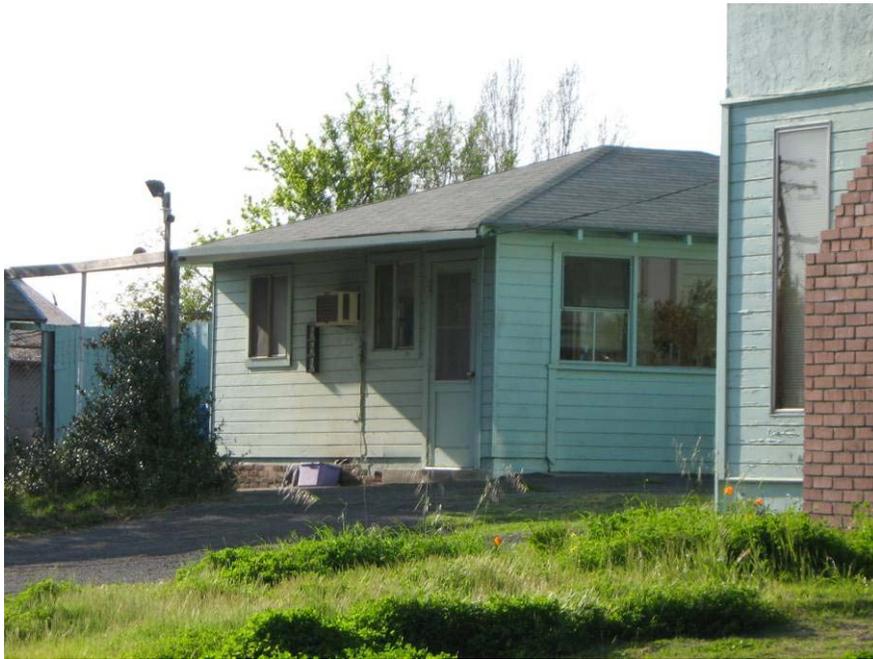
A secondary residential building is located to the rear (west) of the main house. Built circa 1940, the secondary residence is a 1-story, wood frame, single-family residence designed in a vernacular style. The building is rectangular in plan, capped by a hip roof, and clad with wood shiplap siding. The foundation is concrete. The primary entrance appears to be located at the east side of the south façade and is a partially-glazed, paneled, wood door. A metal carport projects from the south façade. Typical fenestration consists of single-pane, fixed, wood-sash windows and sliding, aluminum-sash, replacement windows, with flat board trim. The roofline features open eaves with exposed rafter tails.

Secondary residential building, south and east façades, looking northwest from Silverado Trail.

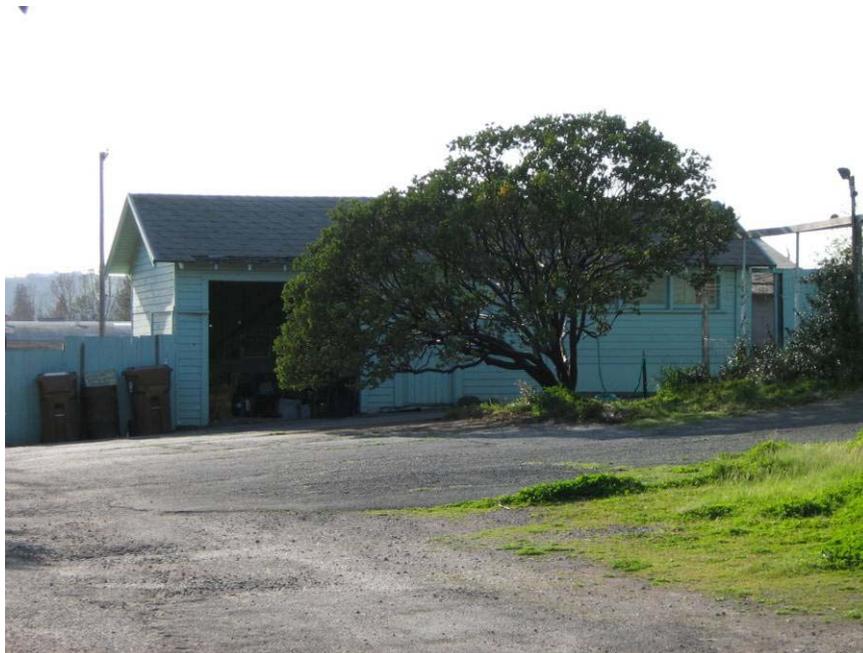
To the rear (west) of the secondary residence, is an auxiliary building, that appears to function as a garage and shop. Built circa 1940, it is a 1-story, wood frame, vernacular style building. It is rectangular in plan, capped by a gable roof, and clad with wood shiplap siding. The foundation is not visible. A vehicular entrance is located at the south end of the primary (east) façade and has no door. A pedestrian entrance is located near the center of the façade and features a door made of vertical wood boards. A band of single-pane, fixed, wood-sash windows is located on the north side of the primary façade. The roofline features open eaves with exposed rafter tails. A gable-roofed, corrugated metal addition is located on the northwest corner of the auxiliary building.

Auxiliary building, east facade, looking west from Silverado Trail.

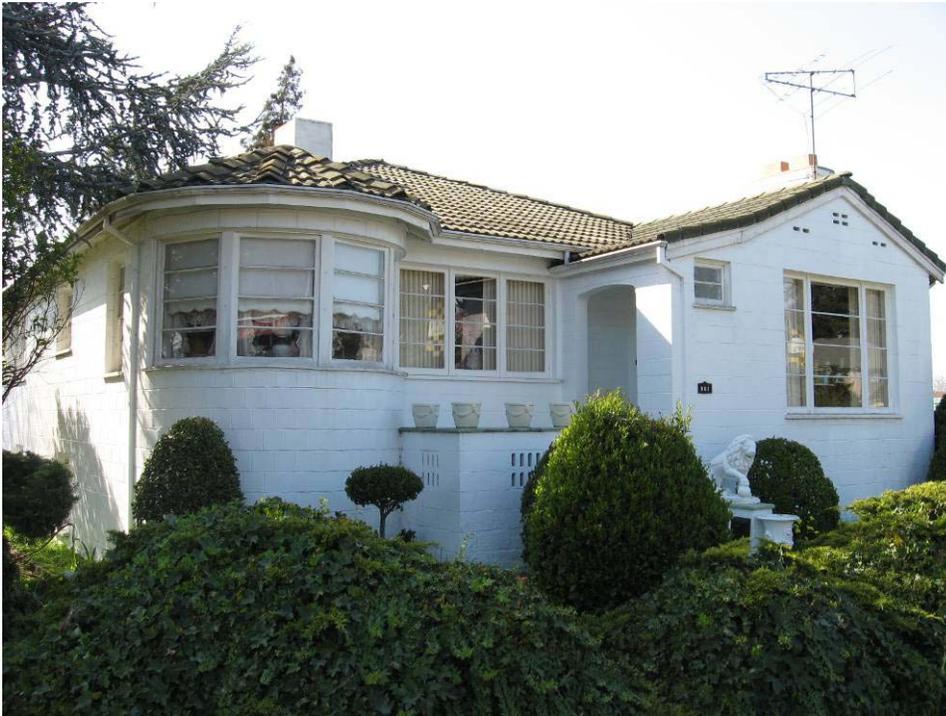
*P3a. Description: (Describe resource and its major elements. Include design, materials, condition, alterations, size, setting, and boundaries.)
801 Silverado Trail is located on a rectangular lot on the northwest corner of Silverado Trail and 3rd Street. Built in 1939, 801 Silverado Trail is a 1-story over raised basement, concrete block, single-family residence designed in the Mediterranean Revival style. The building is rectangular in plan, capped by a hip roof clad with clay tile, and the exterior walls consist of structural concrete block. The foundation is not visible. The primary facade faces east and features a round bay window on the south, and a projecting gable-roofed structural bay on the north. A recessed entry with a centered arch opening is located on the south side of this projecting bay and is accessed by concrete steps and a small deck surrounded by a pierced concrete block railing. The primary entry is a flush wood door with a peep window in the upper portion and molded wood trim. Typical fenestration consists of two-over-two, double-hung and four-pane, casement wood-sash windows with horizontal muntin patterns. Architectural features include a concrete block exterior chimney on the north façade, a concrete interior chimney on the north side of the roof, and a gable-roofed porch on the rear facade. The roofline features shallow open eaves with plain fascia boards, and pierced attic vents in the gable end. The building appears to be in good condition.

*P5b. Photo: (view and date)
Primary facade, looking northwest from Silverado Trail
3/24/2009

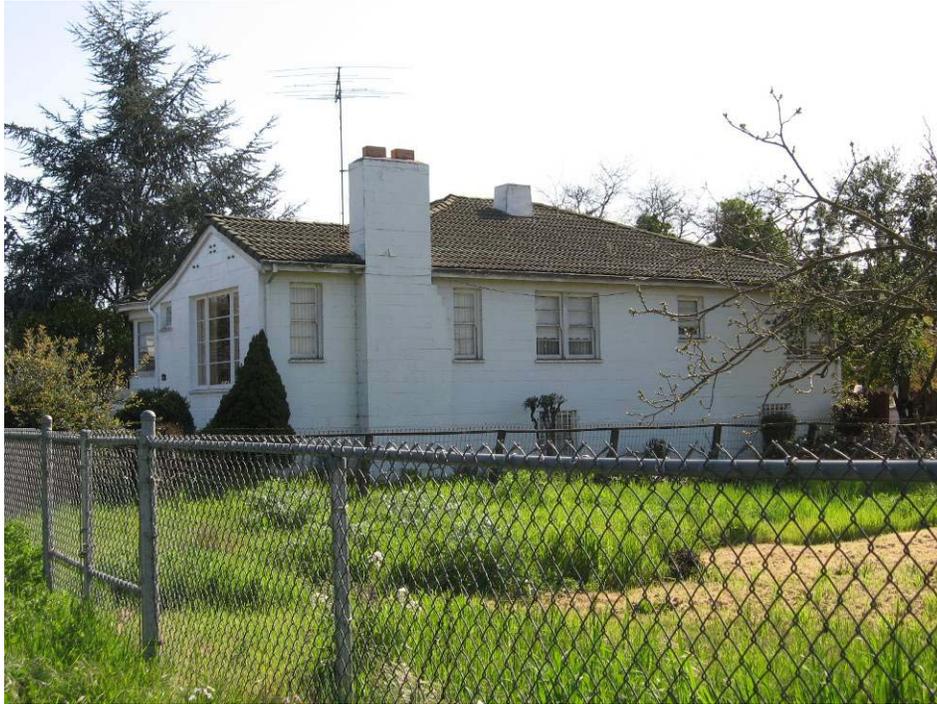
North façade, looking southwest from Silverado Trail.

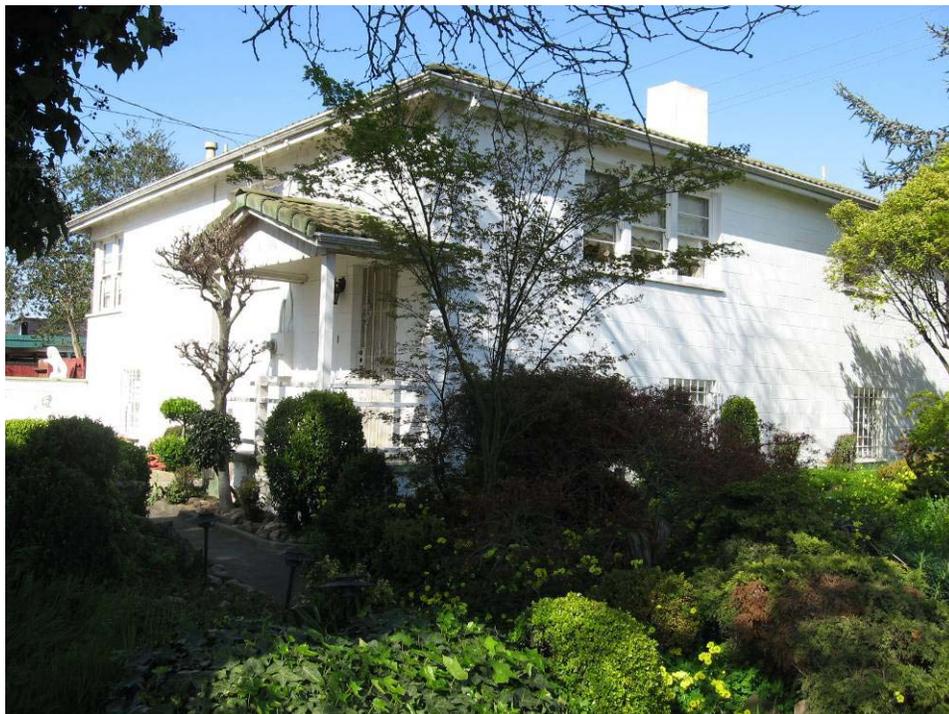
Rear (west) and south facades, looking northeast from 3rd Street.
