**PHASE I  
ENVIRONMENTAL  
SITE ASSESSMENT**

Napa Oaks  
Napa, California

Prepared For:  
Mr. Wayne Policz  
Davidon Homes

ACC Project No. 97-6438-001.00

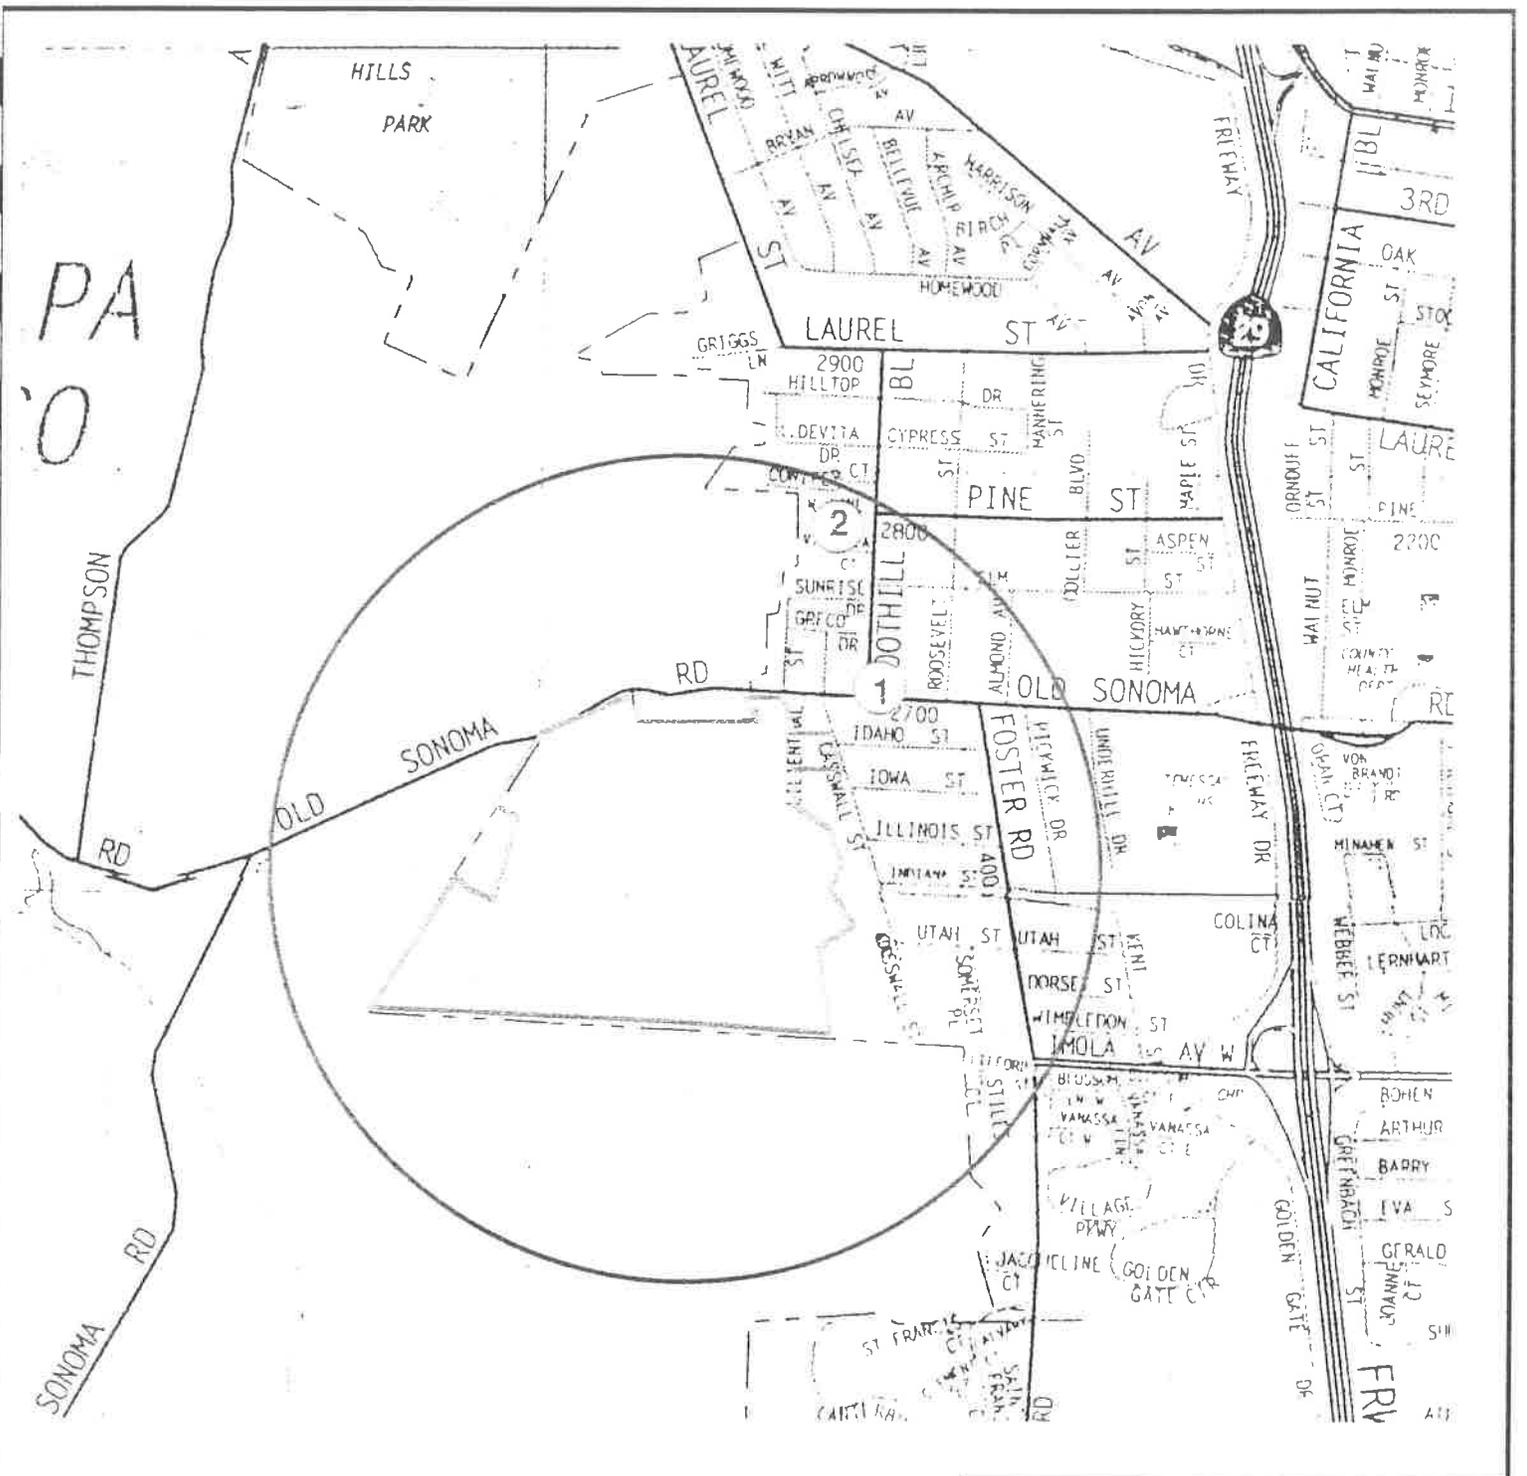
Title: 1/2 Mile Radius Map Napa Oaks Site Napa, California	
Figure Number: 9	Scale: 1" = 1/4'
Drawn By: CLM	Date: 8/11/97
Project Number: 97-6438-001.00	
<b>ACC Environmental Consultants</b> 7977 Capwell Drive, Suite 100 Oakland, California 94621 (510) 638-8400 Fax: (510) 638-8404

**Site Name:** J & P Market  
**Site Address:** 2764 Old Sonoma Road  
**Gradient Direction:** Downgradient  
**Distance/Direction:** 0.32 mile Northeast  
**Radius Map:** Figure 9, Mapped Site #1

**Site Name:** Diego Sheila Verza  
**Site Address:** 2937 West Pine Street  
**Gradient Direction:** Downgradient  
**Distance/Direction:** 0.46 North-Northeast  
**Radius Map:** Figure 9, Mapped Site #2
