State of California — The Resources Agency
DEPARTMENT OF PARKS AND RECREATION
PRIMARY RECORD

Page 1 of 3 *Resource name(s) or number (assigned by recorder) 711 8th Street / 589 Soscol Avenue

P1. Other Identifier: Blaufuss Cider

*P11. Report Citation: (Cite survey report and other sources, or enter "none") Heritage Napa: Soscol Gateway/East Napa Historic Resource Survey

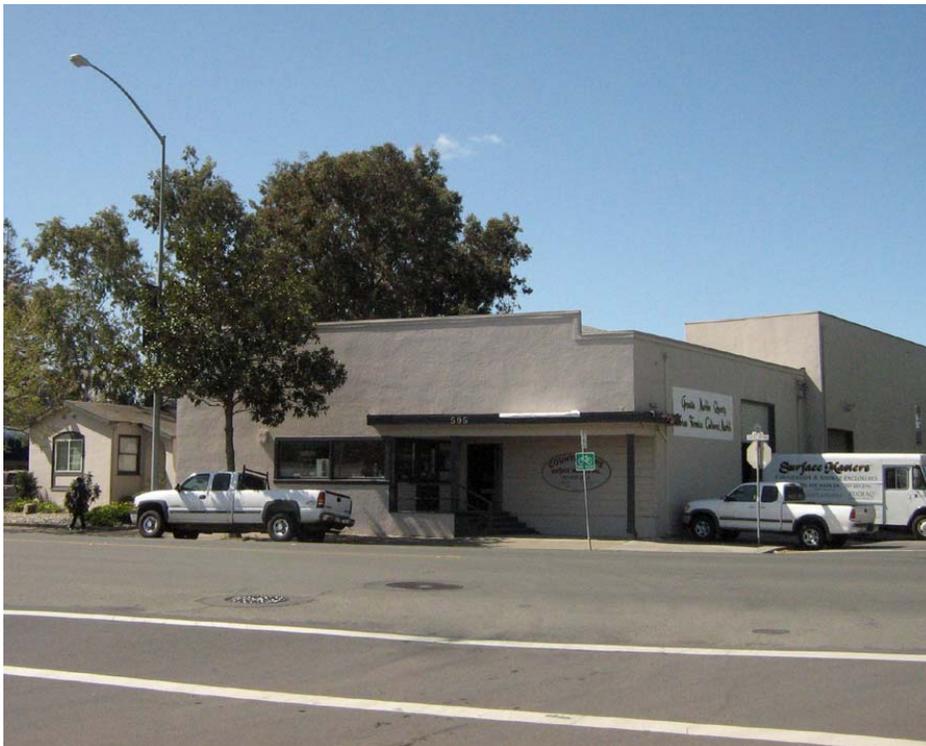
*P5b. Photo: (view and date)
Primary and north façades,
looking west from Soscol Avenue
4/1/2009

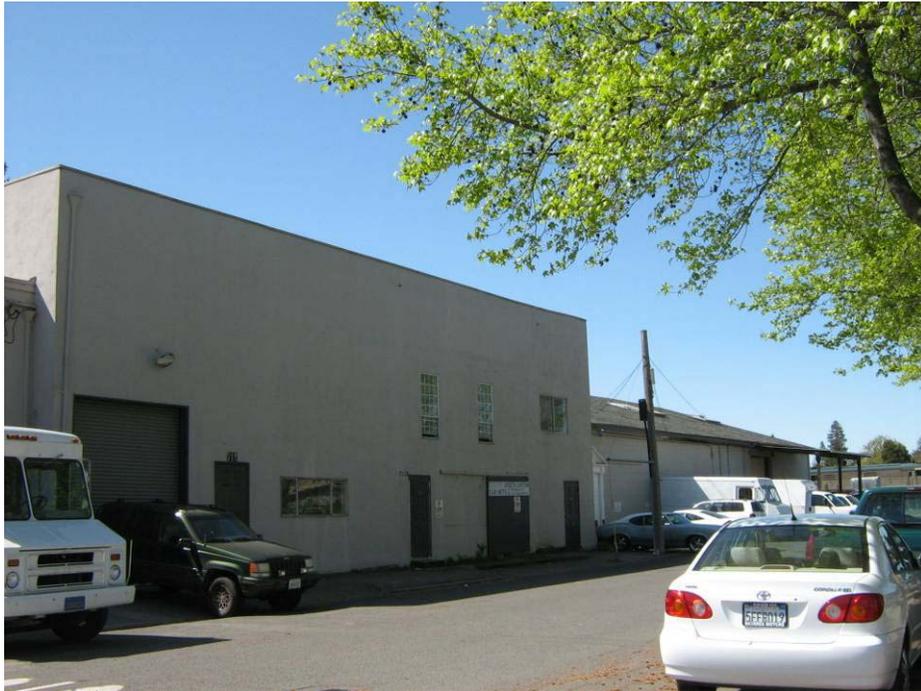
A pedestrian entrance near the center of the north façade features a Neoclassical temple front surround with engaged columns and a pediment adorned with decorative motifs. Fenestration on the office block consists of single-pane, fixed, wood windows, while on the warehouse portion of the building there are sliding and double-hung, vinyl and aluminum-sash replacement windows. Architectural features include a shallow, flat awning above the entry porch. The roofline of the office block features a stepped parapet surrounding the bow truss roof, while the gable roof of the warehouse has shallow open eaves with exposed rafter tails. 711 8th Street appears to be in good condition.

711 8th Street, north façade of warehouse block, looking southwest from 8th Street.

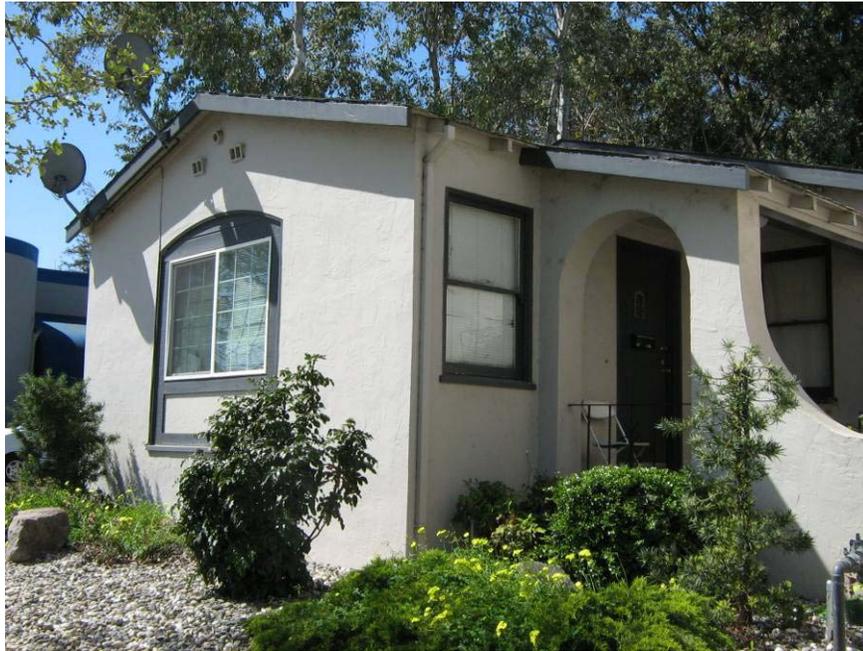
589 Soscol Avenue is located at the southeast corner of the lot and is surrounded by the larger industrial building on the north and west. It appears to have been constructed circa 1925 and is a 1-story, wood frame, residential building designed in the Spanish Eclectic style. The building is generally rectangular in plan, clad in stucco, and capped by a gable roof. The foundation is not visible. The primary facade faces east with an entry porch at the northeast corner. The porch features a round arched opening and a curved wing wall projecting to the north. The entry, located on the south wall of the porch, features a flush wood door with a peep window in the upper portion. Typical fenestration consists of 1-over-1, double-hung, wood-sash windows with molded wood trim. A sliding, vinyl-sash, replacement window is located on the primary façade and has been inserted within a segmental arch opening that also contains wood trim and a stuccoed wall panel below the window. The roofline features shallow open eaves with exposed rafter tails, bargeboards and rectangular and round clay tile attic vents in the gable end. 589 Soscol Avenue appears to be in good condition.

589 Soscol Avenue, detail of primary façade and entry, looking southwest from Soscol Ave.

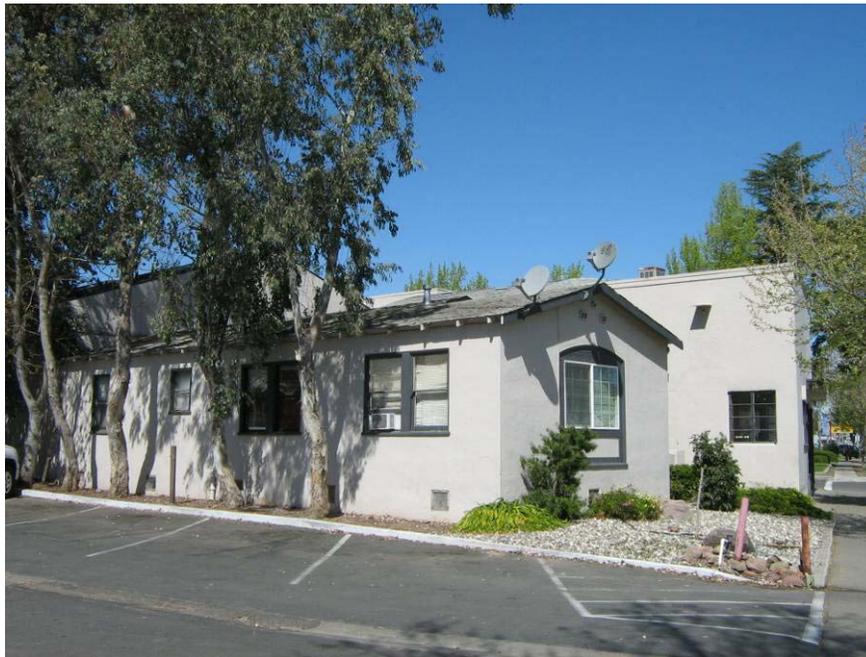
589 Soscol Avenue, primary and south facades, looking north. (711 8th Street visible behind.)
