State of California — The Resources Agency
 DEPARTMENT OF PARKS AND RECREATION
PRIMARY RECORD

Page 1 of 1 *Resource name(s) or number (assigned by recorder) 427 Post Street

*P11. Report Citation: (Cite survey report and other sources, or enter "none") Heritage Napa: Soscol Gateway/East Napa Historic Resource Survey

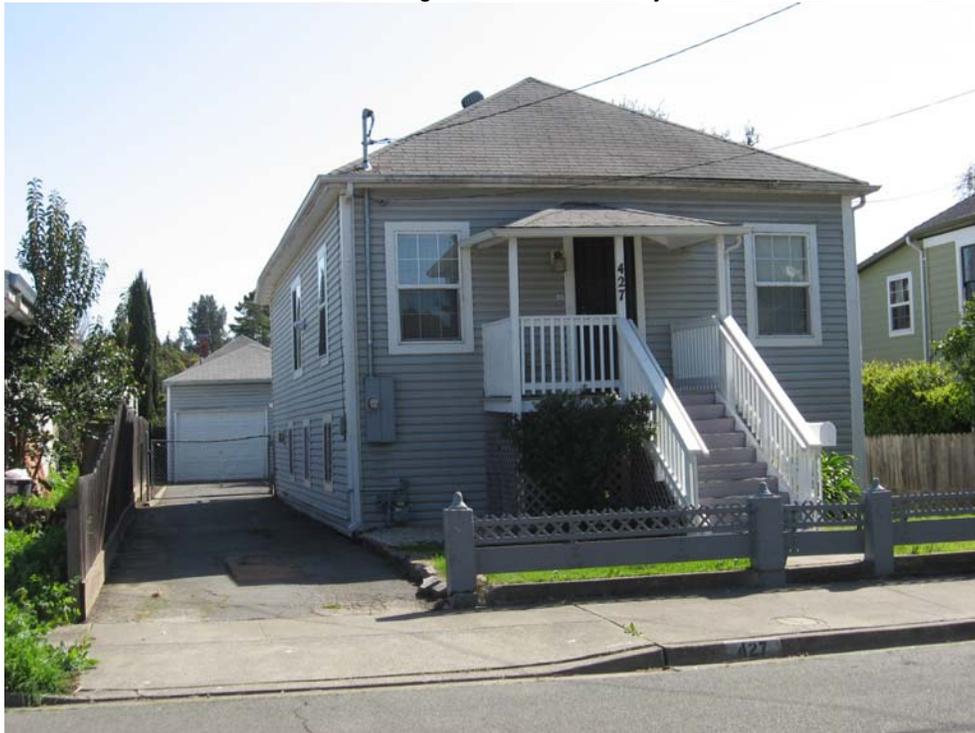
427 Post Street is located on a rectangular lot on the south side of Post Street, between the Napa River and Juarez Street. Built circa 1905, 427 Post Street is a 1-story over raised basement, wood frame, single-family residence designed in the Simple Bungalow style. The building is rectangular in plan, clad in vinyl siding, and capped by a hip roof. The foundation is not visible. The primary facade faces north and features an entry porch at the center. The porch is accessed by wood steps and features wood railings and square wood posts that support a hip roof. The primary entrance is located at the center of the façade and features a paneled wood door with flat board trim. Typical fenestration consists double-hung, vinyl-sash replacement windows with false muntins and flat board trim. Architectural features include corner boards. The roofline includes shallow boxed eaves. A paved driveway is located on the east side of the house and leads to a hip-roofed, detached garage at the rear of the lot. The front of the lot is enclosed by a concrete curb and a low decorative wood fence. The house appears to be in good condition.

P5b. Photo: (view and date)
 Primary façade, looking south
 from Post Street
3/24/2009

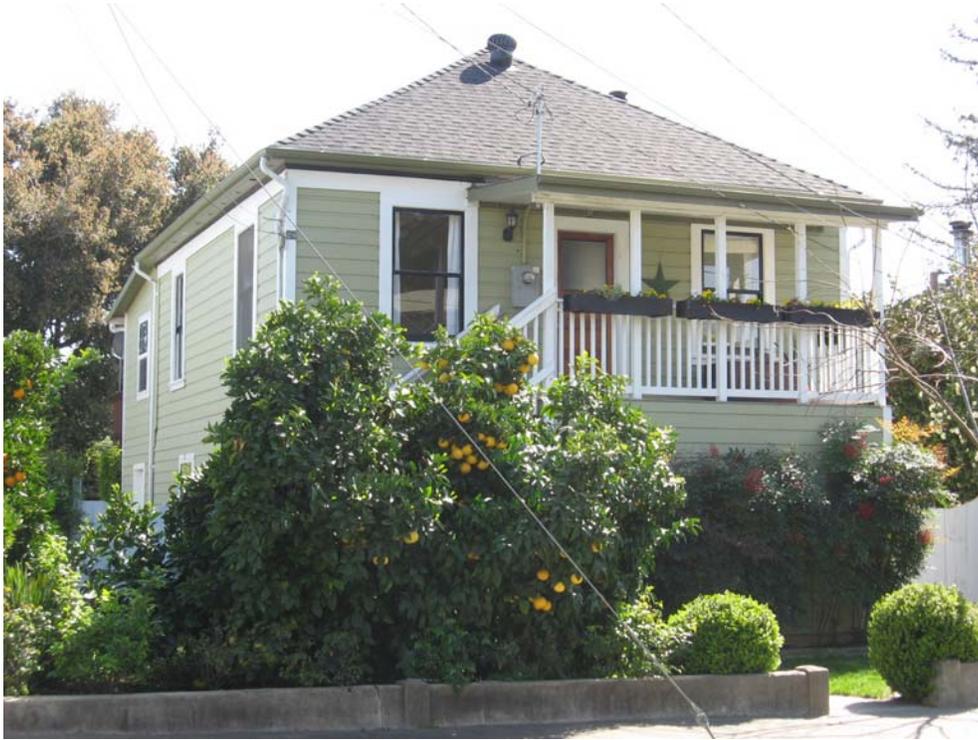
*P3a. Description: (Describe resource and its major elements. Include design, materials, condition, alterations, size, setting, and boundaries.)
437 Post Street is located on a rectangular lot on the south side of Post Street, between the Napa River and Juarez Street. Built circa 1905, 437 Post Street is a 1-story over raised basement, wood frame, single-family residence designed in the Simple Bungalow style. The building is rectangular in plan, clad in channel drop wood siding, and capped by a hip roof. The foundation is not visible. The primary facade faces north and features an entry porch on the west side. The porch is accessed by wood steps that approach from the east and features wood railings and square wood posts that support a shed roof. The primary entrance is located at the center of the façade and features a partially-glazed, paneled wood door with flat board trim. Typical fenestration consists one-over-one, double-hung, wood-sash windows with flat board trim. Architectural features include corner boards and a shed-roofed rear addition. The roofline includes a plain frieze, eave moldings, and shallow boxed eaves. A paved two-track driveway is located on the west side of the house and the front of the lot is enclosed by a low concrete sitewall. The house appears to be in good condition.

P5b. Photo: (view and date)
Primary façade, looking south from Post Street
3/24/2009

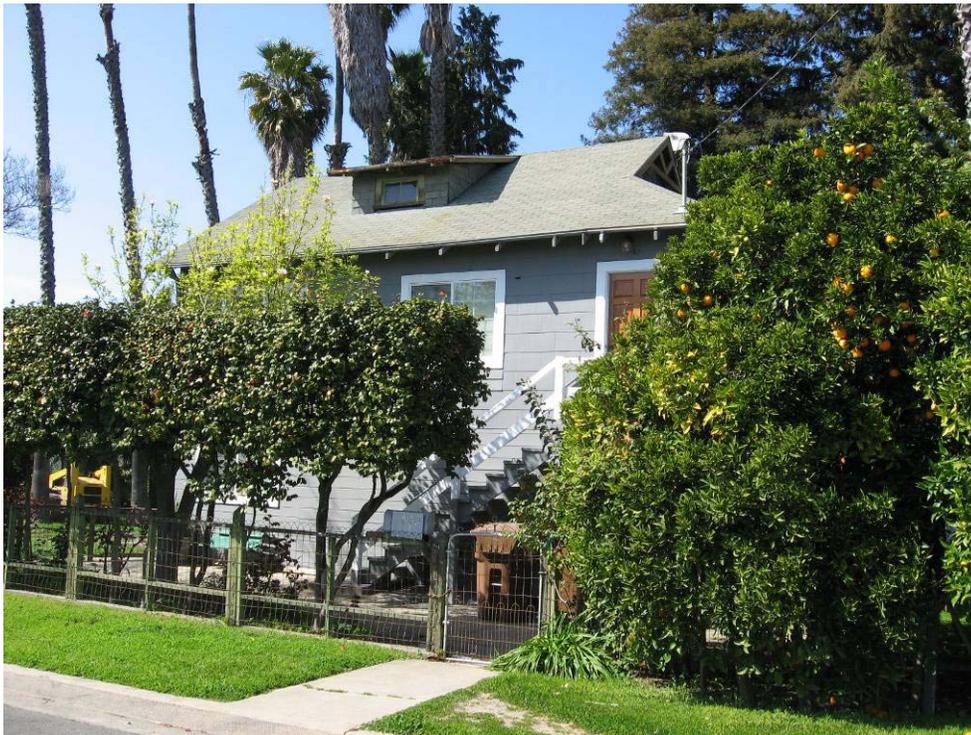
*P3a. Description: (Describe resource and its major elements. Include design, materials, condition, alterations, size, setting, and boundaries.)
 442 Post Street is located on a roughly square lot on the north side of Post Street, between the Napa River and Juarez Street. Built in 1925, 442 Juarez Street is a 1-story over raised basement, wood frame, single-family residence designed in the Craftsman style. The building is generally rectangular in plan, clad in wood shingles with wood shiplap siding at the basement level, and capped by a combination gable and gable-on-hip roof. The foundation is not visible. The primary facade faces south with the primary entry on the east side. The entry is accessed by wood stairs with wood railings that run parallel to the facade and features a paneled wood door surrounded by flat board trim. A secondary entrance is located at the basement level of the west facade. The roofline includes exposed rafter tails, knee braces in the west gable end, a decorative wood truss in the east gable end, and a shed dormer on the south side of the roof. The lot is enclosed by a wood and wire fence and a detached garage with a gable roof and wood board-and-batten siding is located at the east side of the lot. The house appears to be in good condition.

P5b. Photo: (view and date)
 Primary façade, looking north from Post Street.
3/24/2009

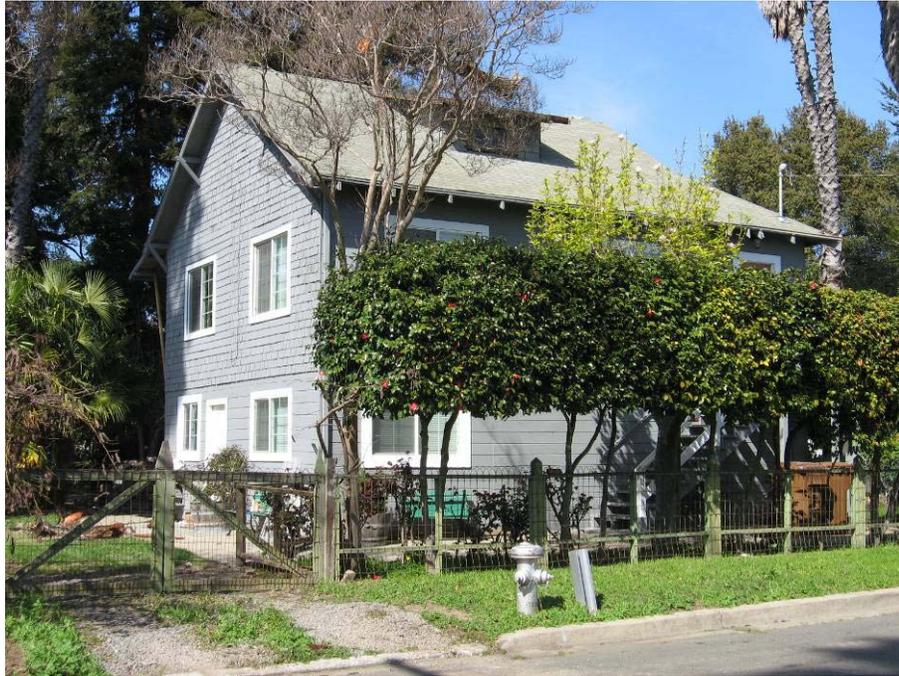
Primary and west facades, looking northeast from Post Street.

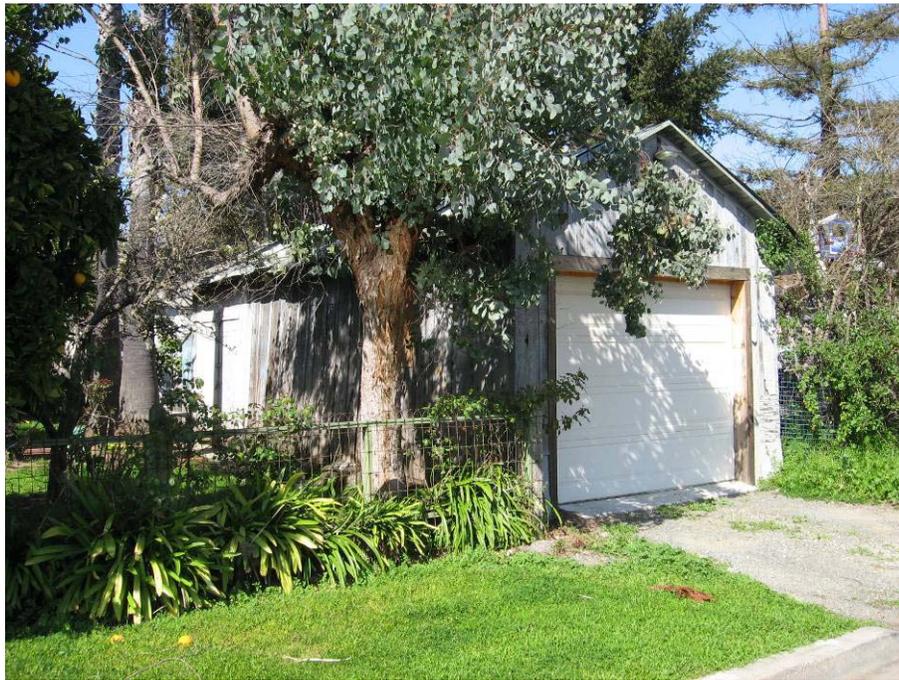
Detached garage to east of house.

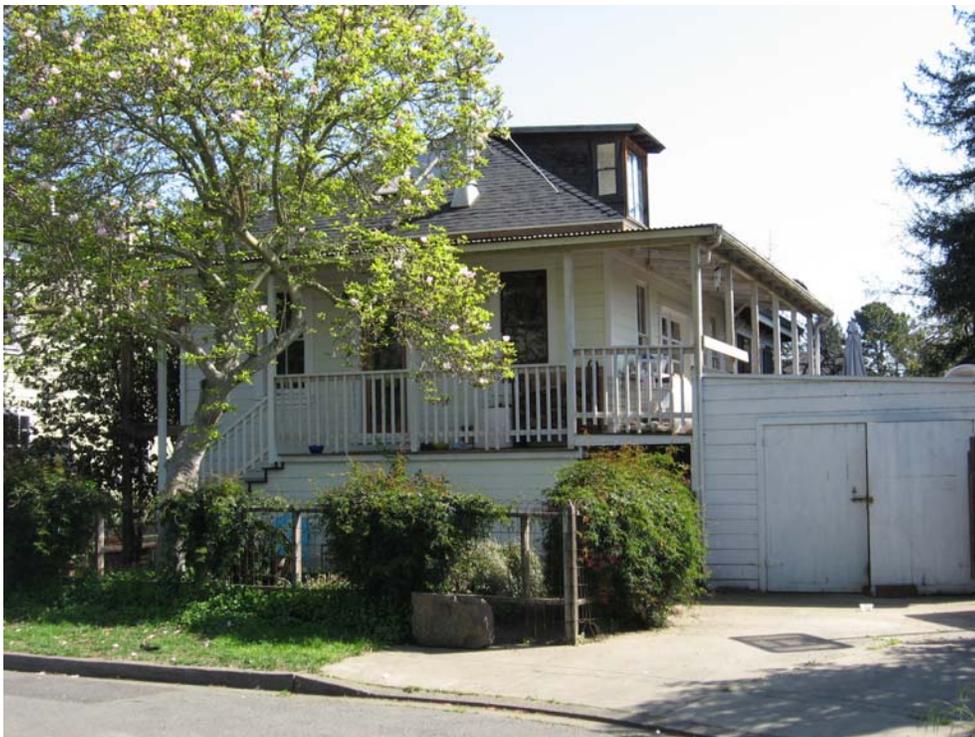
*P3a. Description: (Describe resource and its major elements. Include design, materials, condition, alterations, size, setting, and boundaries.)
443 Post Street is located on a roughly square lot on the south side of Post Street, between the Napa River and Juarez Street. The lot borders the river on the west side. Built circa 1905, 443 Post Street is a 1-story over raised basement, wood frame, single-family residence designed in the Simple Bungalow style, though altered. The building is rectangular in plan, clad in wood shiplap siding, and capped by a hip roof. The foundation is not visible. The primary facade faces north and features a full-width veranda that also wraps the northwest corner of the house and continues along the west facade. The porch is approached from the east by wood steps and features wood railings and square posts that support a hip roof made of corrugated metal. The primary entrance is located at the center of the primary façade and consists of a fully-glazed, wood replacement door with flat board trim. A secondary entrance, consisting of fully-glazed, wood French doors is located on the west façade. Typical fenestration consists of two-over-two, double-hung, wood-sash windows with flat board trim. Architectural features include corner boards, a large rear addition, and a shed-roofed garage addition with hinged double doors that is attached to the west side of the veranda. The roofline includes metal stove pipes on the north and east sides of the roof, and a shed dormer on the west side. The front of the lot is enclosed by a wood and wire fence. The house appears to be in good condition.

*P5b. Photo: (view and date)
Primary and west façades,
looking south from Post Street
3/24/2009
